Berry, L., Phillips, C. & Penney, D. (2016). Understanding the role of snout contamination in the formation of an oxide based defect in hot dip galvanised coating. *Surface and Coatings Technology*

Understanding the role of snout contamination in the formation of an oxide based defect in hot dip galvanised coating

Lewis J. Berry, Craig H. Phillips, David J. Penney

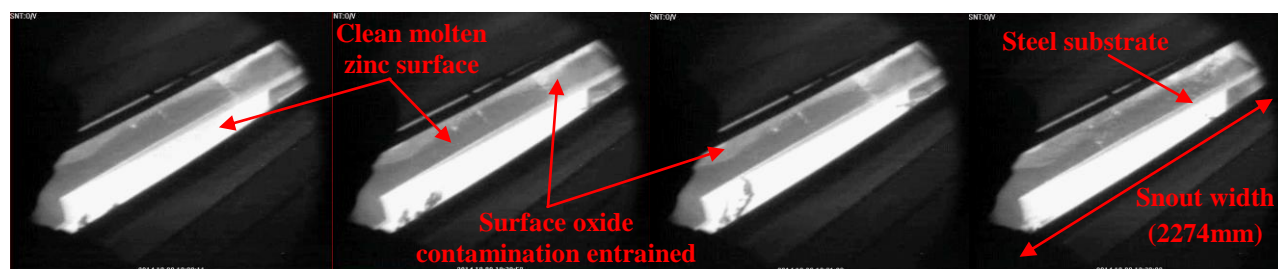
Figure 2

The entrainment of the surface oxide type contamination was observed with use of the snout camera as indicated in Fig. 2 and with consideration of the XRD patterns produced by the arrowhead defect and the contamination collected from the snout, a consistent and distinct ZnO peak is observed at  $\theta = 32$  at increased penetration depths, Fig. 18. Whilst the intensity of the ZnO peaks associated with other crystal planes are masked by the intensity of the zinc peaks, this distinct ZnO  $[\bar{1},0,0]$  crystal plane is readily observed and confirms the presence of particles from the ZnO barrier layer within the arrowhead defect. This assignment is confirmed with analysis of the SEM/EDX cross sections and incrementally etched samples whereby discrete ZnO particles are observed within the zinc coating.

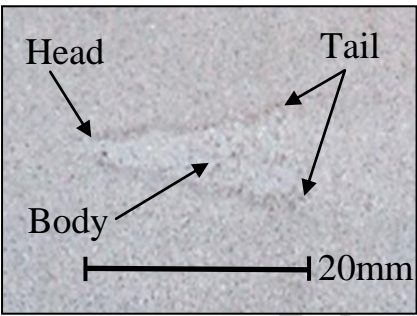
Figure 3 – Arrowhead defect image taken from Galvanizing line quality inspection system

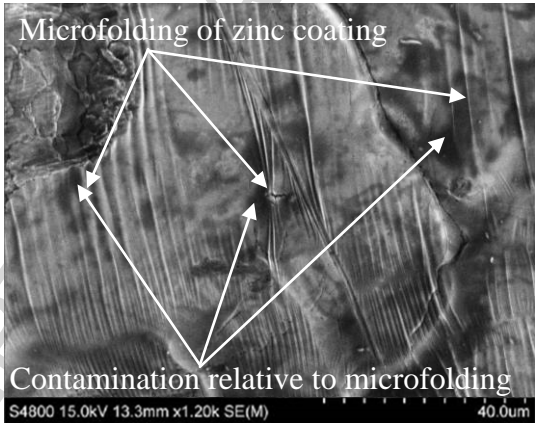
Figure 4

The characteristic microscopic topography of the defect under SEM analysis can be shown to be a consequence of microfolding of the zinc coating, Fig. 4. This is consistent with that observed for the entrainment of other forms of contamination present during gas wiping [9]. The folding of the surface suggests the contamination present within the coating provides an obstacle to ideal coating weight control during wiping.

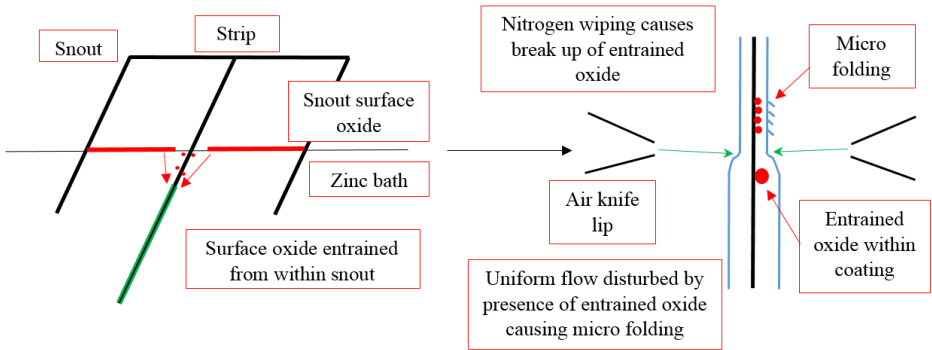
It is postulated that the mechanism for the formation of the arrowhead defect is formed by the wiping action of the gas knives. The high velocity gas impinges on the moving strip, wiping excess liquid zinc back down into the bath. When an entrained oxide passes through the gas wiping jet it prevents uniform flow of the liquid zinc back into the bath. Instead, liquid zinc is forced to flow around the particle, forming the characteristic arrow head shape. Furthermore, larger oxide particles can break up under the action of the wiping force and become entrained along the arrowhead contours resulting in the micro folding seen in Fig. 5. White light Interferometry was used to map the topography of the defective surface. The average surface roughness  $R_a$  for defective ( $2.01\mu\text{m}$ ) and non-defective material ( $1.22\mu\text{m}$ ) can be directly compared, however, consideration of  $R_a$  alone is not enough to determine the relationship between the entrainment of surface contamination and topographical effects. The comparison of the characteristic surface topography of the arrowhead defect with non-defective galvanized material is shown in Fig. 6. For the defective material an arrowhead like region of low surface roughness ( $R_a = 0.5\mu\text{m}$ ) surrounds a region of greater surface roughness throughout the body of the defect ( $R_a = 1.93\mu\text{m}$ ). Regions of non-defective coating surrounding the defective region of the sample are comparable to defect free samples ( $R_a =$

Figure 5 - Schematic illustrating the formation of the arrowhead defect indicating the entrainment of snout surface oxide and its break up when subject to high velocity wiping

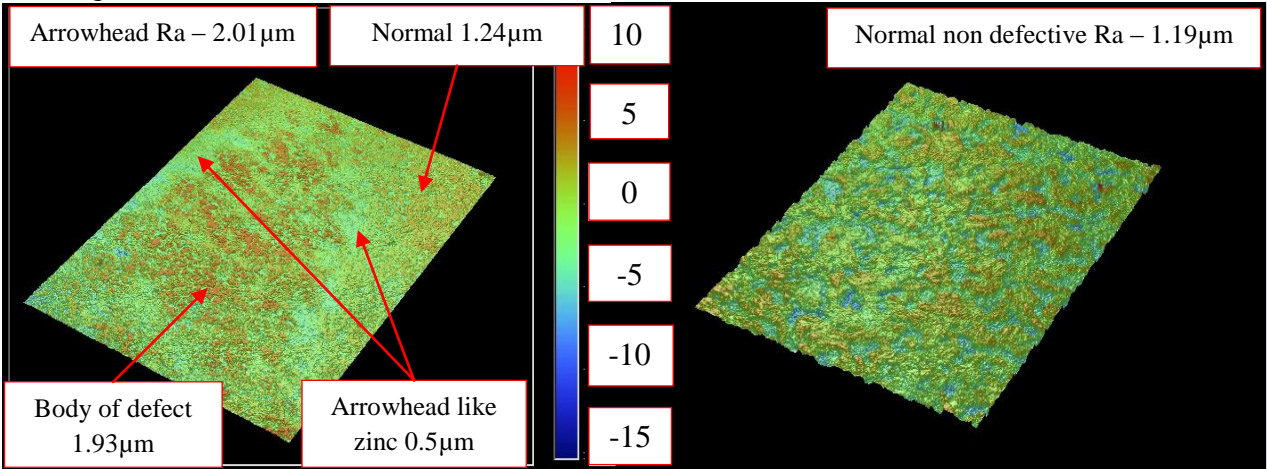
1.24 $\mu\text{m}$ ). It can be concluded that the increase in surface roughness within the body of the defect is due to greater temper roll roughness transfer brought about by differences in zinc coating thickness [19]. Furthermore, the interface between the zinc coating of normal surface roughness and regions of reduced roughness around the extremities of the defect have been linked to the presence of contamination within the coating.

Figure 6 – White light interferometry 3d surface map indicating surface topography with associated Ra for arrowhead defective and non-defective material

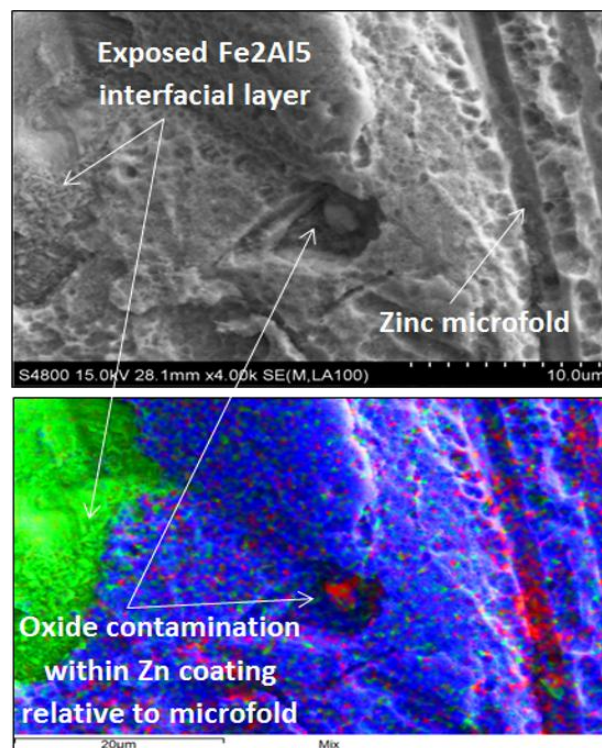
Figure 9

decreased zinc coating thickness and reduced surface roughness [19]. Regions of oxide associated with microfolding of the zinc coating can also be seen in Fig. 9, where green = Al, red = O, blue = Zn. After 8 seconds of incremental etching, particles of intermetallic top dross were observed dross within the body of the defect. EDX was used to confirm its chemical composition, as indicated in Fig 10. Whilst the majority of the sample was still covered by a thick zinc coating, at the head end of the defect the interfacial  $\text{Fe}_2\text{Al}_5$  was exposed after a relatively short etching period. This is in agreement with phenomena described by Vlot et al [19] which showed regions of decreased surface roughness due to localised lower coating thicknesses. This suggests that the presence of the zinc oxide based contamination found at the coating substrate interface promotes micro folding and localised inhomogeneous coating thickness.

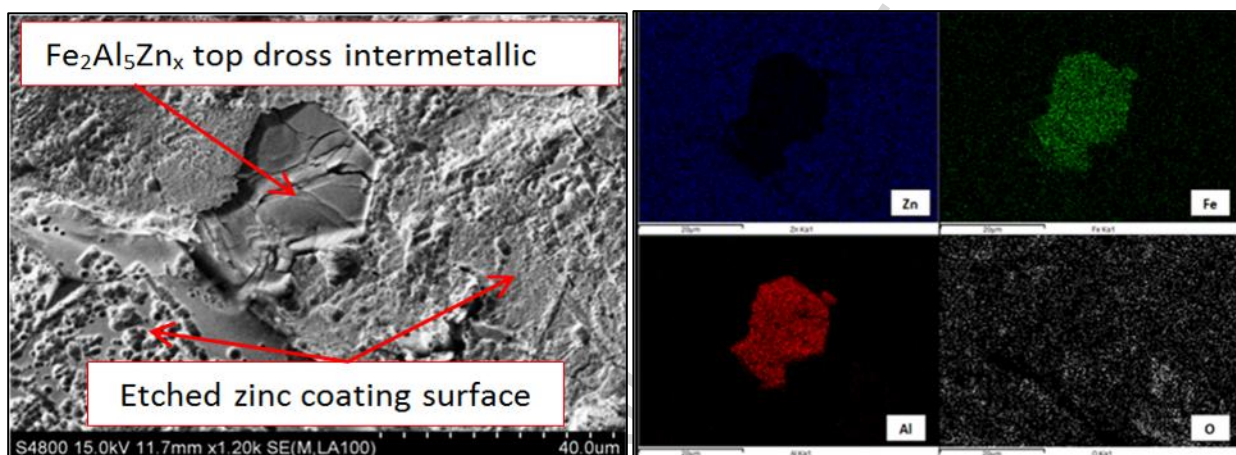
Figure 10 – SEM image of etched GI Full Finish surface/EDX surface colour mapping of individual chemical constituents highlighting presence of intermetallic  $\text{Fe}_2\text{Al}_5\text{Zn}_x$  top dross particle entrained with tail of the defect

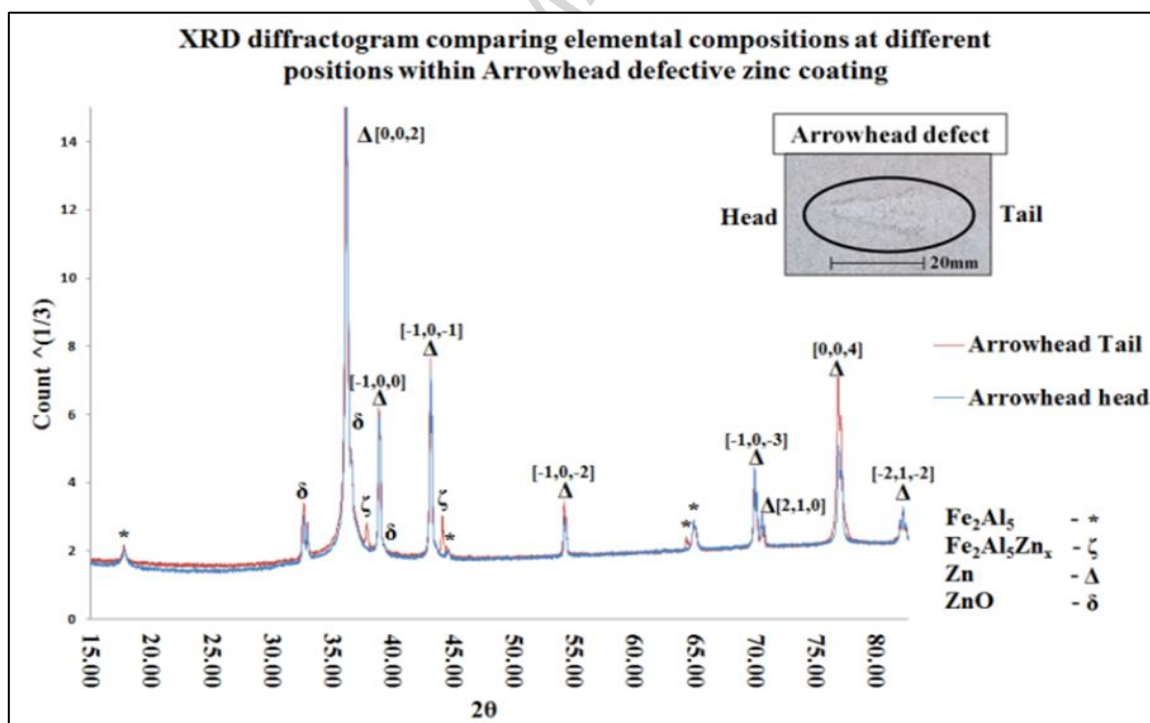
The nature of the contamination observed within the zinc coating can be characterised with the use of X-Ray Diffraction (XRD). XRD analysis of the arrowhead defect containing Full Finish sample produced the X-ray diffractogram highlighted in Fig. 11.

The majority of the peaks observed within the arrowhead XRD spectra are associated with the zinc coating which dominate over the peaks associated with the contamination. Small contamination peaks have been characterised through comparison with known XRD scattering patterns of the types of contamination that would be observed around the snout of a galvanizing line [20-23], including the  $\text{Fe}_2\text{Al}_5$  interfacial layer, intermetallic  $\text{Fe}_2\text{Al}_5\text{Zn}_x$  top dross, zinc oxide ( $\text{ZnO}$ ), alumina ( $\text{Al}_2\text{O}_3$ ) and zinc aluminate ( $\text{ZnAl}_2\text{O}_4$ ).

The smaller peaks were used to characterise the presence of the  $\text{Fe}_2\text{Al}_5$  interfacial layer, zinc oxide and intermetallic dross within the tail of the arrowhead defect. Zinc oxide can be formed through two different mechanisms as indicated previously within the snout, through oxidation

Figure 11 – XRD diffractogram comparing head end and tail end chemical composition of the arrowhead defect

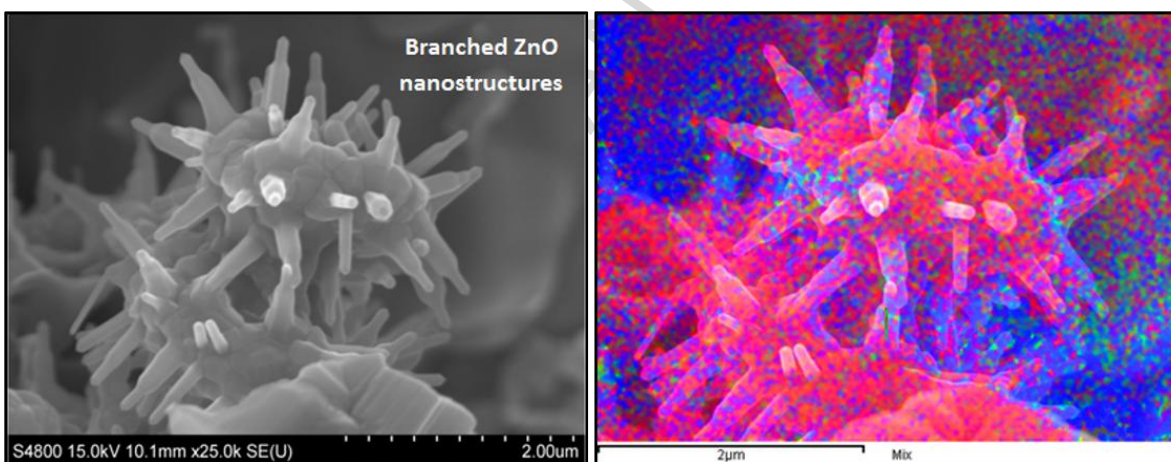
Figure 15 – SEM image of microstructural phenomena of snout contamination/EDX mix colour map highlighting presence of Zn & O. Where Green = Al, Red = O, Blue = Zn

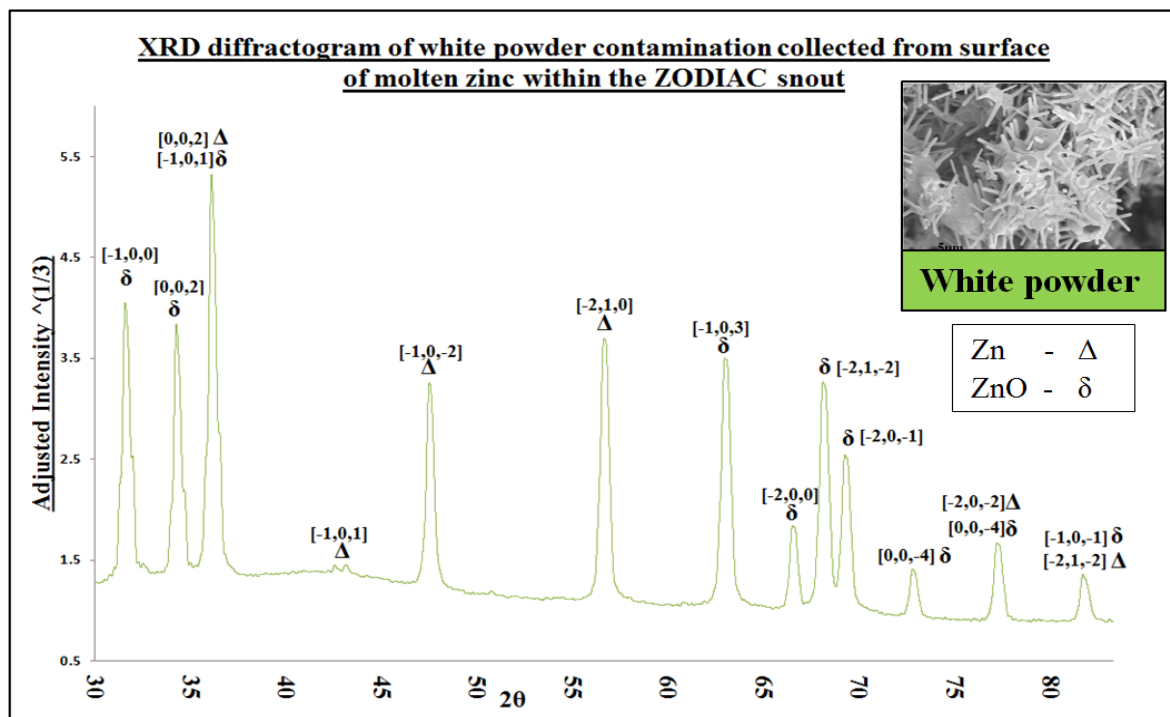
Figure 17 – XRD diffractogram of white ZnO surface oxide snout contamination

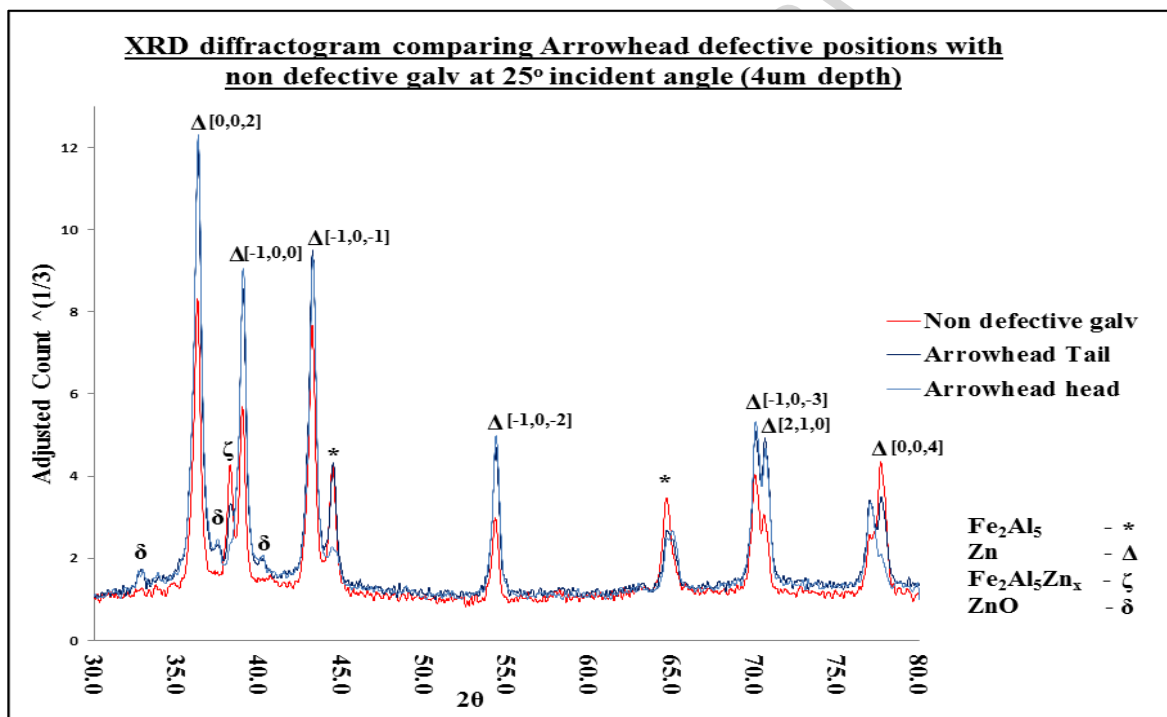
Figure 18 – XRD diffractogram of Arrowhead defective and non-defective GI Full Finish at a 25 Primary optic incidence angle
