Solid particle erosion protection for the BLOODHOUND SSC front wheel arches

Chris J Hannon<sup>1,2</sup> and Ben J Evans<sup>1</sup>

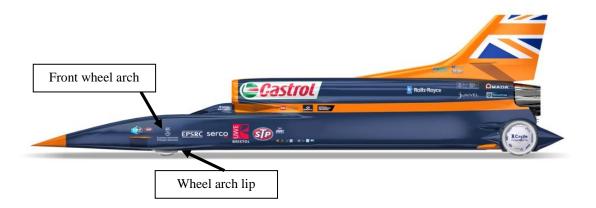
Figure 1: Side view of the front half of BLOODHOUND SSC, with the front wheel arches highlighted

The area of interest for the BLOODHOUND SSC engineers was the front wheel arches (Figure 1), as multiple

carbon fibre. In addition to this a removable metallic liner with a thickness of 1.2 mm would be used to protect the composite. A separate component was used on the lip of the wheel arches (Figure 1), which served the purpose of sealing any gap between the liner and the lower chassis. To maximise erosion resistance, this small component could be made from a material best able to cope with local flow conditions.

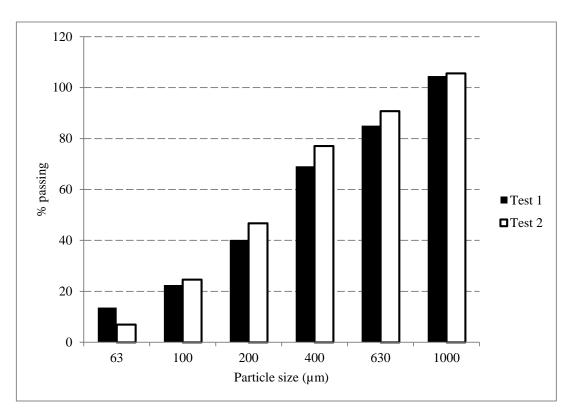
Figure 2: Cumulative undersize particle distribution of Hakskeen Pan soil sample

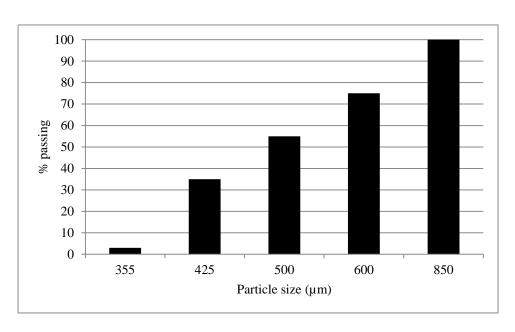
Figure 3: Cumulative undersize particle distribution of FEPA 36 abrasive (9)

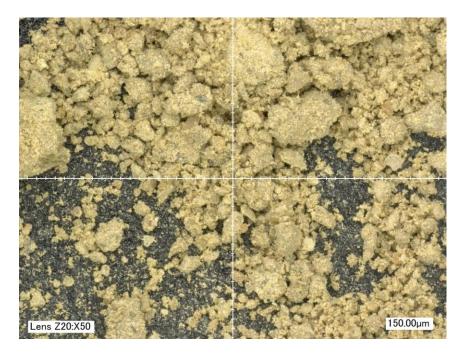
Figure 4: Hakskeen Pan soil sample showing the large range of particle sizes present

Only a relatively small (145 g) sample of Hakskeen Pan soil was available, meaning it was necessary to carry out erosive wear testing using a surrogate erodent. Figure 4 was generated using a Keyence Digital microscope (6) and shows that there is substantial variation in particle size for Hakskeen Pan soil. Particles with sizes above 1 mm were discounted from consideration as these were unlikely to become entrained in the flow. Characterisation of the soil was performed using a sieve shaker, accelerated for 15 minutes at approximately 10 g (98.1 m·s<sup>-2</sup>), with the following sieve apertures: 1 mm, 630  $\mu$ m, 400  $\mu$ m, 200  $\mu$ m, 100  $\mu$ m and 63  $\mu$ m (7). The resulting mass of particles in each section of the sieve shaker was determined using an Adam PW214 analytical balance with  $\pm 0.3$  mg accuracy and the results are plotted in Figure 2. The cumulative total exceeds 100 % due to retained particles in the apertures dislodging during testing, in spite of a rigorous brushing and washing procedure prior to testing. Approximately 80 % of particles had diameters less than 630  $\mu$ m. In addition to the soil, small pieces of shale rock are also present in the desert. Both the Hakskeen Pan soil and shale have a Mohs hardness of approximately 7 (8).

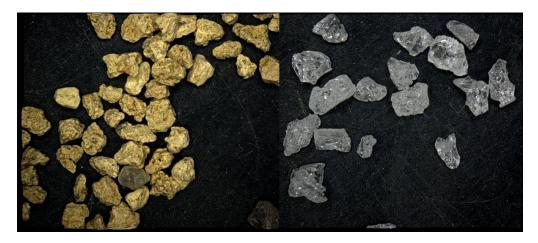
Figure 5: Hakskeen Pan soil,  $400\,\mu m$  to  $630\,\mu m$  sample (Left) compared with the white alumina erodent (Right), sieved to FEPA 36, used during testing.

White alumina was decided as a suitable surrogate erodent, due to its conservative Mohs hardness of 9 and its friable property mimicking that of the soil. A conservatively hard erodent was used to, in part, mitigate the risk of unknowns in the testing, such as the actual erodent speed. Average erodent particle size was agreed with the BLOODHOUND SSC engineers as 525  $\mu$ m (Federation of European Producers of Abrasive Products (FEPA) 36) (10). The size distribution of FEPA 36 is shown in Figure 3, which matches the Hakskeen Pan distribution reasonably well. Larger particles would either not be entrained in the flow, or would most likely not be accelerated to velocities to be of concern, as erosion rate by elasto-plastic fracture is approximately proportional to particle velocity cubed (2). Figure 5 shows a sample of white alumina FEPA 36 and Hakskeen Pan soil sieved to between 400  $\mu$ m to 630  $\mu$ m. The particle sizes are a close match and the angularity of the alumina is higher, meaning that cutting action due to erosion by plastic deformation is likely to be conservative.

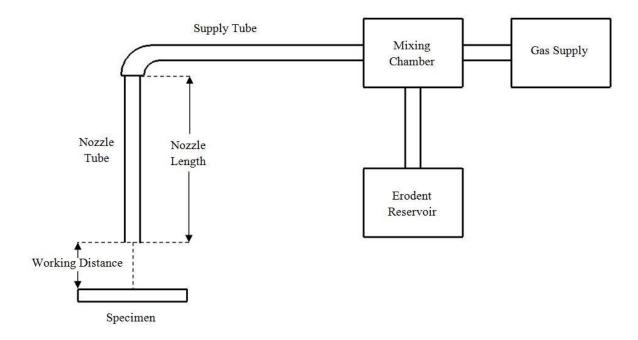
Figure 6: Generic gas blast erosion rig architecture, based on ASTM G76-13 (12)

Several common approaches exist regarding solid particle erosion testing. Whirling arm erosion rigs affix samples to a blade tip, then spin the sample through a cloud of erodent (11). This method was not used due to higher equipment costs and safety implications. ASTM G76-13 provides the general architecture for gas blast erosion rigs, which is shown in Figure 6 (12). Due to key differences in the test conditions, such as internal nozzle diameter and particle velocity, this standard was used to inform testing decisions, rather than dictate them.

A gas blast erosion rig, based on a commercially available open loop shot blaster with a 6 mm diameter, 35 mm long, ceramic nozzle and a working distance of 15 mm was used during testing. Flow conditions were provided via a compressed air cylinder with a multi-stage regulator set to 120 psig (827 kPa). The rig architecture was essentially identical to that recommended by ASTM G76-13 (Figure 6) (12). The rig was able to maintain specific erodent mass flow rates of approximately 300 kg·m<sup>-2</sup>·s<sup>-1</sup>, which for the typical test time of 30 seconds, equated to an erodent mass per unit area of 9000 kg·m<sup>-2</sup>. This was significantly higher than that used for helicopter erosion protection testing and was intended to address the uncertainty regarding the actual sand cloud density for the application. The test time of 30 seconds reflected the limited operational use of BLOODHOUND SSC, with run times over 950 mph expected to last approximately seven seconds.

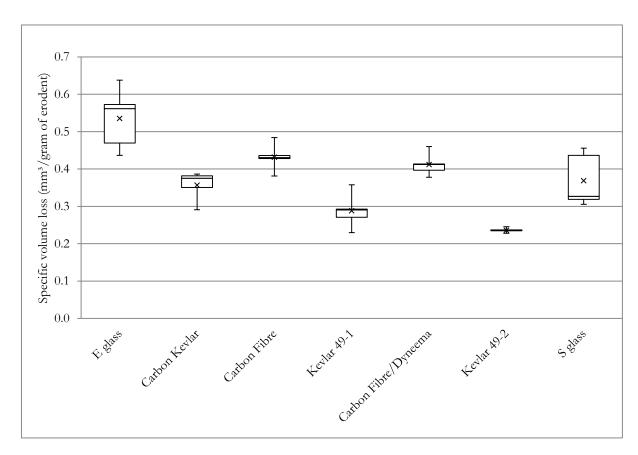
Figure 7: Composite volume loss erosion rates,  $15^{\circ}$  Impact angle, Alumina FEPA 36,  $9000 \text{ kg} \cdot \text{m}^{-2}$ ,  $132 \text{ m} \cdot \text{s}^{-1}$ , error bars indicate range of results

As can be seen from Figure 7, the best composite material was the plain weave Kevlar 49-2, particularly on a volume loss basis. Its erosion mechanism at the 15° Impact angle was type I cutting, as can be seen in Figure 8 and compared favourably against the theoretical mechanism (2). Kevlar is a trade name for aramid fibres, which were designed to resist impact, which explains its superior performance during testing relative to other fibre types (22). The variation in the range of results for different composite materials is pronounced. The smallest range of results is for Kevlar 49-2, which also has the smallest resin volume fraction. E glass and S glass have a larger spread of results, despite the fibre volume fraction of just under 50 % being approximately equal to the other laminates (apart from Kevlar 49-2 and the carbon/Kevlar hybrid, which had approximately 60 % fibre volume fraction). The cause of the higher erosion rate for the E Glass fibre samples is most likely the eight harness satin weave, where eight warp tows 'float' over each weft tow, compared to a one-one ratio for a plain weave. This indicates that satin weave composites are particularly vulnerable to erosion and that the spread of results for the Glass fibre samples was due to a variation in where exactly the warp fibres were cut by the erodent particles.

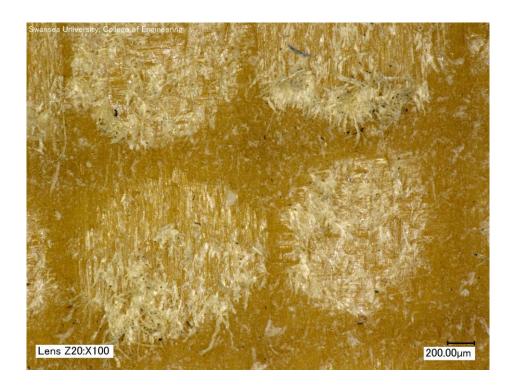
Figure 8: Kevlar 49-2 at 15° Impact angle, with type I cutting deformation evident.

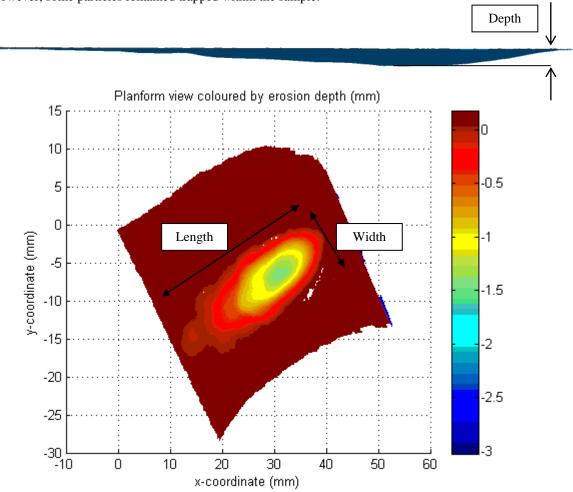
Figure 9: Digital scan of one of the Carbon Fibre impact craters

A Solutionix Rexcan CS+ system, using a 100 mm lens was used to scan the craters of the composite samples with a resolution of 0.012 mm. Scanning was not possible for the metallic samples as the impact craters were not of sufficient depth to allow resolution of the scan after application of Sprayable Chalk, used to reduce the reflectivity of the surface. A typical impact crater scan is shown in Figure 9. Table 3 summarizes the key dimensions of the impact craters for the different composite samples. The crater dimensions do not correlate well with the volume loss of the samples. For example, the craters for E glass were the shallowest; however, the profile of the crater was very smooth, indicating the satin weave of the sample allowed uniform removal of material. The twill and plain weaves of the other samples was less uniform, with pronounced 'steps' along

the length of the crater. This was likely due to the partially cut fibres collecting against a weft tow, with the loosely bundled fibres resisting further erosion. This effect was exaggerated due to erodent particles becoming trapped in the loose bundles, further enhancing erosion resistance and reducing mass loss of the sample. The majority of these particles were removed after testing by cleaning the sample with compressed air at 80 psig; however, some particles remained trapped within the sample.

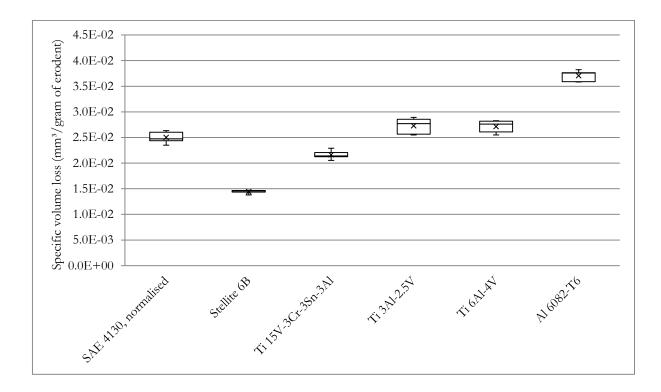
Figure 10: Metal volume loss erosion rates, 15° Impact angle, Alumina FEPA 36, 9000 kg·m-2, 132 m·s<sup>-1</sup>, error bars indicate range of results

The metallic liner performance can be evaluated by Figure 10. Stellite 6B was superior on a volume loss basis, but was rejected due to its high cost and density. Figure 12 shows striations indicating Type II cutting of the Titanium 15V-3Cr-3Sn-3Al sample at 15° Impact angle. This was marginally the best titanium grade on a mass loss basis, which may be attributable to its metastable beta phase microstructure having a higher fracture toughness than the alpha-beta microstructures of the other titanium grades considered in this study (23). It also performed relatively better on a volume loss basis which was due to the higher vanadium content leading to an increase in density (Table 2). A similar explanation justifies the superior erosion performance of Ti 15V-3Cr-3Sn-3Al at 90° Impact angle (Figure 11), relative to the other titanium grades. Al 6082-T6 performed the worst of all the metals at 15° Impact angle, on a volume loss basis. This was due to its lower hardness, which made it susceptible to the cutting action dominant at this Impact angle (2).

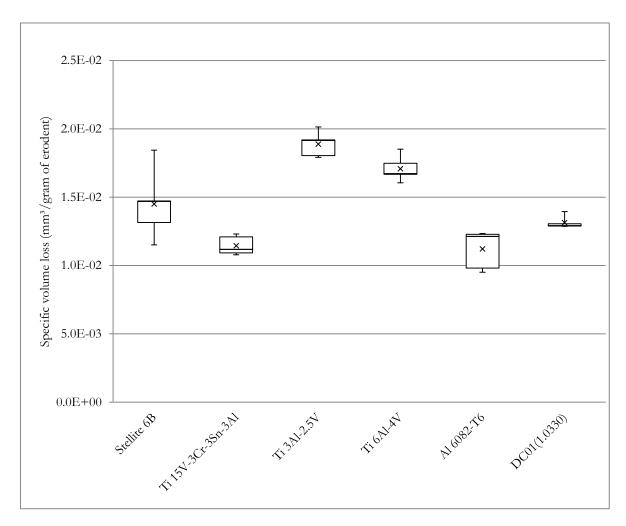
Figure 11: Metal volume loss erosion rates, 90° Impact angle, Alumina FEPA 36, 9000 kg·m-2, 132 m·s<sup>-1</sup>, error bars indicate range of results

Figure 11 show the erosion performance at 90° Impact angle, with Figure 13 showing a typical wear surface, which exhibited a roughened surface free of the cutting striations seen on samples eroded at 15° Impact angle. The roughened surface was essentially a series of overlapping impact craters, with material removal achieved

by brittle fracture. DC01(1.0330) steel had a mid-range erosion rate on a volume loss basis but was rejected due to a desire to reduce vehicle mass. Stellite 6B performed comparatively poorly at 90° Impact angle, which was attributed to its high Rockwell hardness of 33-43 HRC leaving it more susceptible to erosion by brittle fracture.

Al 6082-T6 eroded at approximately the same rate as Ti 15V-3Cr-3Sn-3Al on a volume loss basis, which was attributed to its high ductility. This ductility enabled it to sustain more particle impacts before the stress in sections of the sample surface exceeded the material tensile strength and local fracture occurred. This made it a potential candidate for the wheel arch lip protection, due to its lower cost and density. However, as the geometry of the wheel arch lip extended over a larger region than just the stagnation point, Ti 6Al-4V was chosen by the BLOODHOUND SSC engineers for this component. This grade was chosen over Ti 15V-3Cr-3Sn-3Al plate due to unacceptably long lead times, at the expense of an almost 50 % higher erosion rate on a volume loss basis.

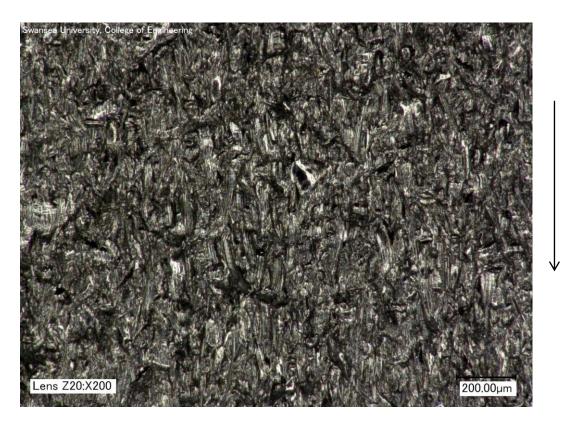
Figure 12: Ti 3Al 2.5V at 15° Impact angle, with cutting action evident. Particle flow direction is indicated by the arrow to the right of the figure.

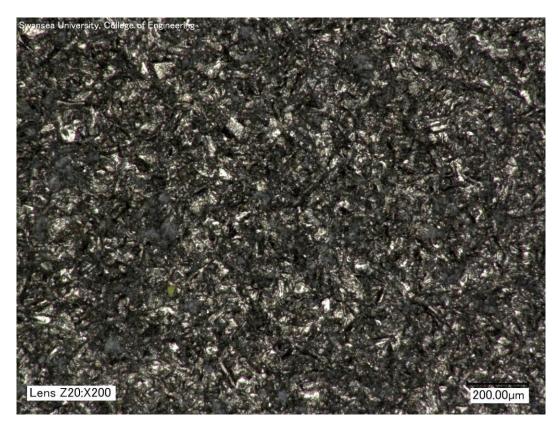
Figure 13: Ti 3Al 2.5V at  $90^{\circ}$  Impact angle, with impact craters evident.
