*Thermal measurement and  
degradation quantification of  
teeming ladle refractories and the  
effects on the process*

Submitted to Swansea University in fulfilment of the requirements for  
the Degree of Doctor of Engineering

September 2020

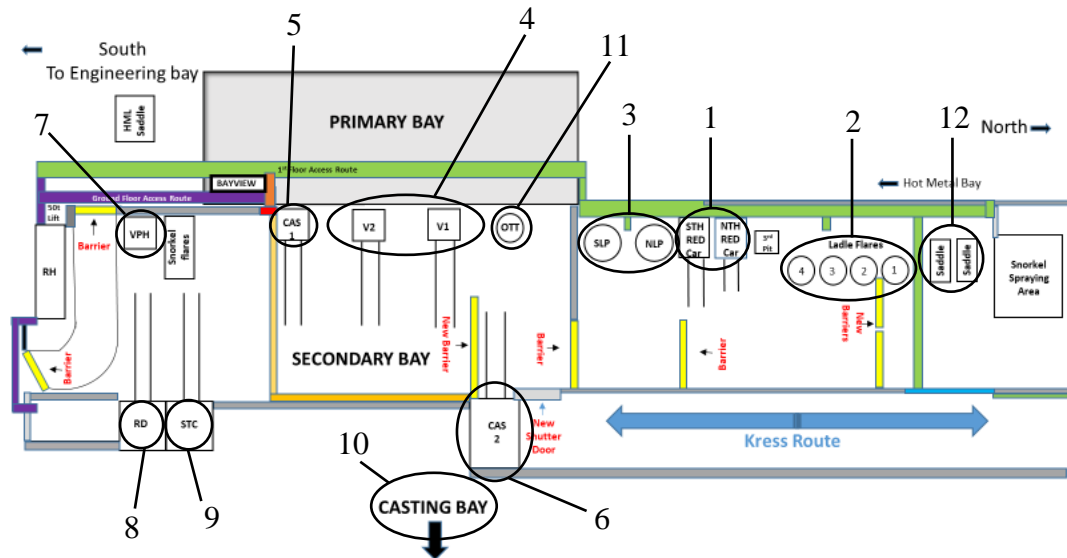
Figure 1: Steel production stages with teeming ladle processes circled.

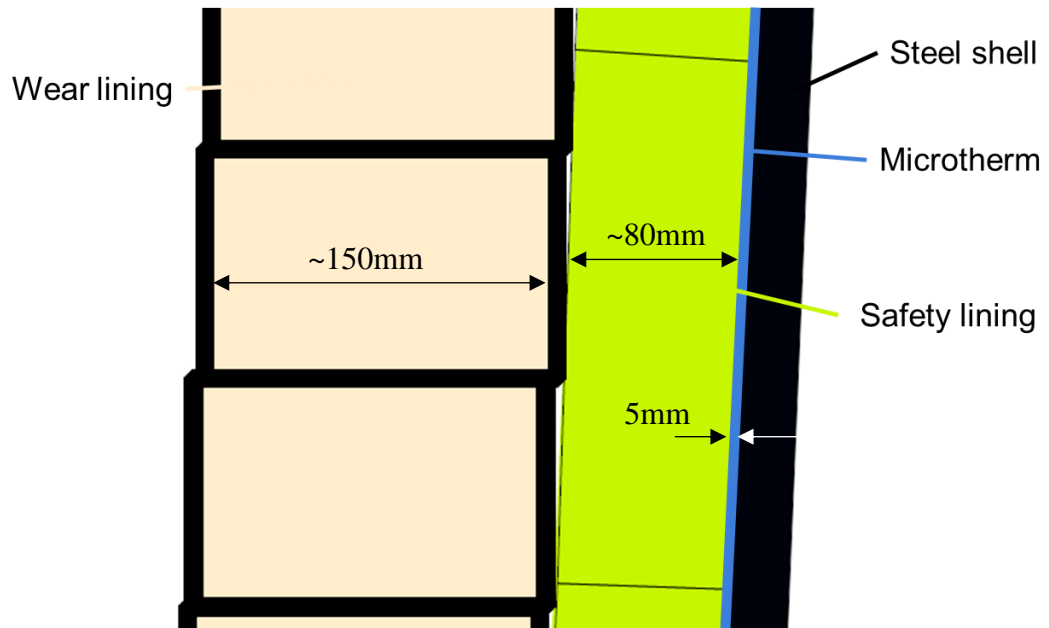
Figure 5 shows a detailed view of a typical three-layer refractory build on the ladle barrel. The wear lining is a higher density refractory designed to resist the consistent interaction with steel and slag. MgC bricks are typically used for the barrel wear lining, however, with the drive to reduce ladle shell temperatures and reduce heat losses fired spinel and AMC bricks are now also commonly used. The fired alumina safety lining (or linings in a 4 layer refractory design) is designed to reduce the temperature the insulation is exposed to, ensuring it is below its working limit. It is also able to survive one cycle of steel production as a last line of safety against losses of containment. It is generally understood this is not something that should be relied on regularly. If the safety lining does not remain intact it causes catastrophic failure of the shell and a loss of containment (8). The insulation layer consist of an amorphous silica board or panel and is the final layer of refractory that is designed to ensure the ladle shell is not subjected to temperatures above its designed service temperature, typically 350°C. The most common form of insulation used is microporous pyrogenic silica, which is contained in a fiberglass bag and pressed to give a flexible board.

Figure 5: Three-layer teeming ladle refractory design of the barrel (area X from Figure 3).

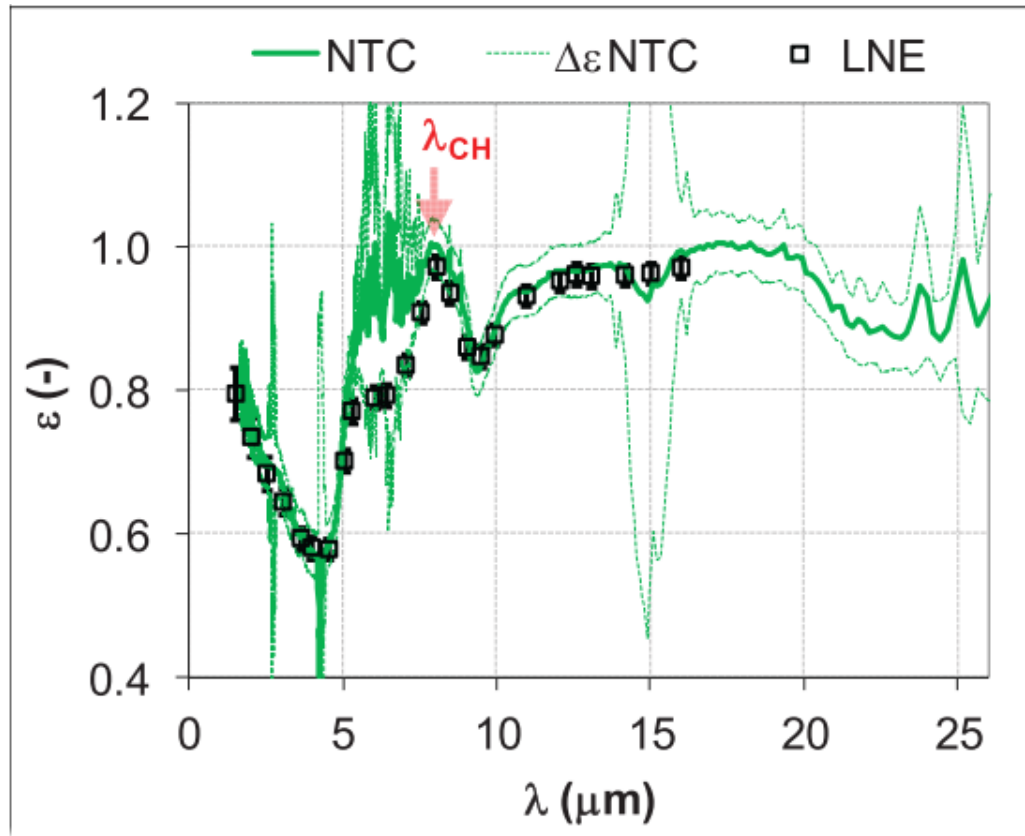
The emissivity of an object also changes with wavelength, as seen in Figure 7 which is taken from a study conducted by Honnerova et al. (2014) (48). In this study Honnerova et al. (2014) quantified the spectral emissivity of coatings in the spectral range from 1.38 $\mu\text{m}$  to 26 $\mu\text{m}$ . During the study they were able to demonstrate conclusively that there are large differences in the emissivity values when measuring at different wavelengths. The results from the study can be seen in Figure 7 with the difference from the maximum and minimum recorded to be 0.4. This highlights the importance of conducting emissivity studies at the wavelength used to measure the object.

Figure 7: Wavelength against emissivity performed by various research centres taken from Honnerova et al. (2014) (48). NTC = New Technologies Research centre, LNE = Laboratoire National d'Essais

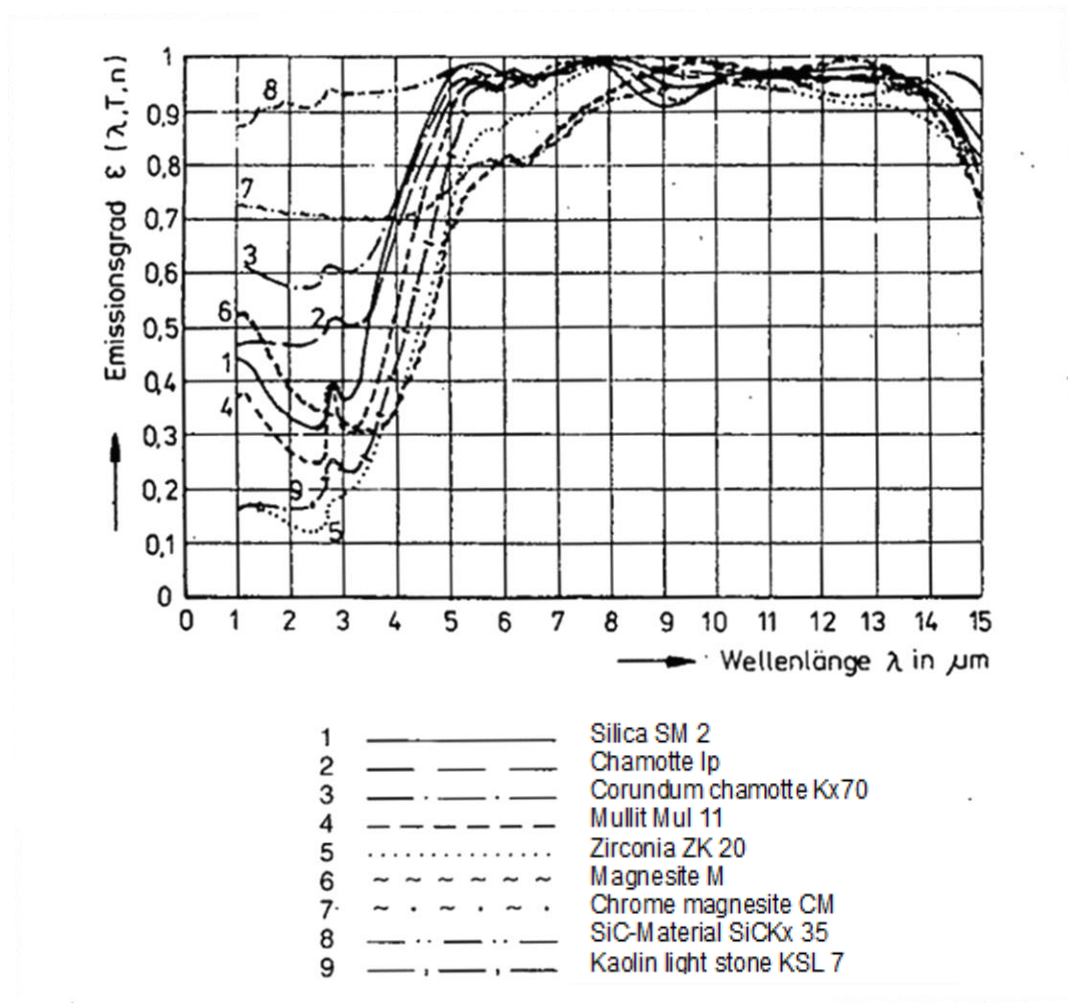
Figure 8: Emissivity table from Bauer (1990) of emissivities at various wavelengths for different refractories at 750°C (49).

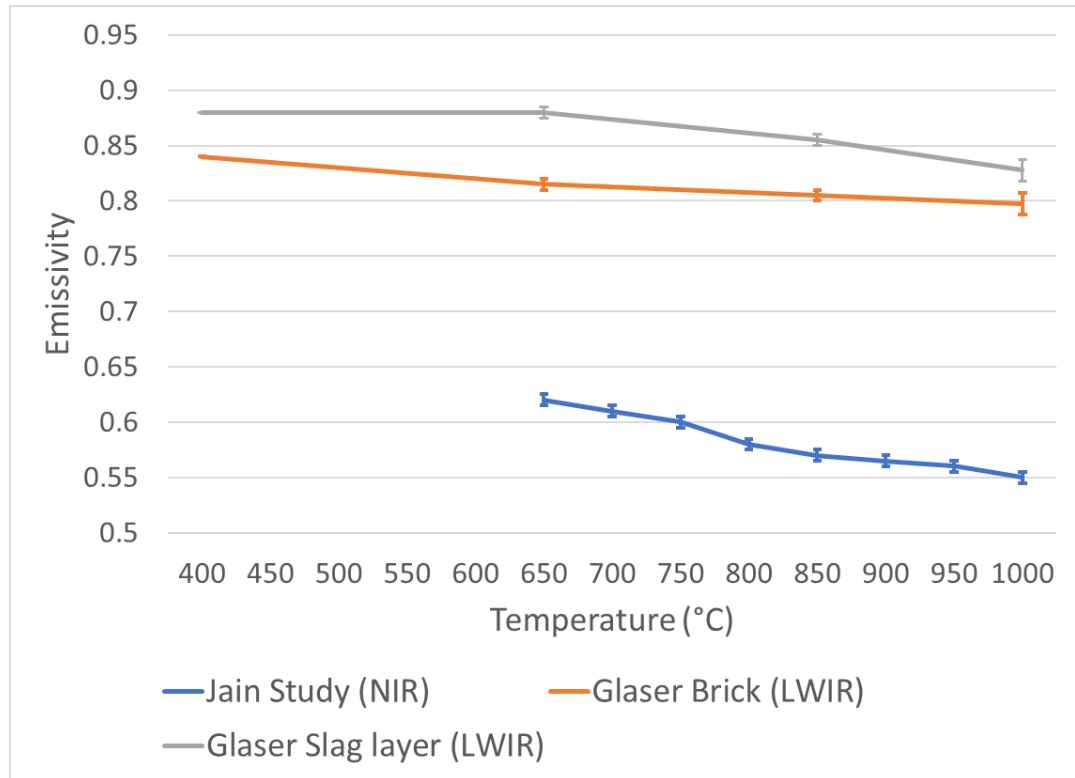
A study needs to be conducted in an inert atmosphere that will reduce the decarburisation to a minimum throughout the testing at each temperature interval. The author has graphed the values from the Glaser and Jain studies and clear differences can be seen up to 0.15 in the emissivity values measured. This information can be seen in Figure 11. The differences in spectral response are demonstrated and it is important to note the differences in emissivity results. Neither Glaser nor Jain quantify the errors in their studies. The author has produced error bars based on the differences in their results.

Figure 11: Emissivity values from Glaser and Jain studies plotted on same graph with error bars calculated from variance in data published.

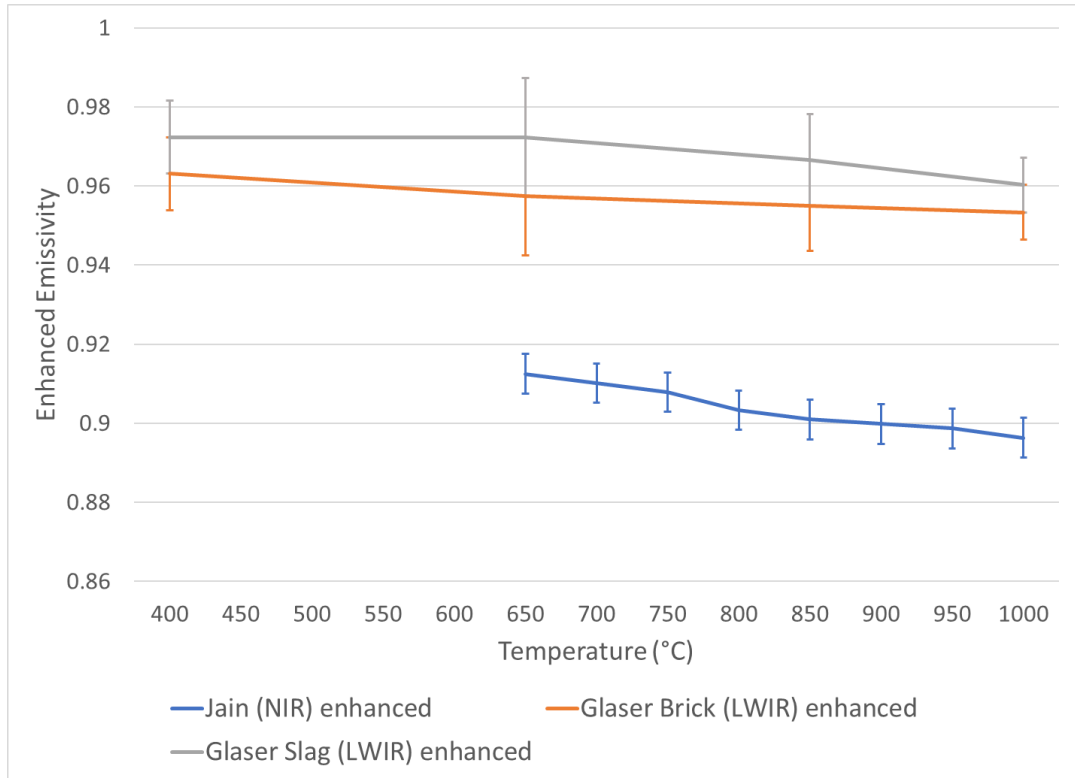
Utilising the geometry enhancement of Equation 6 and applying it to the findings in Glaser's and Jain's studies Figure 12 was produced by the author. The enhanced emissivity values reduce the gap from the different wavelengths from 0.15 to 0.06. However, this increases the errors in the study as each of the values is consistently 0.15 higher than the measured values of Glaser's study and around 0.3 for Jain's study.

Figure 12: Enhanced emissivity values produced using Equation 6 and measurements in Glaser's and Jain's studies.

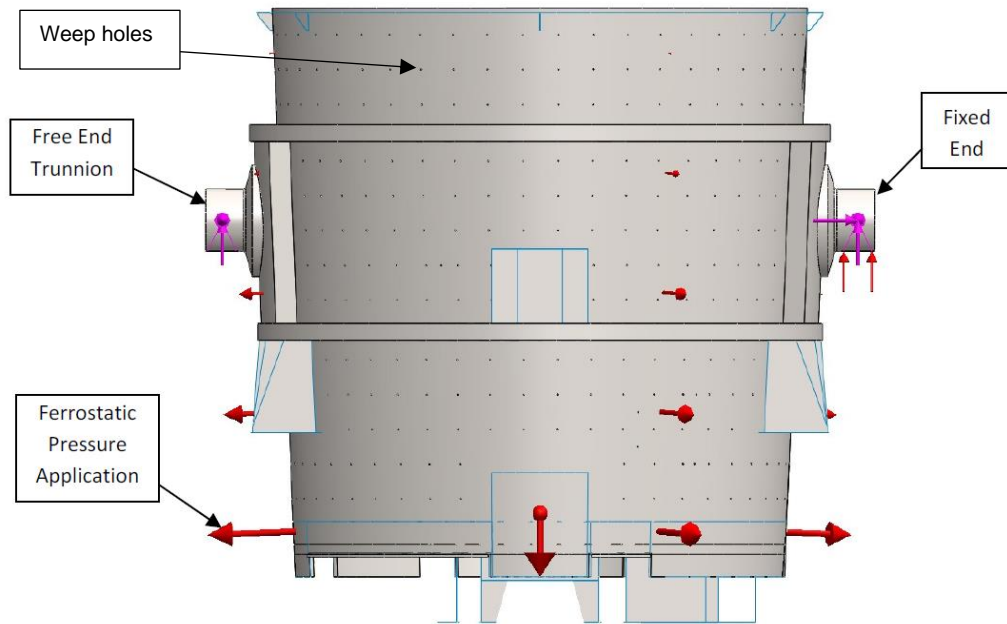
*Figure 15: Boundary conditions for FEA of teeming ladle with extra thermocouple holes.*

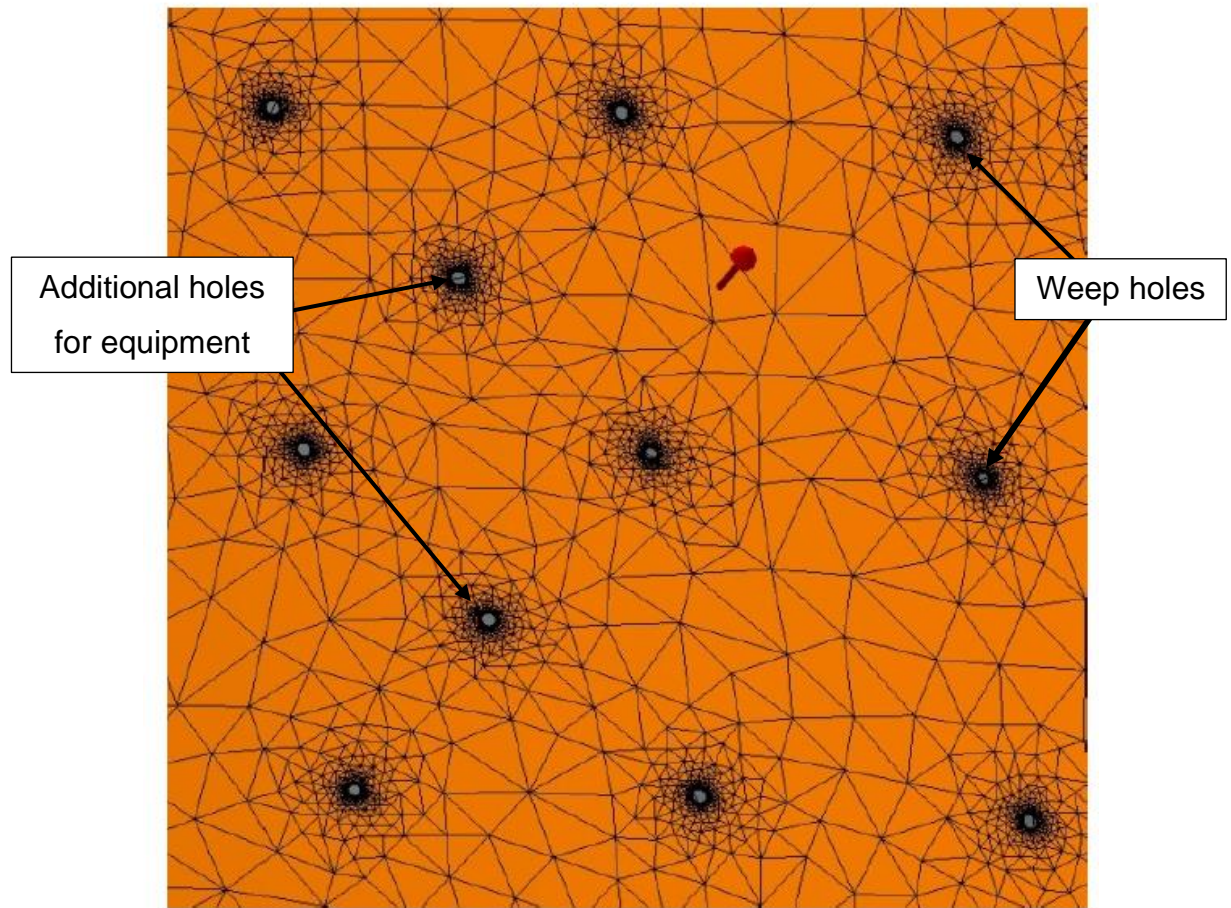
during cooling are positioned far enough away that stress concentrations did not occur and increase the hoop stresses to a point of failure. Figure 16 shows the mesh concentration, which focussed primarily on the areas around the holes in the shell. The concern was that the additional holes could cause a stress concentration that could cause a breakout. Therefore, to ensure the stresses did not increase to the point of failure the mesh concentrated on the areas surrounding the holes.

*Figure 16: Mesh for FEA of teeming ladle, with increased density around holes.*

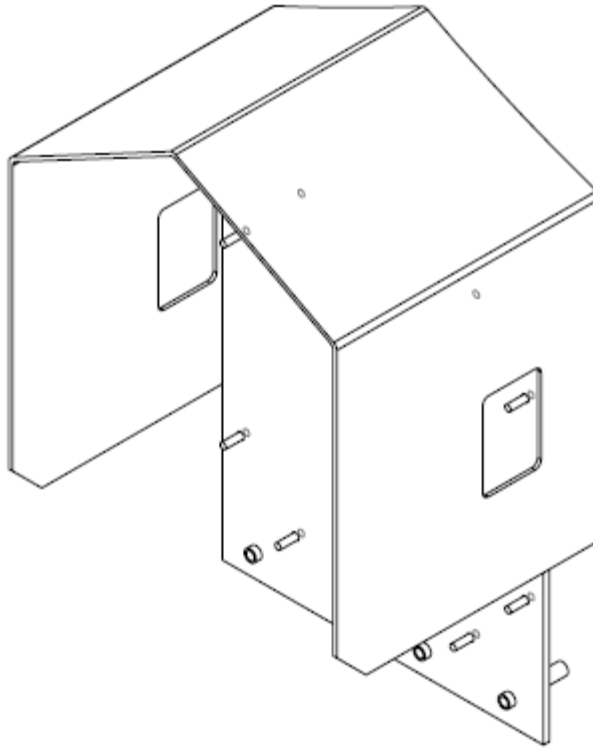
*Figure 17: Mounting plate used to attach insulation box to ladle.*

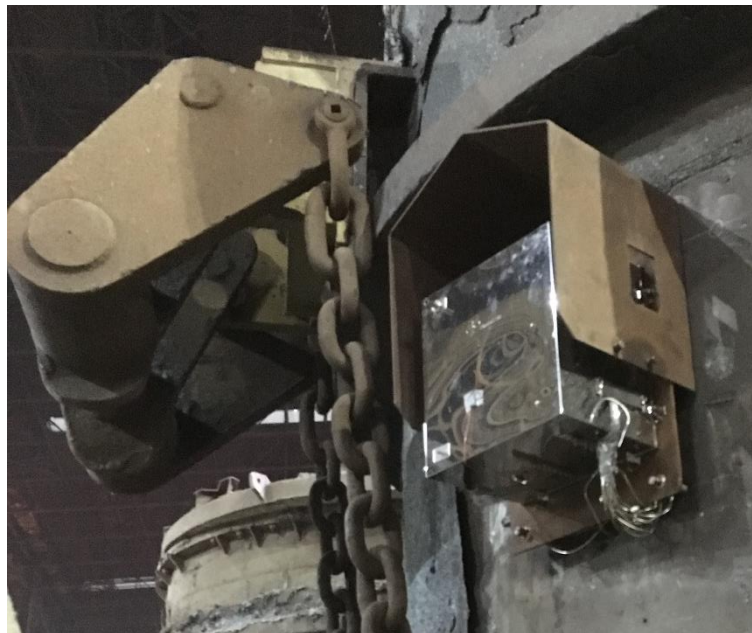
Threaded bars were then fixed into the holes and the mount's design allowed for tubes to pass over the threaded bars and were bolted in place. Two bolts were used to lock the mount to the ladle and reduce any chance of the bolts coming loose. Figure 18 shows the installed equipment on the ladle.

*Figure 18: Insulation box and mount attached to ladle.*

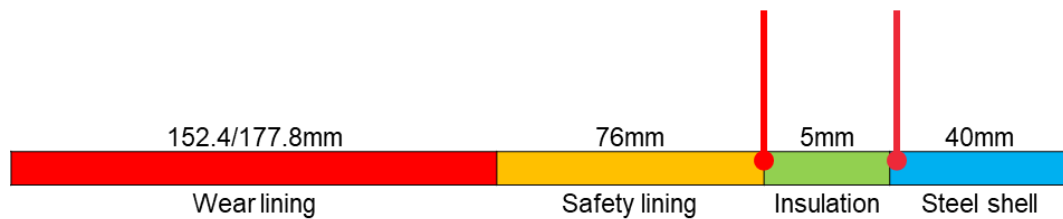
Once the equipment was attached the thermocouple holes were drilled ensuring they were separated by at least 10cm and were not within 10cm of any weep holes that were already on the shell (as recommended by the FEA). The thermocouples were then inserted into the ladle shell through the access holes. The thermocouples' labels were checked inside the ladle to ensure they had not been damaged whilst passing through the access holes. At this point the thermocouples were protected inside the shell for transport to the refractory installation area of the plant. During the refractory build it was important to track the locations of the thermocouples for future reference, to understand which thermocouple corresponded to the locations within the refractory build. It was also essential to track where the thermocouples' cables were, from the access holes in the shell to the measurement point. By doing so it was then possible to place the subsequent thermocouples without overlapping the cables, which would have then cause damage once the lining expanded and the ladle was filled with steel. Figure 19 shows a schematic of the thermocouples installed either side of the insulation (indicated by red lines).

*Figure 19: Refractory layers and thermocouple locations in ladle barrel, indicated either side of insulation.*

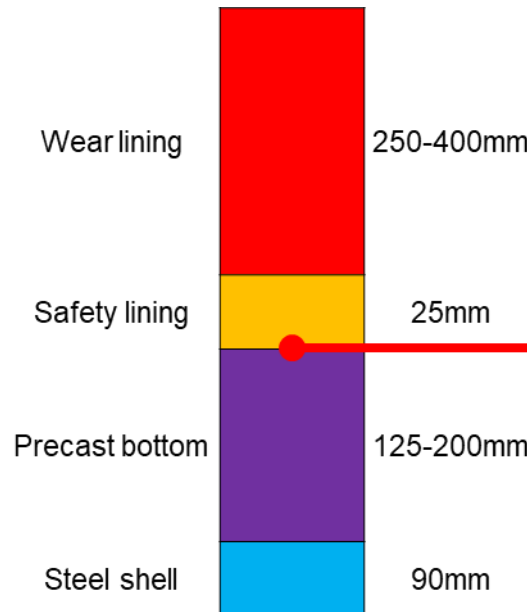
*Figure 20: Refractory layers and thermocouple locations in ladle bottom, indicated between safety lining and precast bottom.*

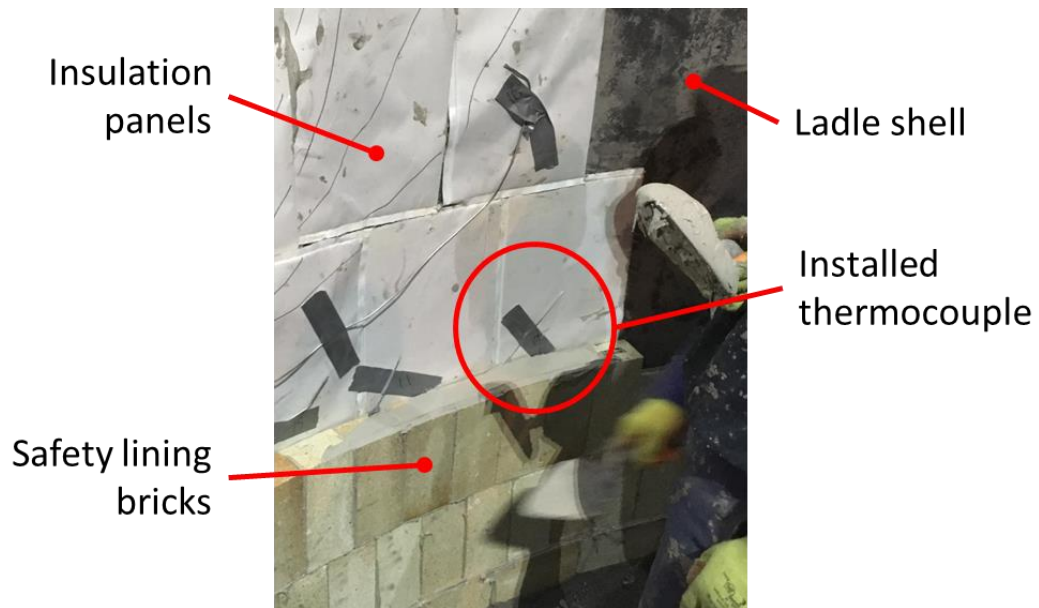
*Figure 21: Thermocouple cables tracked with marker pen and held in place with duct tape until secured by safety lining.*

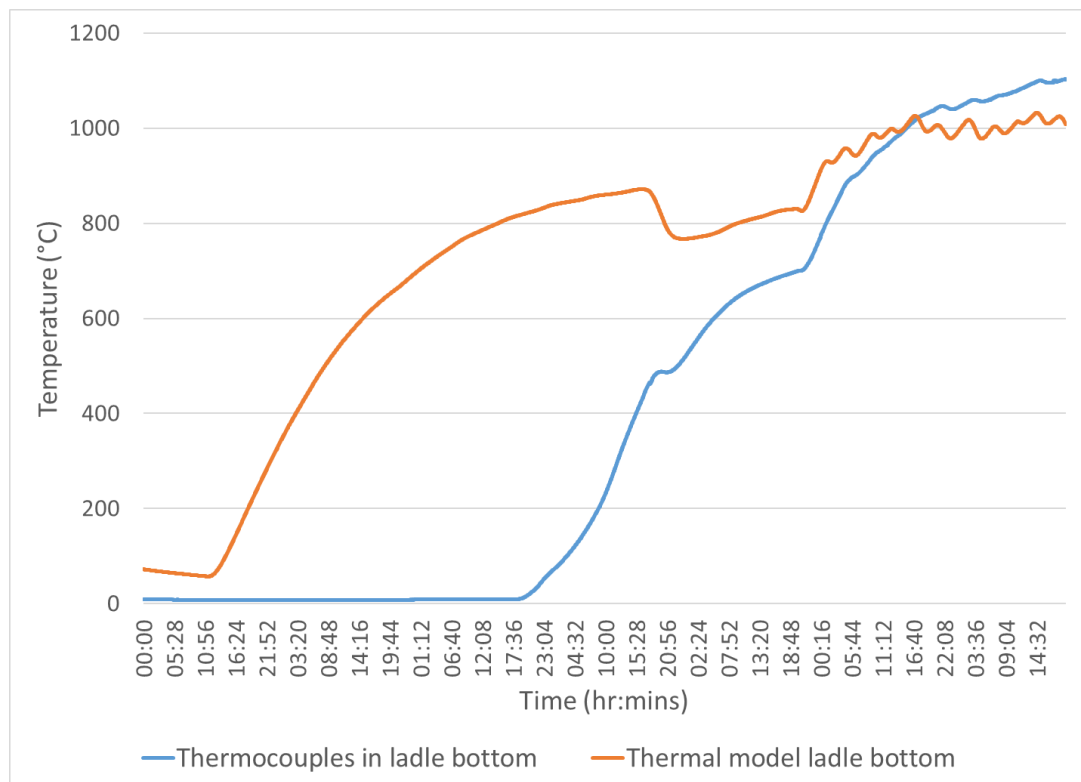
still being built on the RED car, shown in the plant layout in the appendices. This created a large discrepancy with the predicted temperatures from Ladle Watcher and the temperatures of the refractory recorded by the thermocouples in the same location. The temperatures predicted by Ladle Watcher and the recorded temperatures from the thermocouples can be seen in Figure 22. The difference peaked at 800°C and there was still a difference of 100°C in this location when the ladle was first used in production. This 100°C difference in the safety lining cold face may not transfer to the same temperature discrepancy from Ladle Watcher vs the real temperatures of the wear lining when preheated. However, the heat storage in the back layers of the lining is essential when the ladle is taken into production. This acts as heat storage for the wear lining and reduces the refractory cooling rate (31). This is also the case when the steel is tapped into the ladle, with insufficient heating of the layers behind the working lining. More heat is transferred from the steel which then has to be replaced by reheating, causing an increase in production costs and carbon footprint (31). In Chapter 5 this cooling effect is quantified.

Figure 22: Ladle Watcher outputs and thermocouple measurements.

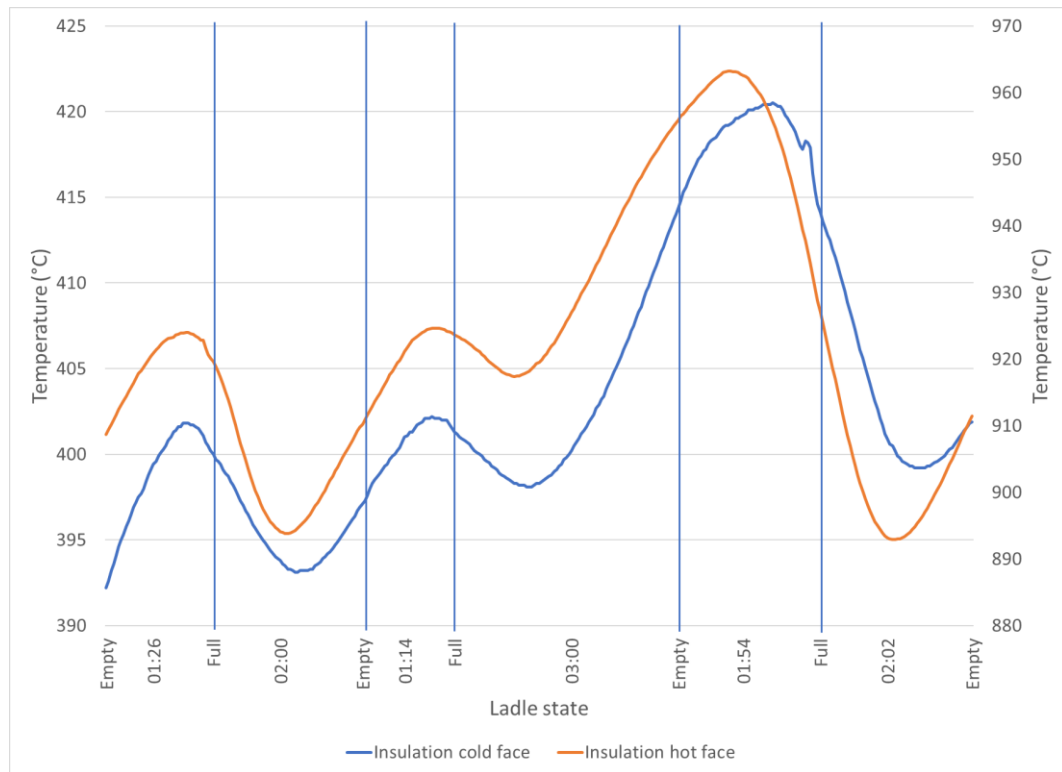
i.e. the first number on the x-axis “1:26” denotes the ladle was empty for 1 hour and 26 minutes then the next number “2:00” shows the ladle was full for 2 hours. It is interesting to note that during the time the ladle was empty the thermocouple temperatures were increasing rather than decreasing. This was shown to be accurate and demonstrated similar findings from the studies produced by Van Beurden et al. (2015) and Buhr et al. (2016) (31,65). The temperatures increased due to the thermal storage of the wear lining and safety lining discussed in the studies. Van Beurden et al. attributed the shell temperature delay with state to a thermal wave passing through the refractory lining to the ladle shell (65). The crossing of the hot and cold face in Figure 23 are due to the thermal wave passing through the refractories and verified this theory. This also highlighted the potential safety concern for teeming ladles. It is common practise to measure the cold face of the ladle with a thermal imaging camera to determine if the insulation has degraded, to verify accuracy of thermal models and check if the shell is being overheated (2,29,31,37,42). Temperature increases can be seen up to 10°C depending on the time after the ladle was empty and the temperature was measured. Even though this was relatively small it would still be enough to take a ladle from a safe temperature of 380°C to 390°C which would have required attention from production.

Figure 23: Thermocouple data from insulation hot and cold face plotted on same graph but on different vertical axes (cold face left hot face right) to show heat wave delay flowing through ladle lining.

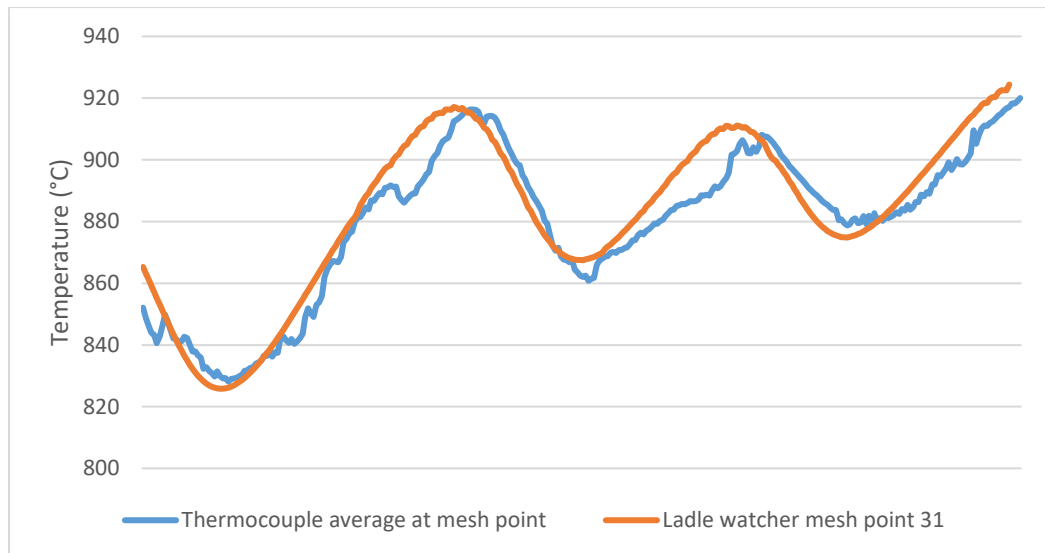
Figure 24 shows the measurements from the thermocouples installed on the barrel. It shows the outputs from Ladle Watcher and the thermocouple measurements from three cycles of production. There was a strong correlation between the thermocouples and Ladle Watcher outputs, with the largest difference of 20°C equating to a difference of 2.2% of the measured and modelled value. For a predicted model over a period of 12 hours this was highly accurate. With such a small discrepancy more value can be found in investigating other areas of the modelling process.

Figure 24: Thermocouple data compared to Ladle Watcher mesh point 31 of cycles 3-5 in barrel of ladle.

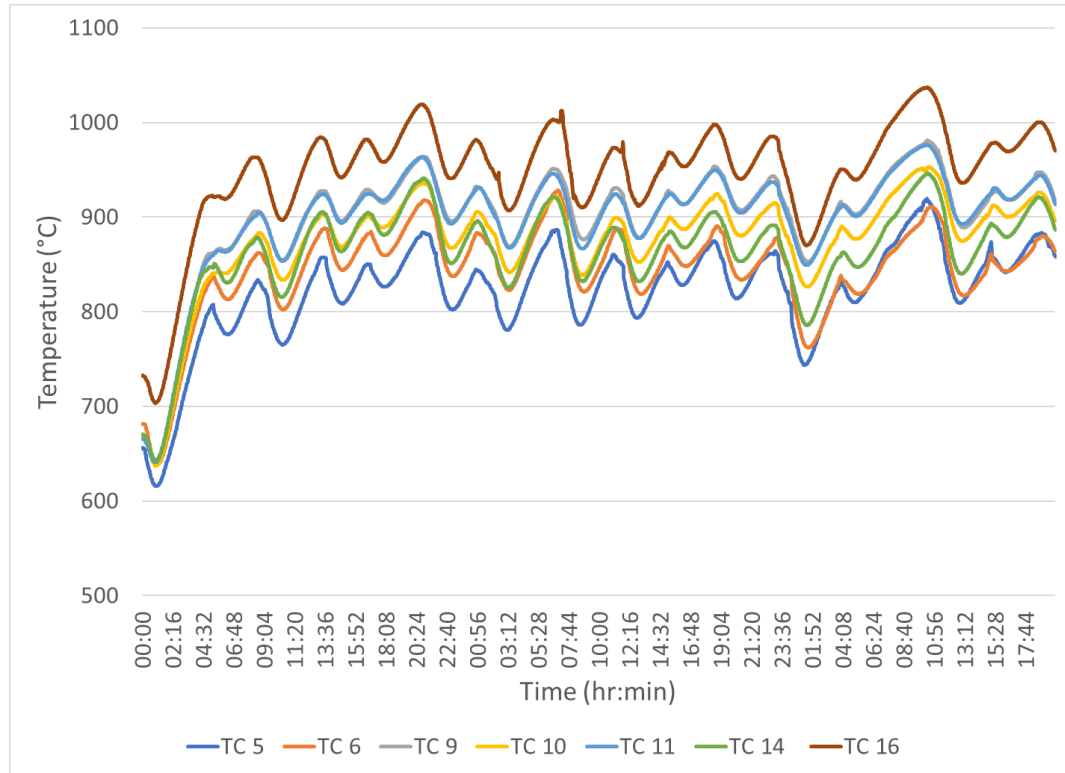
Figure 25 shows the recorded data from the thermocouples installed on the insulation hot face. It can be observed that the temperature recorded by five thermocouples regularly peaked at and above 900°C and that one of the thermocouples peaked above 1000°C on three occasions, with the highest temperature recorded of 1036°C. This information is important for thermally characterising the insulation samples recovered from the ladle at the end of the wear lining campaign. Using differential scanning calorimetry (DSC) it was possible to verify the temperatures recorded in Figure 25. More information on the DSC measurements can be found in Chapter 4.

Figure 25: Thermocouple output of insulation hot face during steel production.

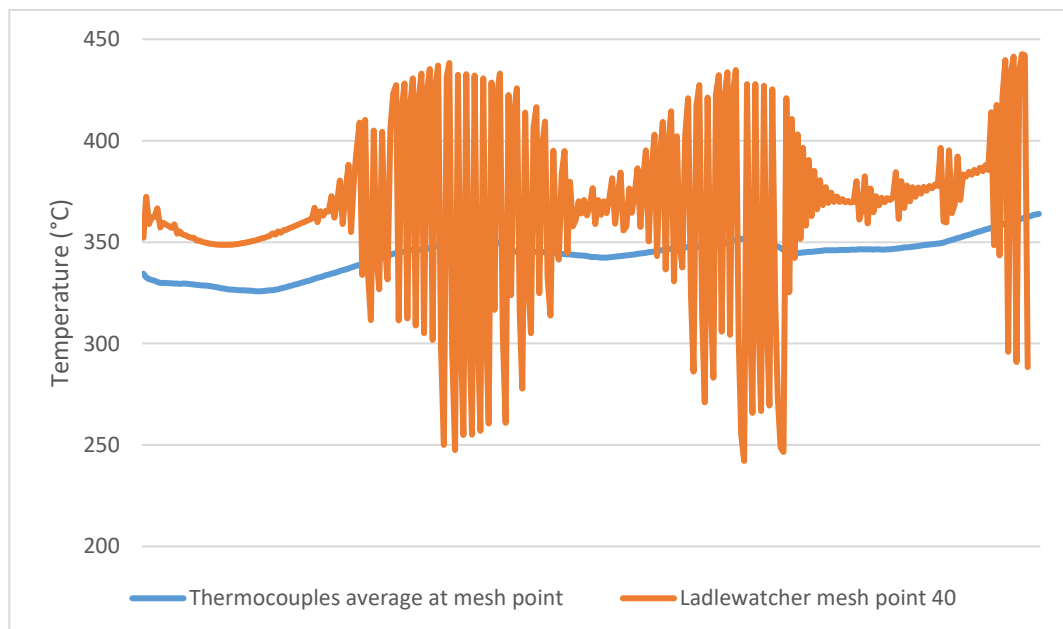
*Figure 26: Ladle Watcher instability and thermocouple measurements.*

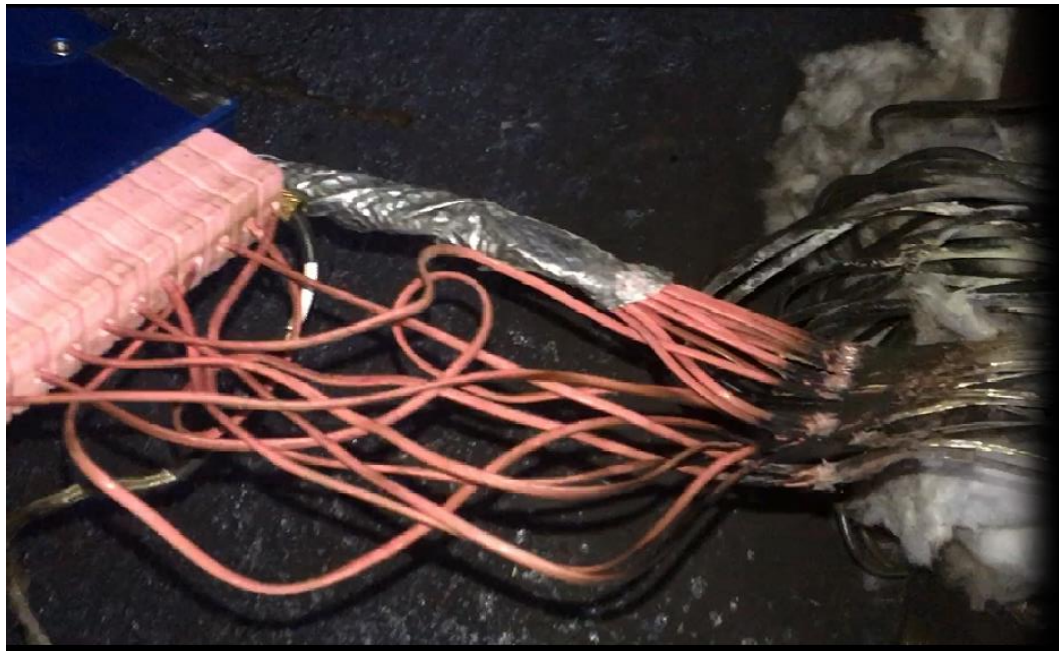
*Figure 27: Thermocouple PTFE cables with heat damage and clear melt line where cables inside insulation box were protected.*

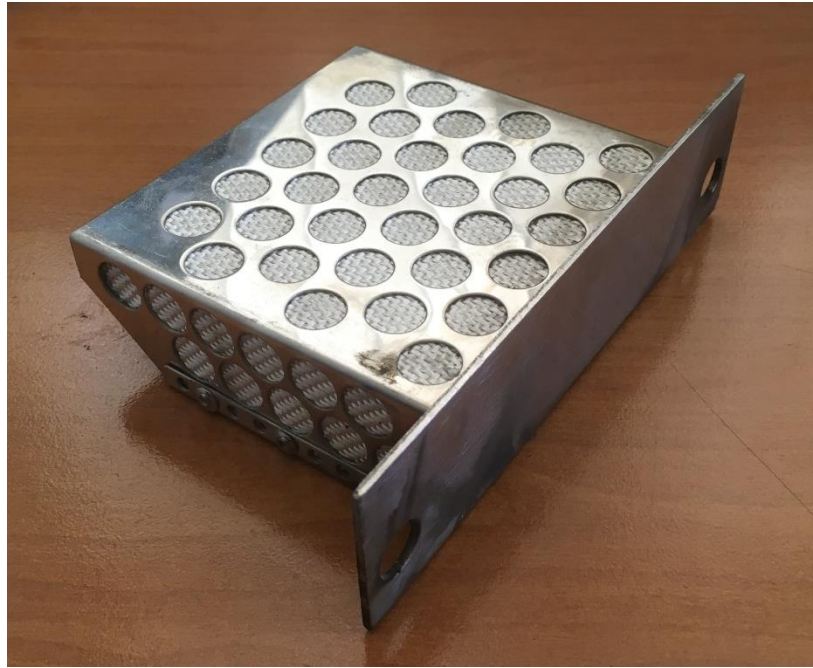
Figure 28: Original insert designed with slot for PTFE cables to exit cavity.

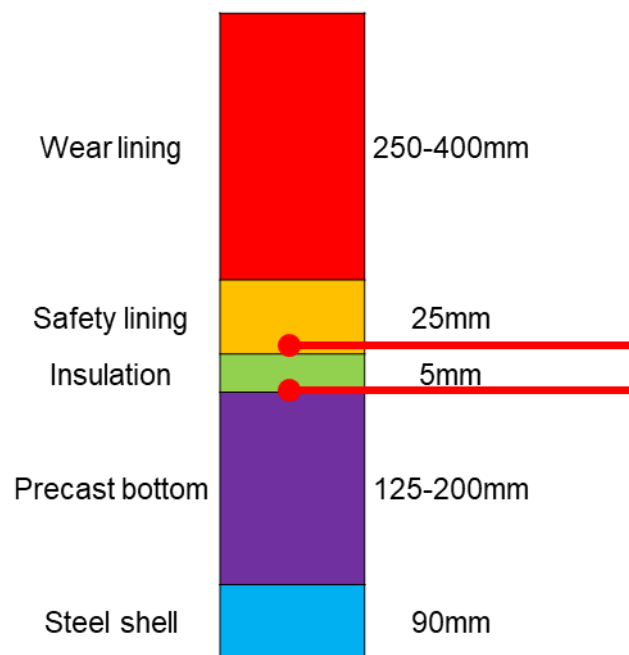
*Figure 30: Refractory build of ladle bottom including insulation panel.*

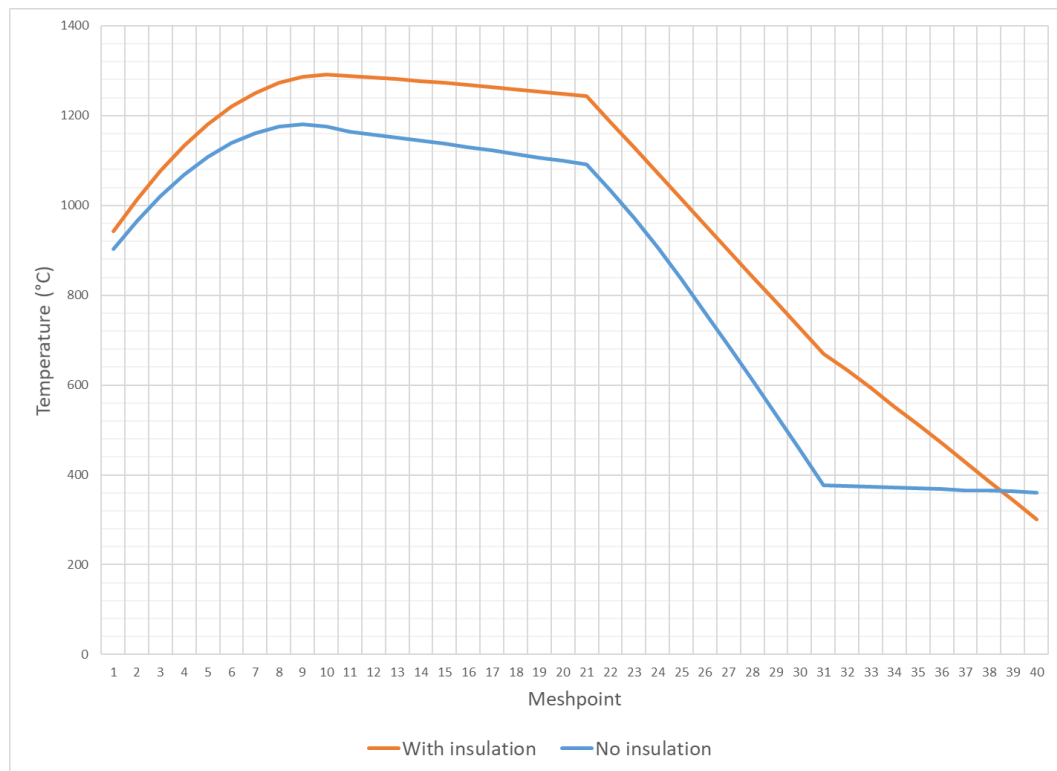
Figure 31: Ladle Watcher outputs of ladle bottom refractories with and without insulation layer, the Meshpoint refers to the thermal model outputs at the different layers of the refractory.

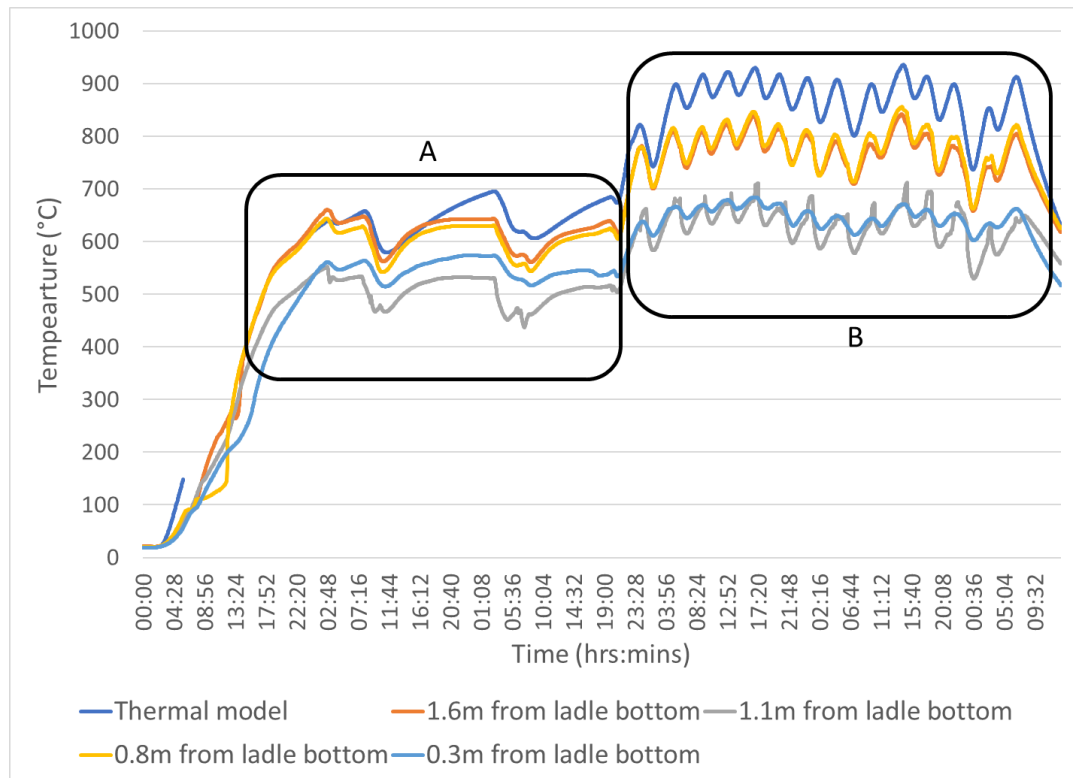
Figure 32: Comparison of Ladle Watcher data and thermocouple data, numbers in legend denote meters from the bottom of the ladle the thermocouples were positioned.

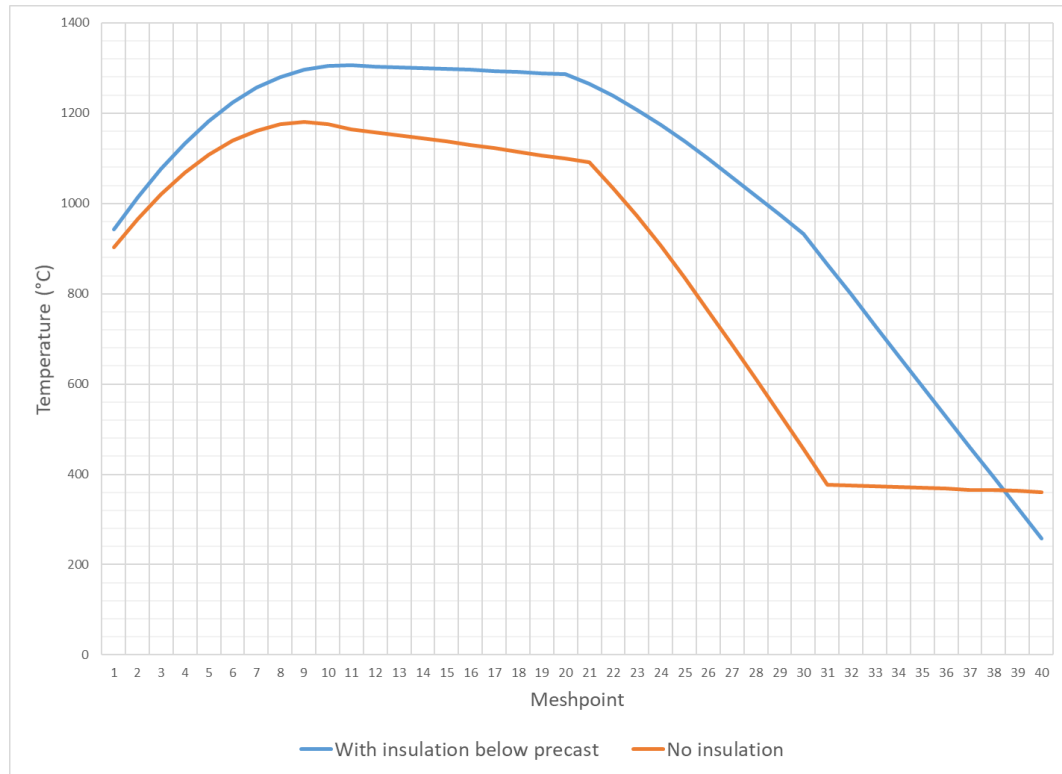
Figure 33: Output from offline Ladle Watcher model with insulation modelled below precast bottom.

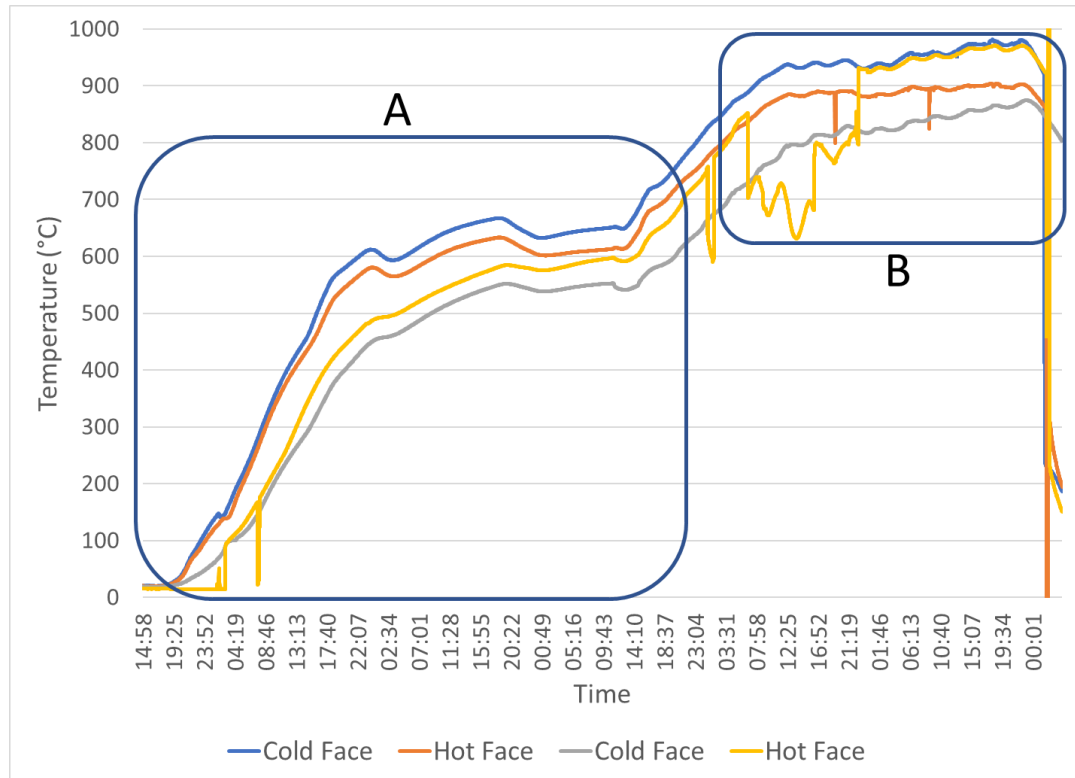
refractory build. Therefore, little conclusions can be made by the thermocouples installed in the bottom refractories and the data in Figure 34.

Figure 34: Thermocouples installed in bottom of ladle to determine if insulation layer provides benefit to thermal storage. Area A shows the duration of the ladle preheating process and area B shows the ladle during the first ten cycles of the steel plant.

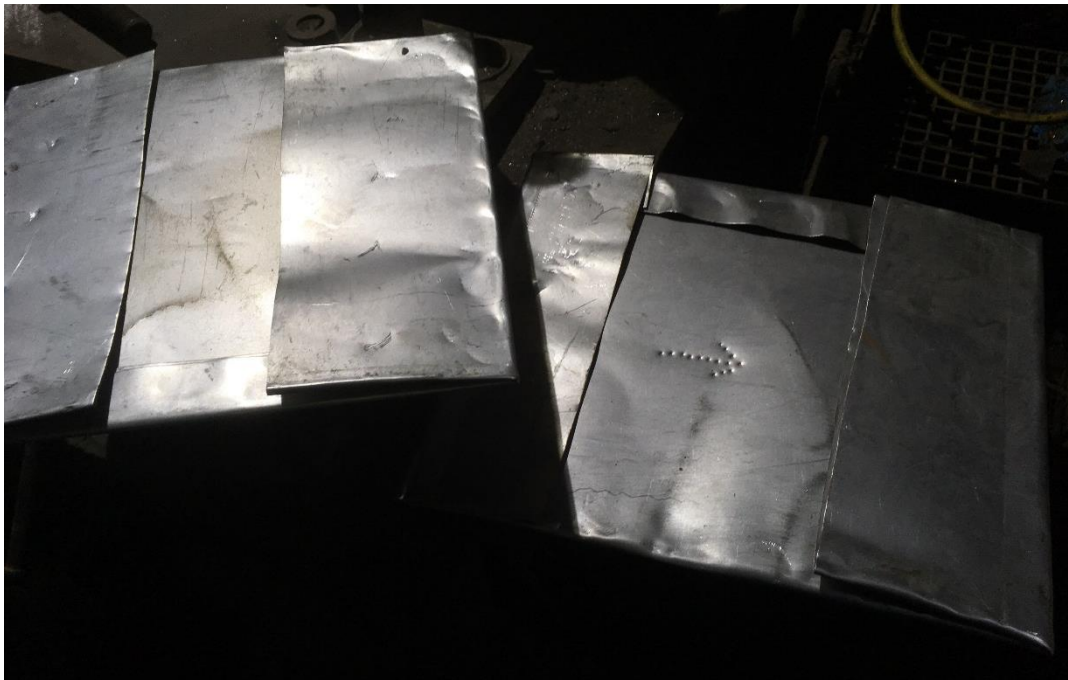
*Figure 35: Fabricated steel envelope around insulation panel.*

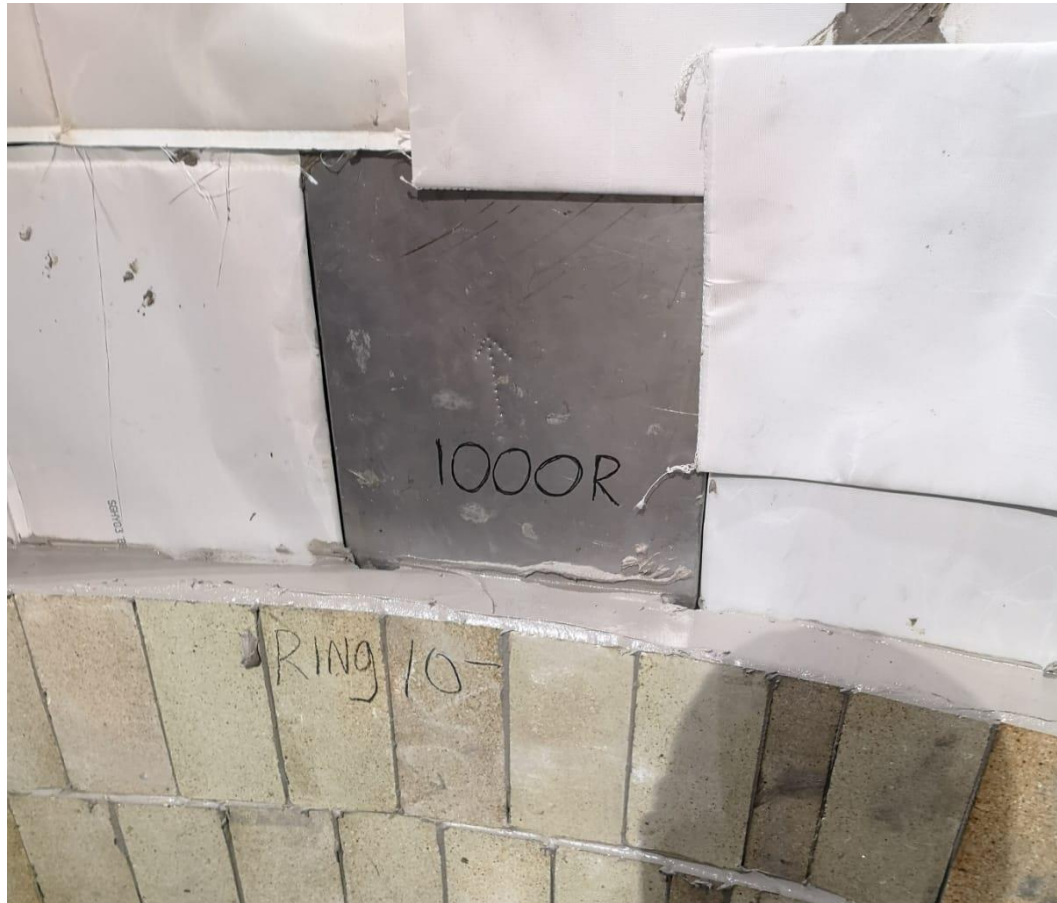
*Figure 36: Sample installed in ladle with number of rings recorded to calculate height of sample in ladle.*
