*Thermal measurement and  
degradation quantification of  
teeming ladle refractories and the  
effects on the process*

Submitted to Swansea University in fulfilment of the requirements for  
the Degree of Doctor of Engineering

September 2020

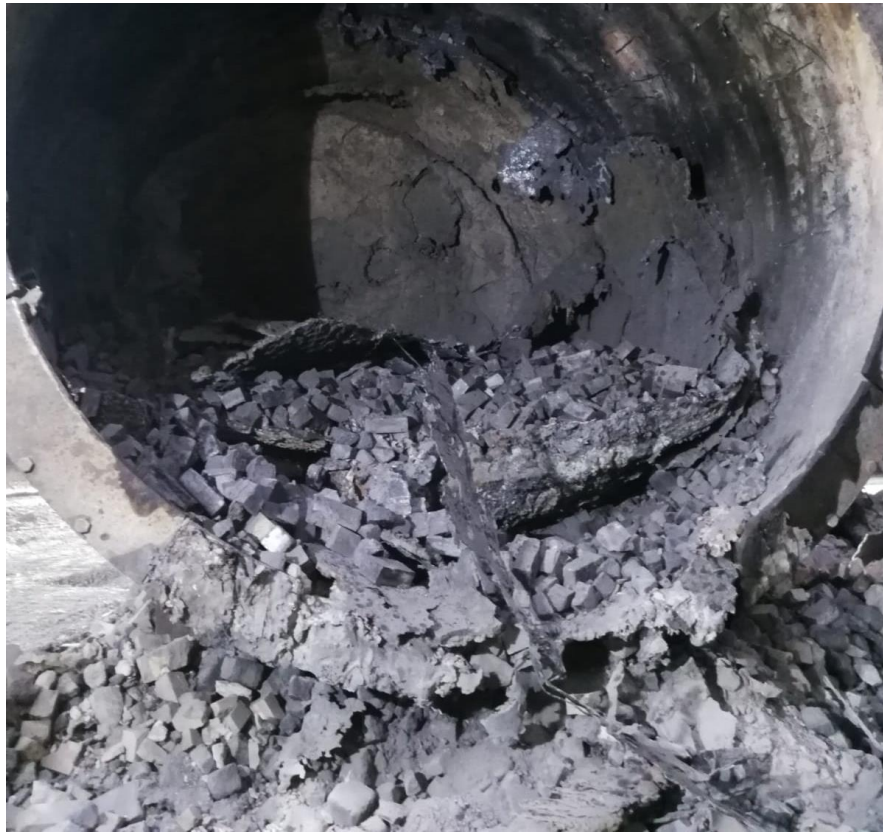
*Figure 37: Insulation samples damaged or lost within the refractory bricks in the ladle.*

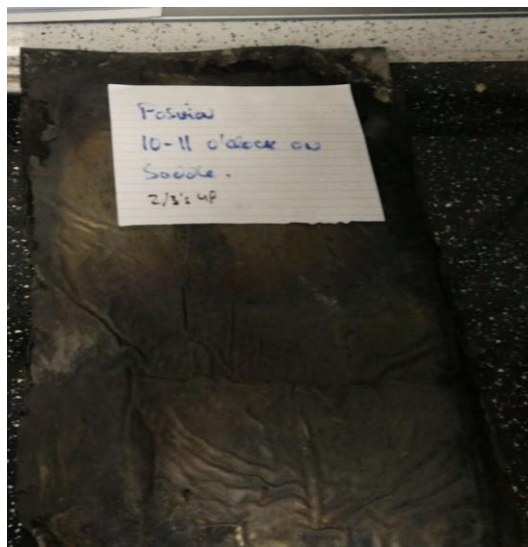
*Figure 38: Recovered steel envelope from barrel which no longer had a sample of the insulation material contained.*

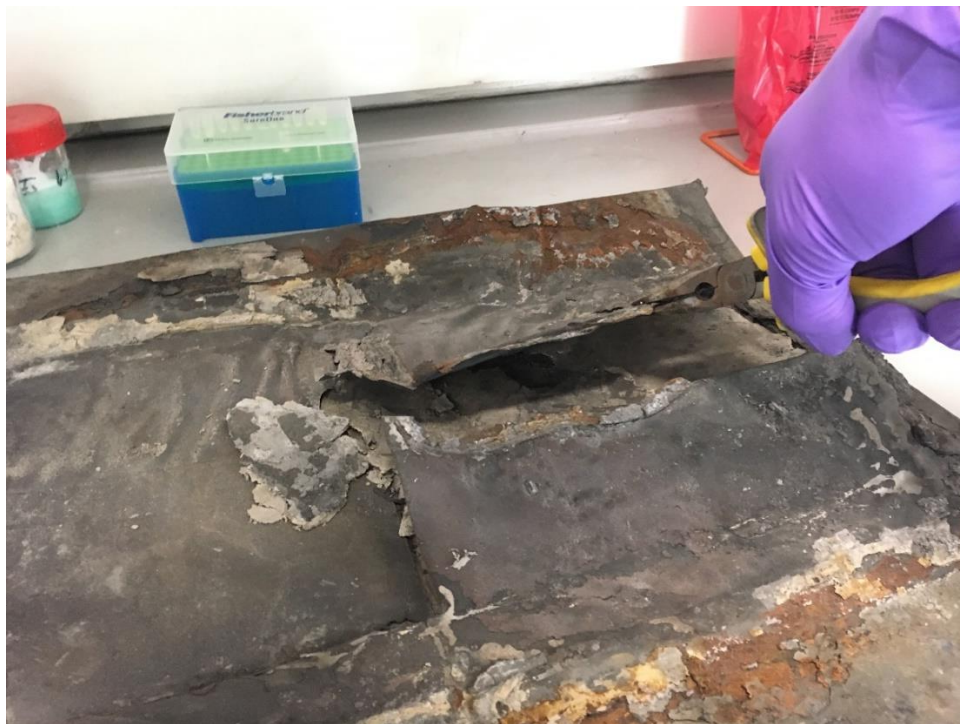
*Figure 39: Steel envelope opened to reveal ladle insulation sample inside.*

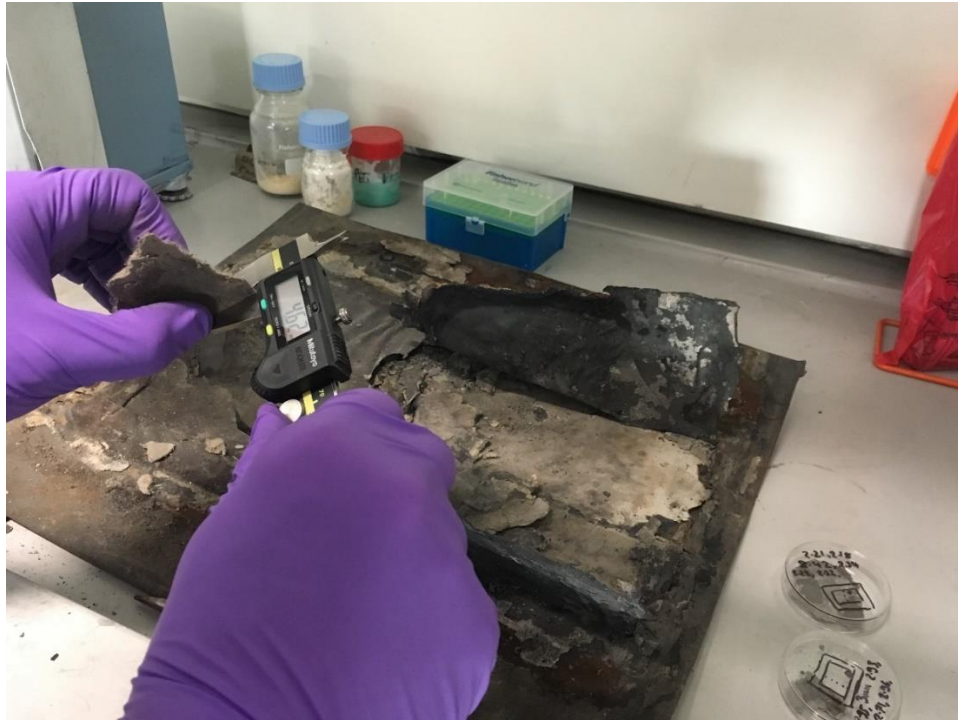
*Figure 40: Insulation sample broken into manageable pieces and the thickness measured.*

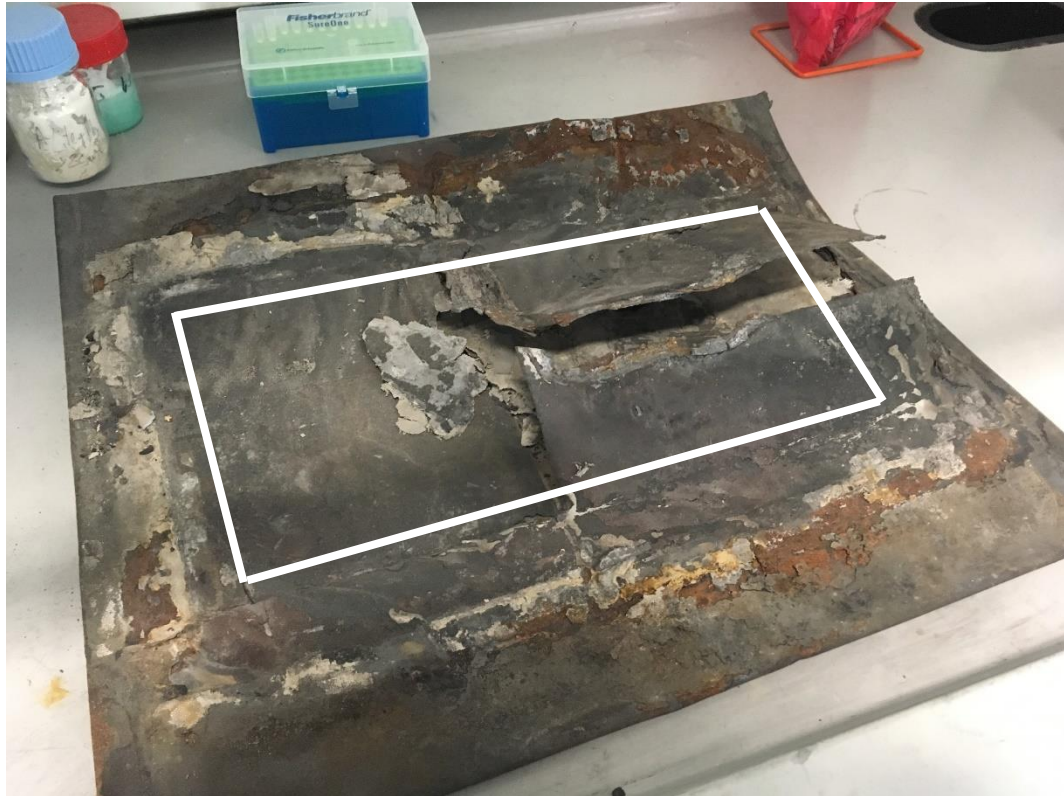
Figure 41: Recovered protected insulation panel with sample area marked to ensure samples were not taken from overlapped area.

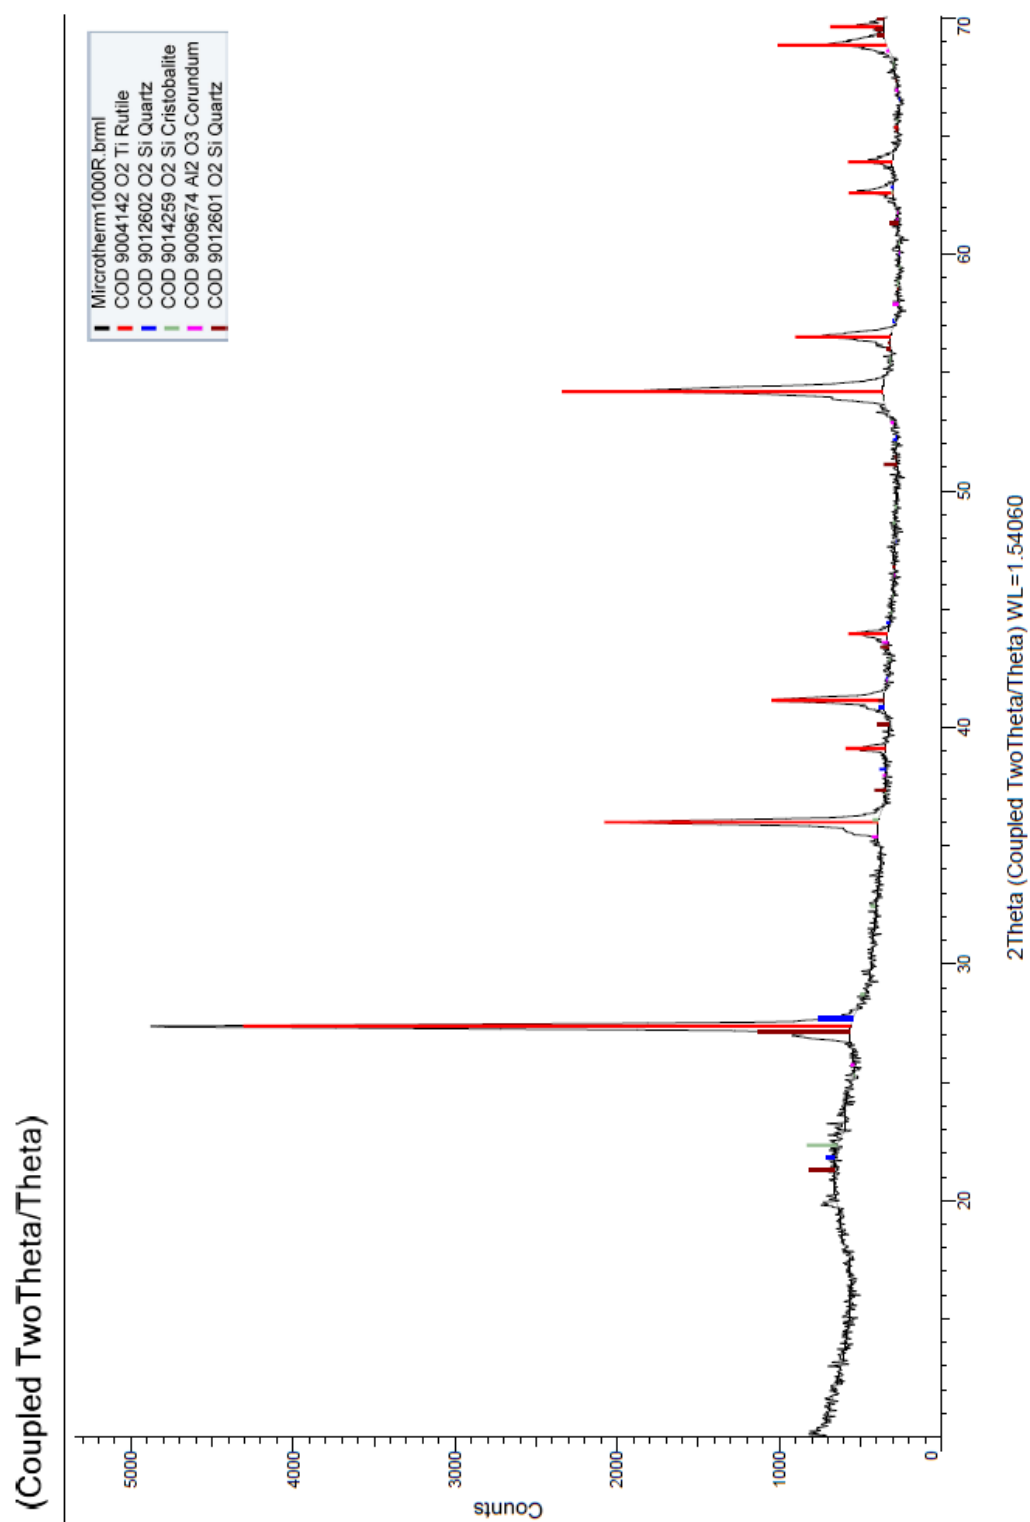
Figure 42: XRD data and analysis for crystalline material present in insulation samples

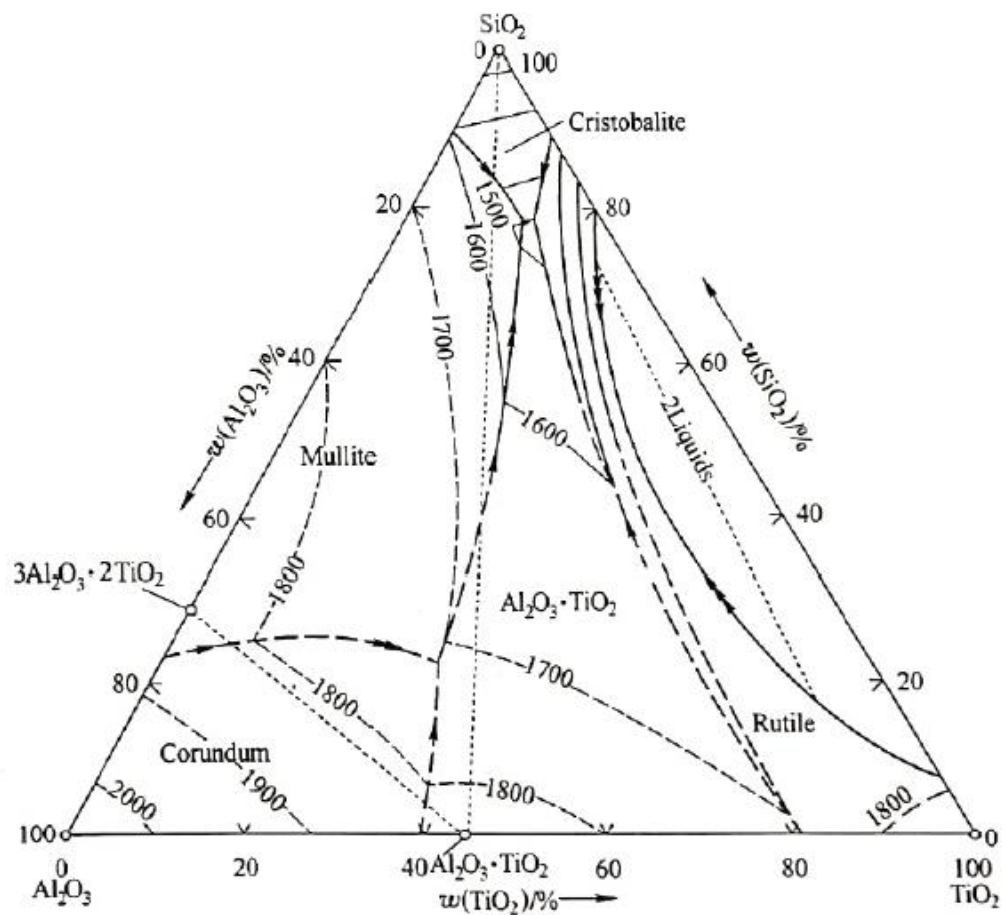
Figure 43: Ternary diagram of  $\text{SiO}_2$  -  $\text{TiO}_2$  -  $\text{Al}_2\text{O}_3$  phases taken from (71).

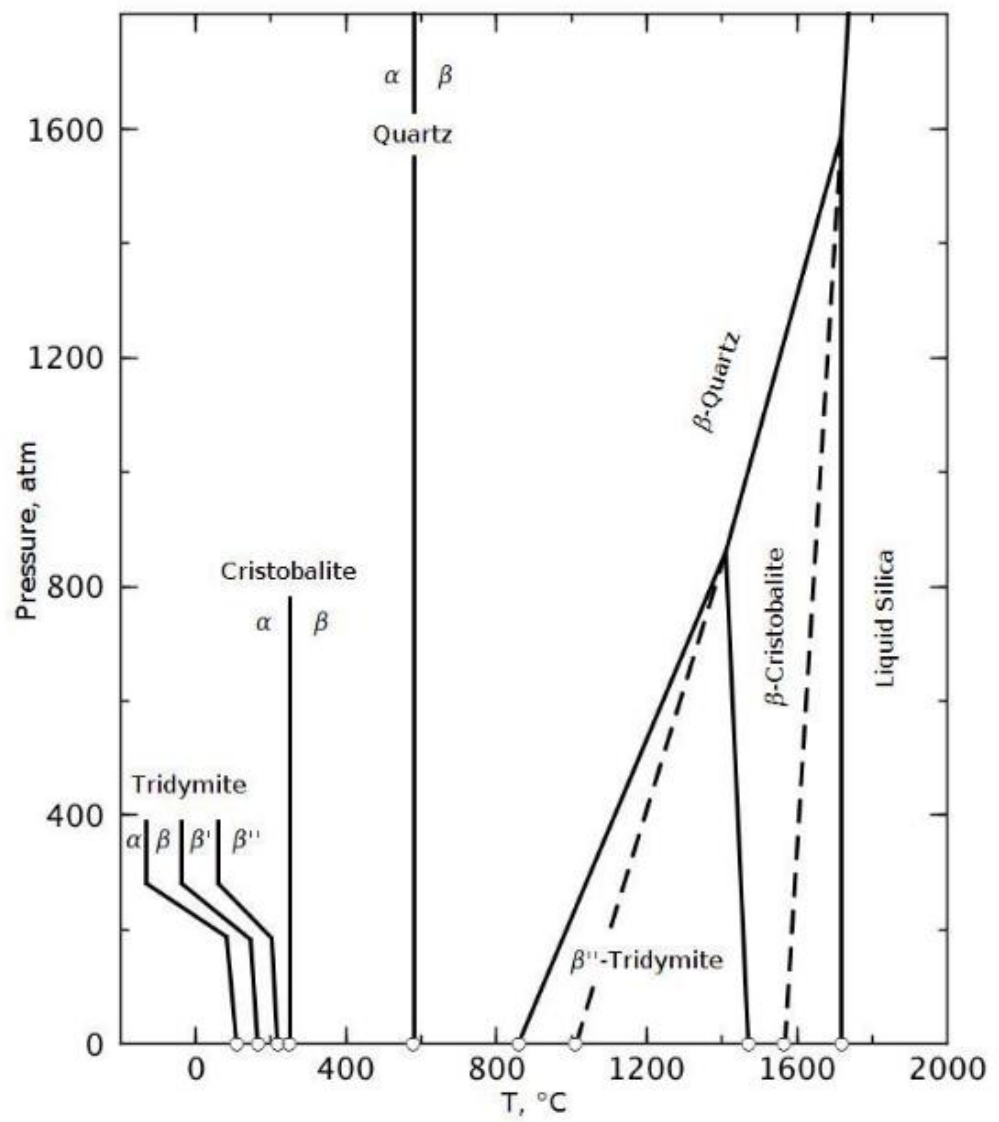
Figure 44: Silica phase diagram taken from (75).

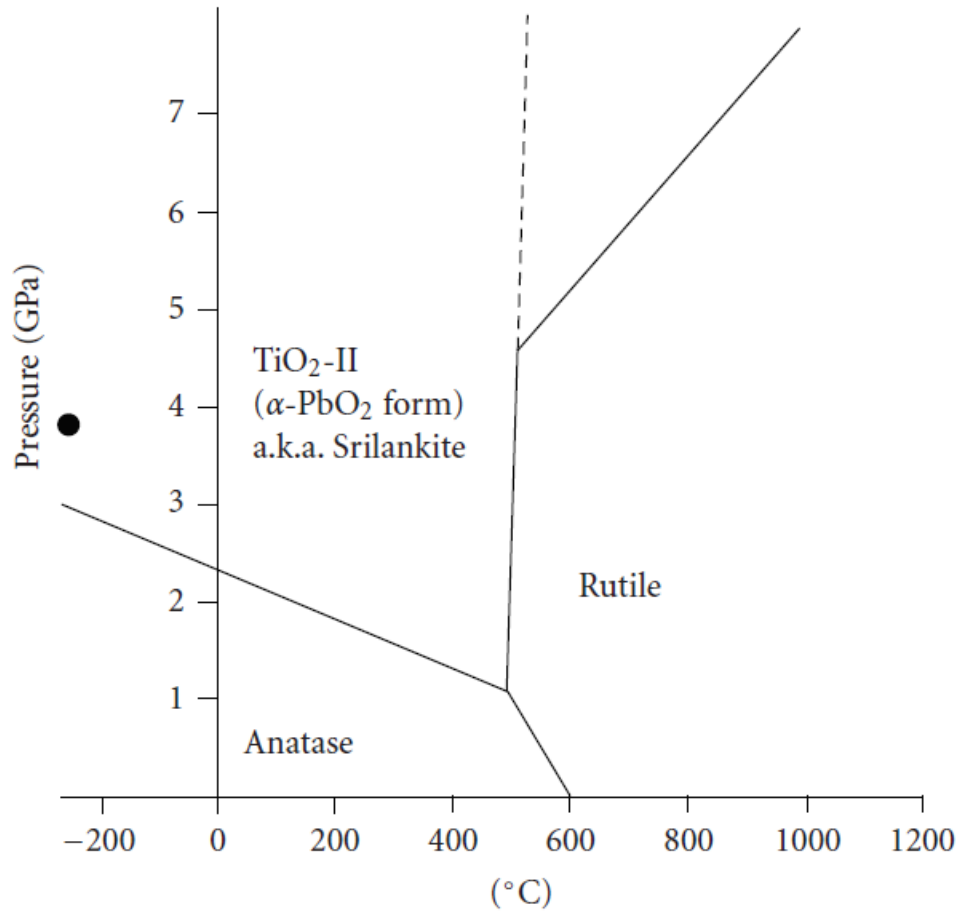
Figure 45: Titania phase diagram taken from (76).

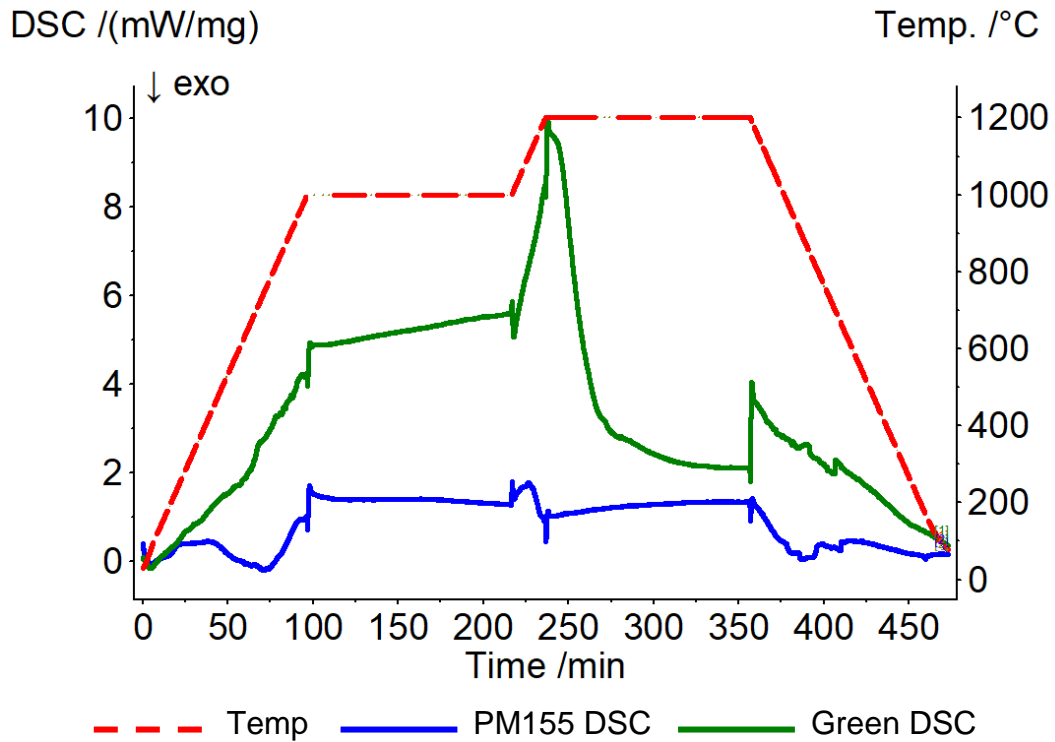
Figure 46: DSC results of Green insulation and post-mortem insulation PM155.

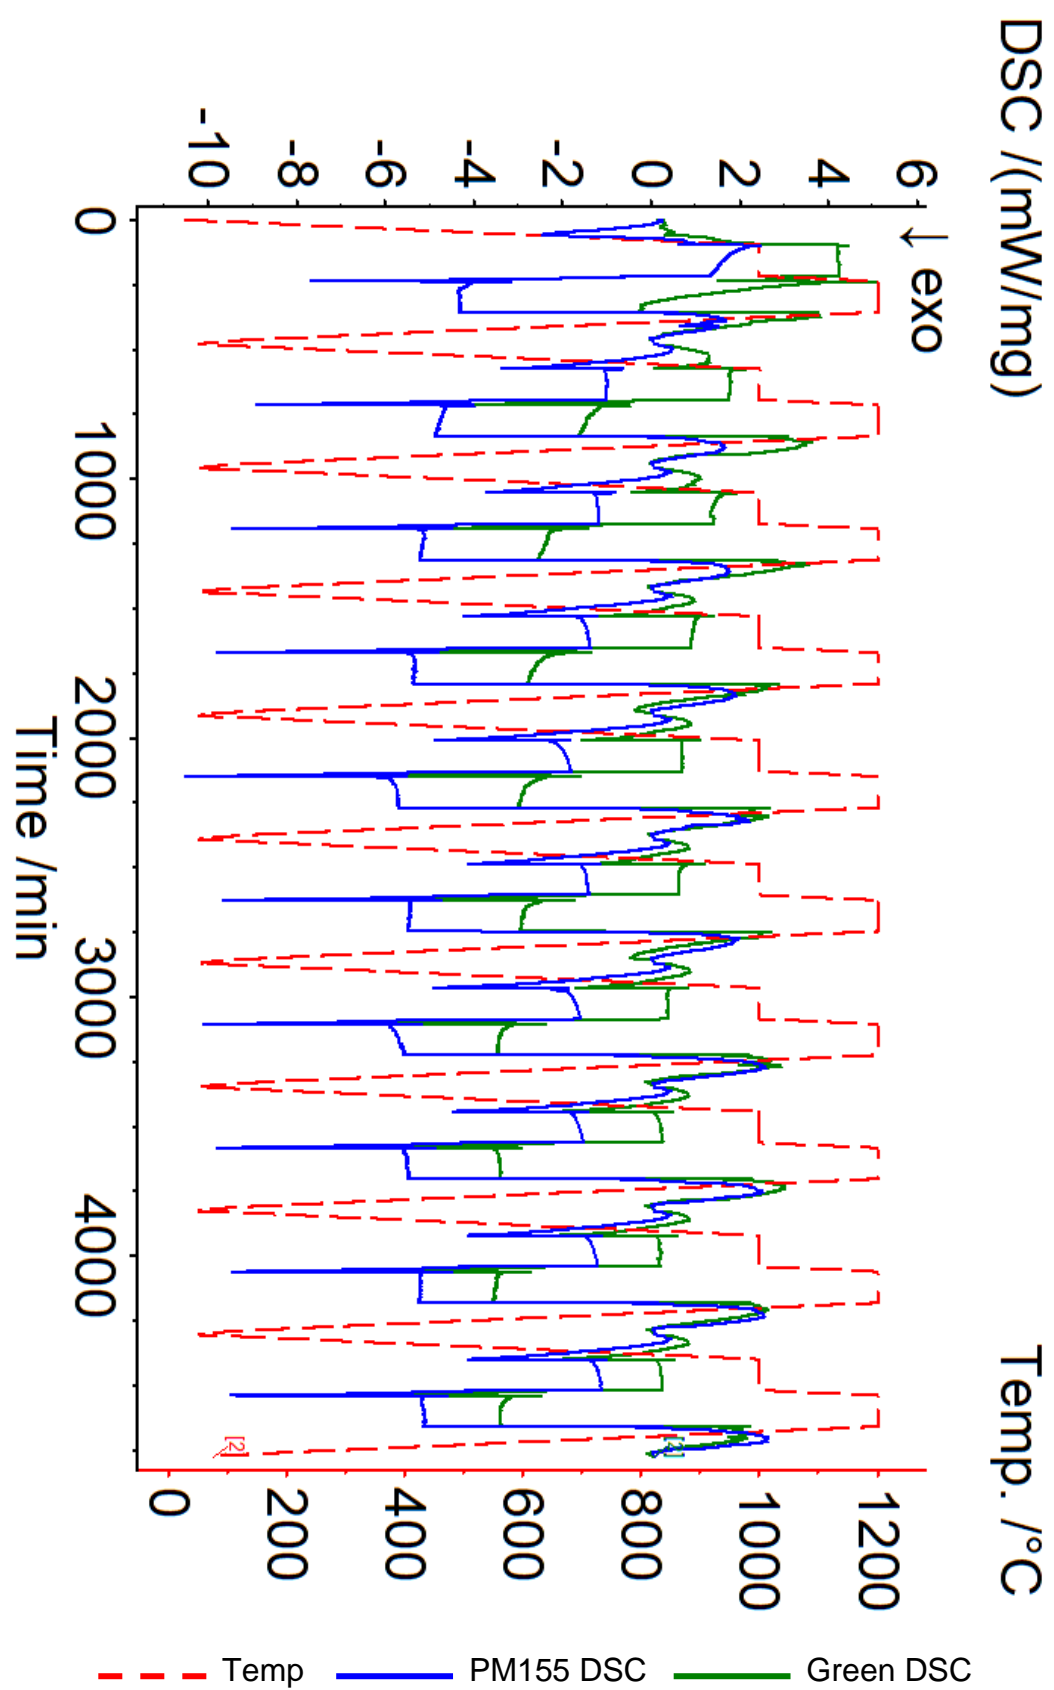
Figure 47: DSC results of ten cycles with peak temperature of 1200°C for the Green and PM155 samples.

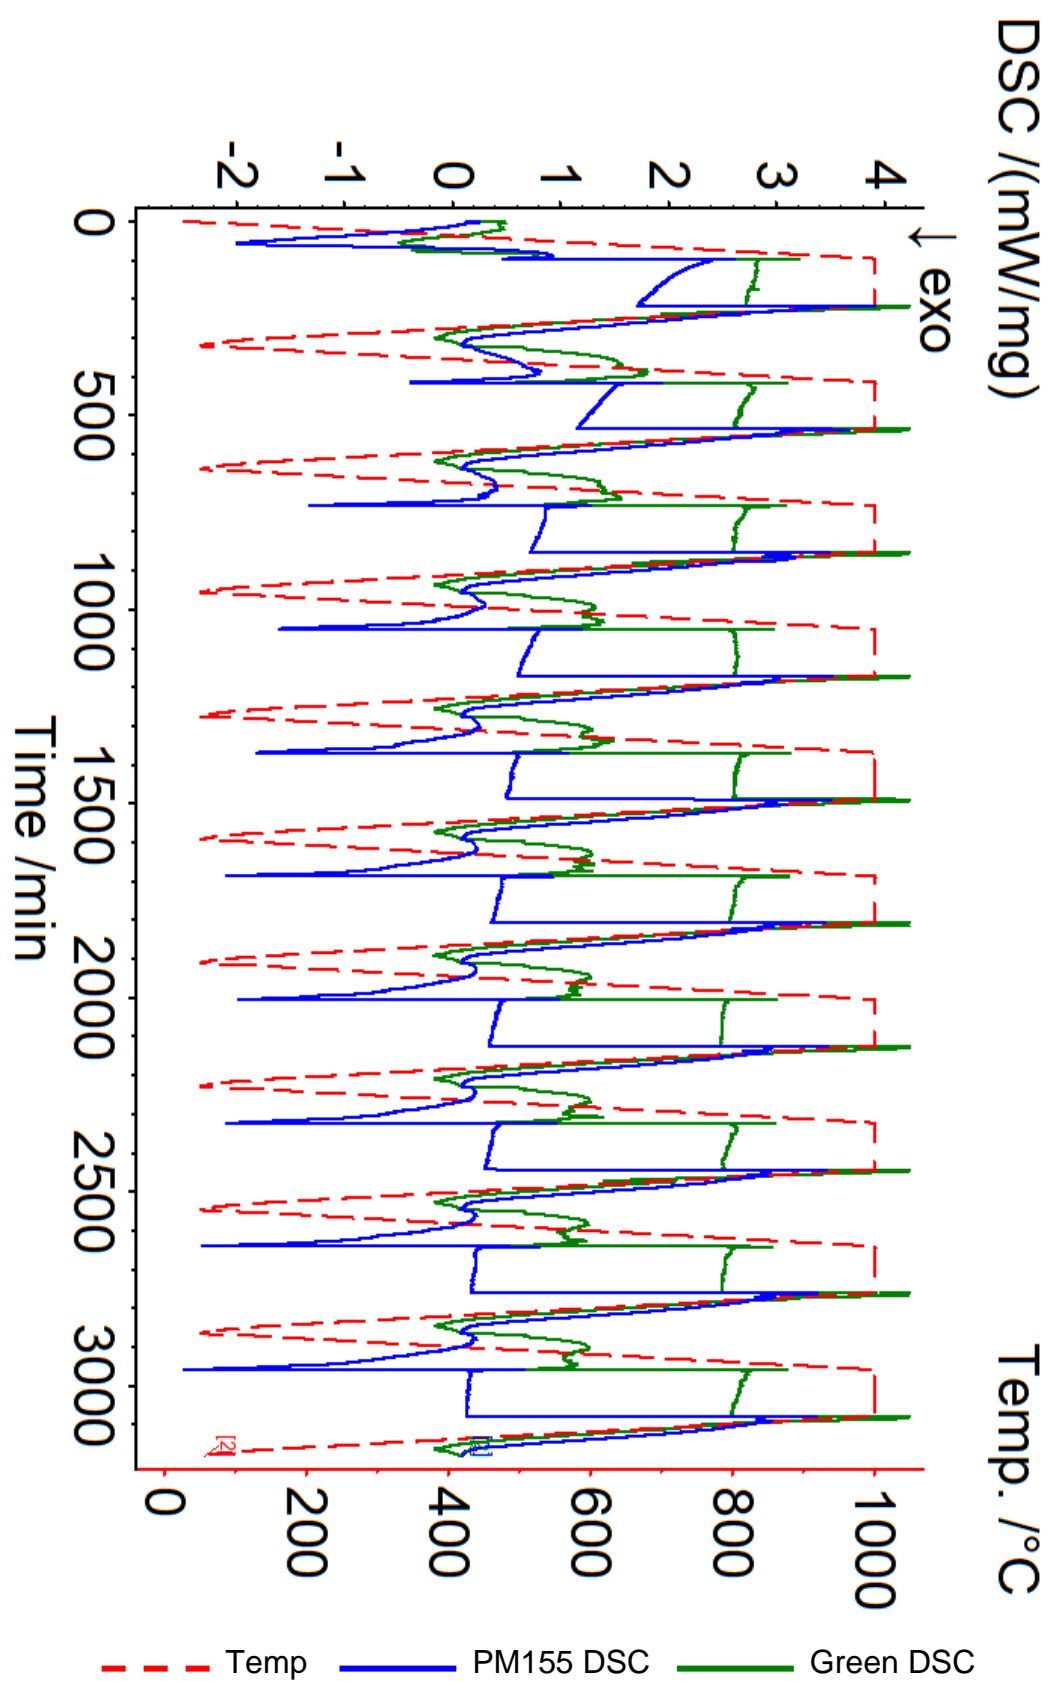
Figure 48: DSC curves for PM155 and Green materials ten cycles to 1000°C.

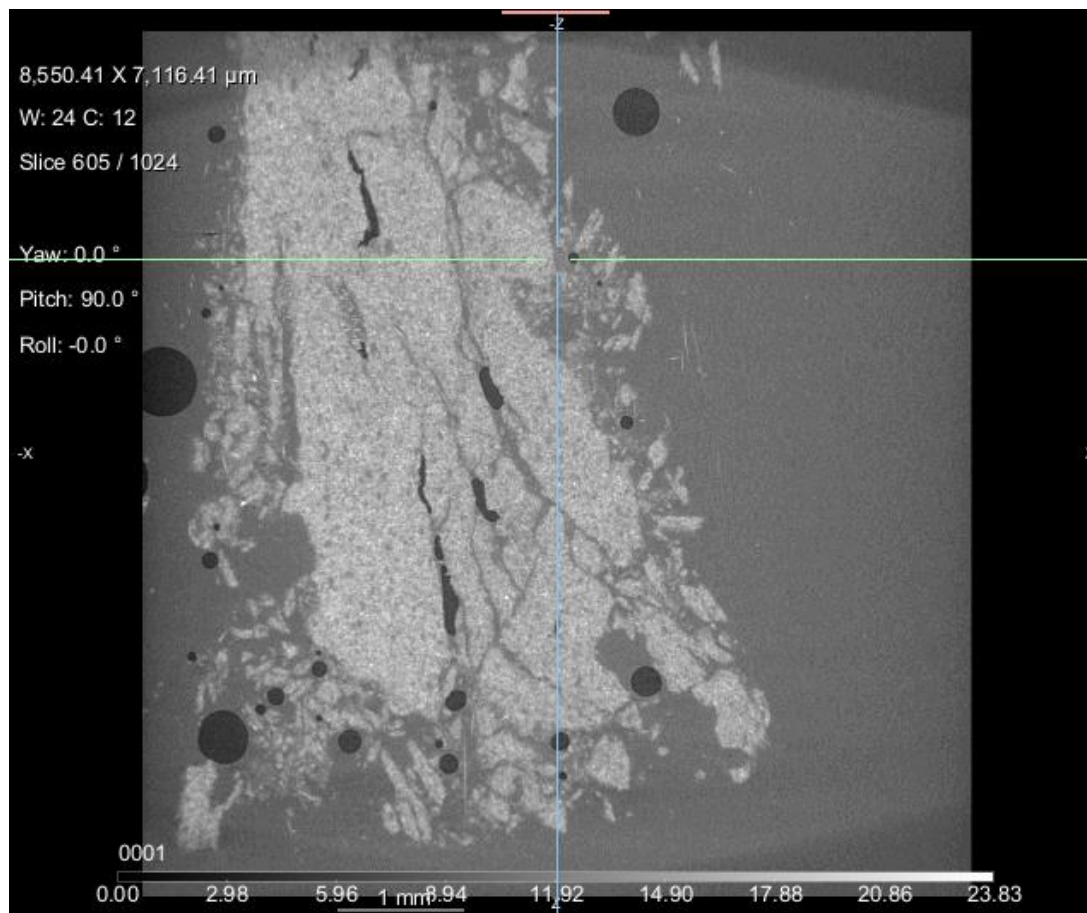
Figure 49: XCT image of Green sample with voxel size in top left corner (this was consistent for Figures 52-55).

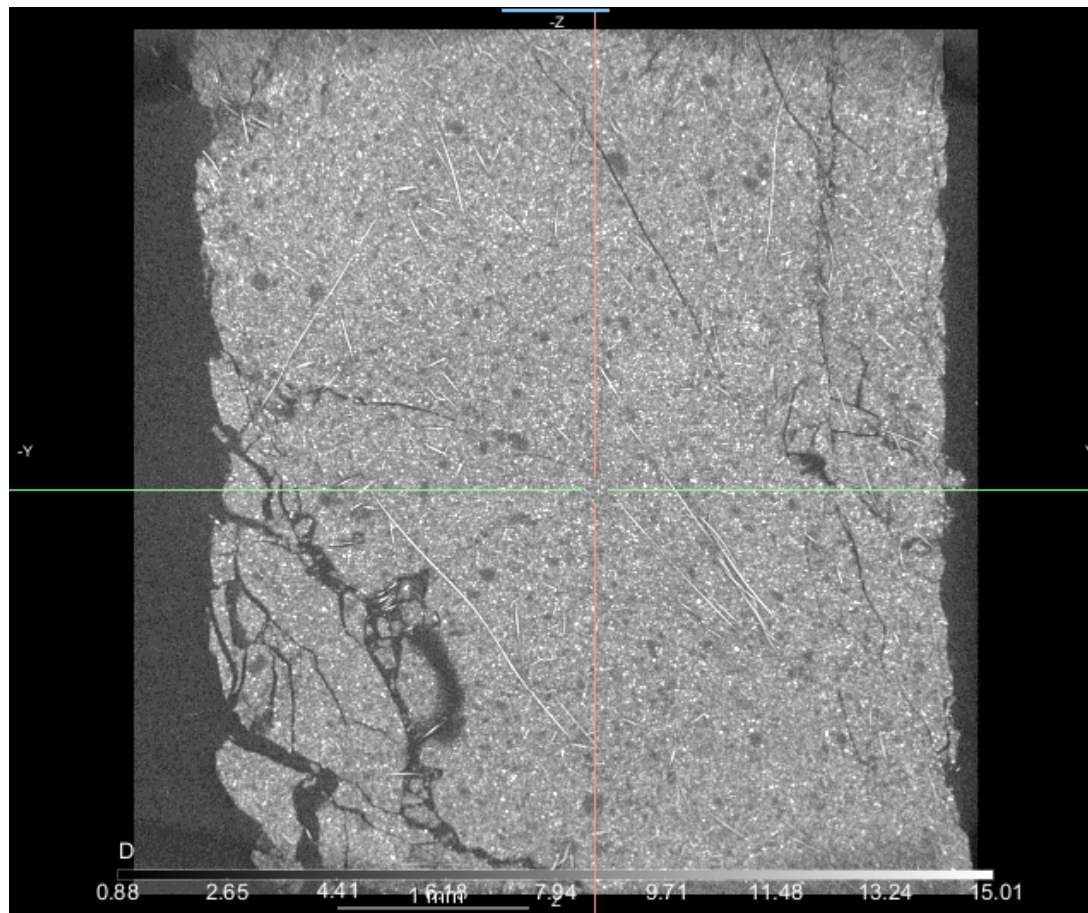
*Figure 50: XCT image of PM155D sample.*

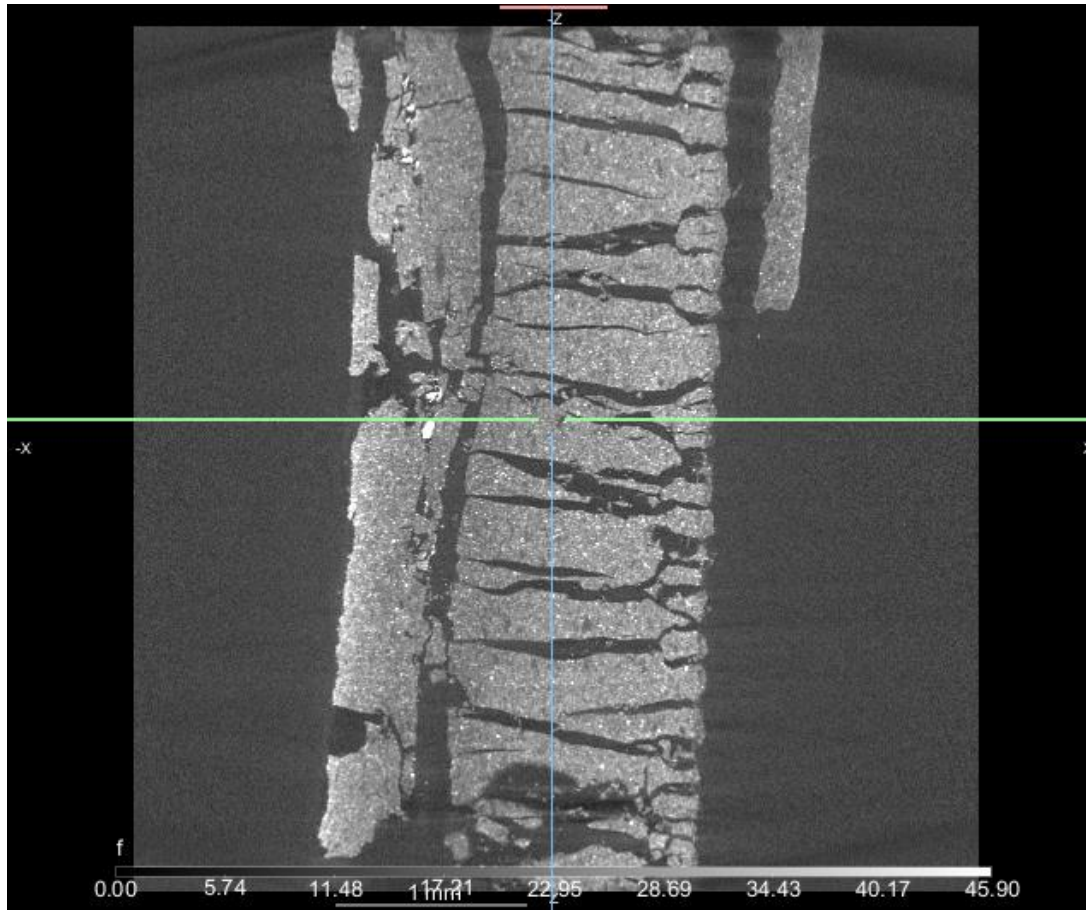
*Figure 51: XCT image of PM1155F sample.*

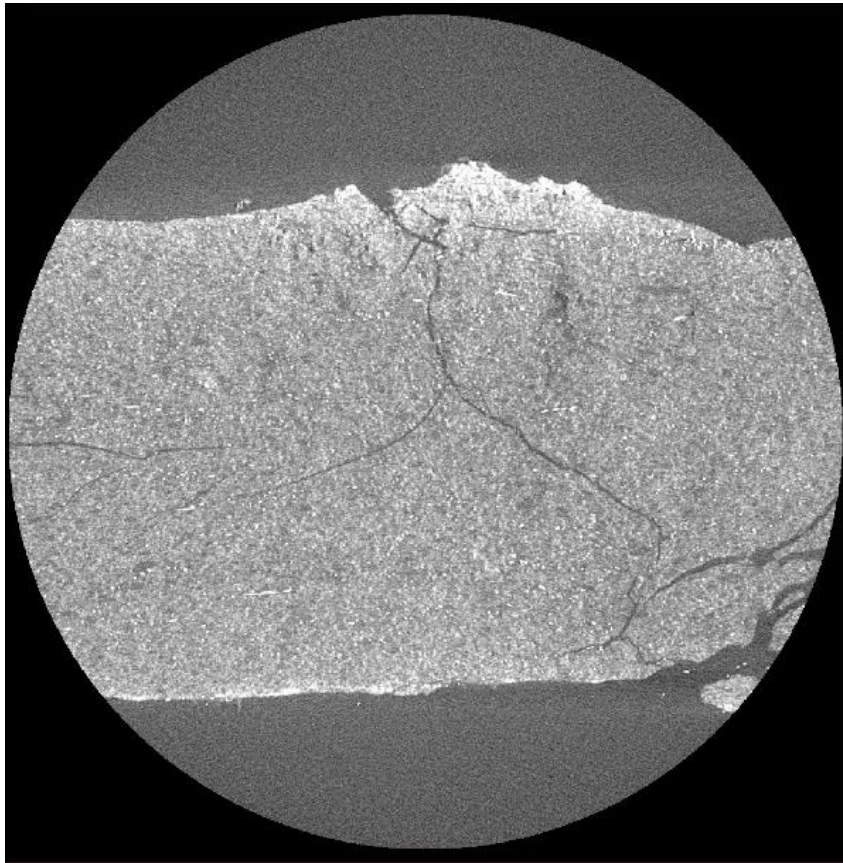
*Figure 53: XCT image of PM126C sample.*

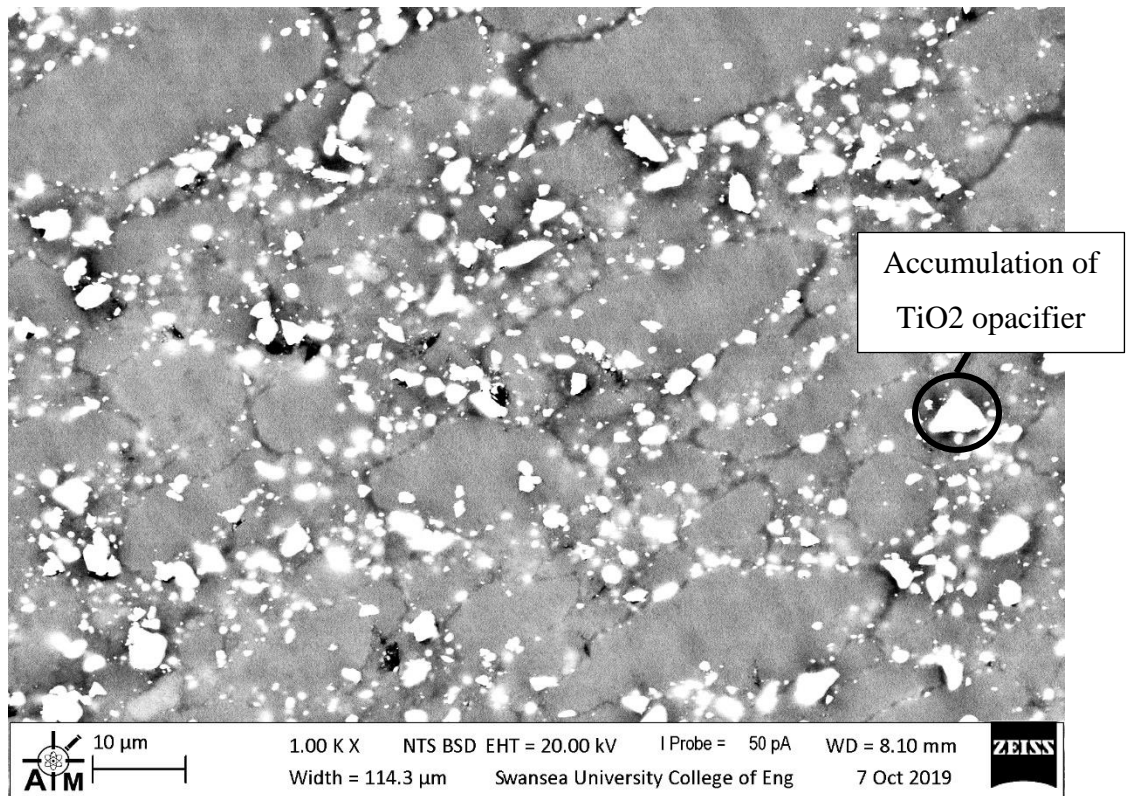
Figure 54: SEM image of Green sample.

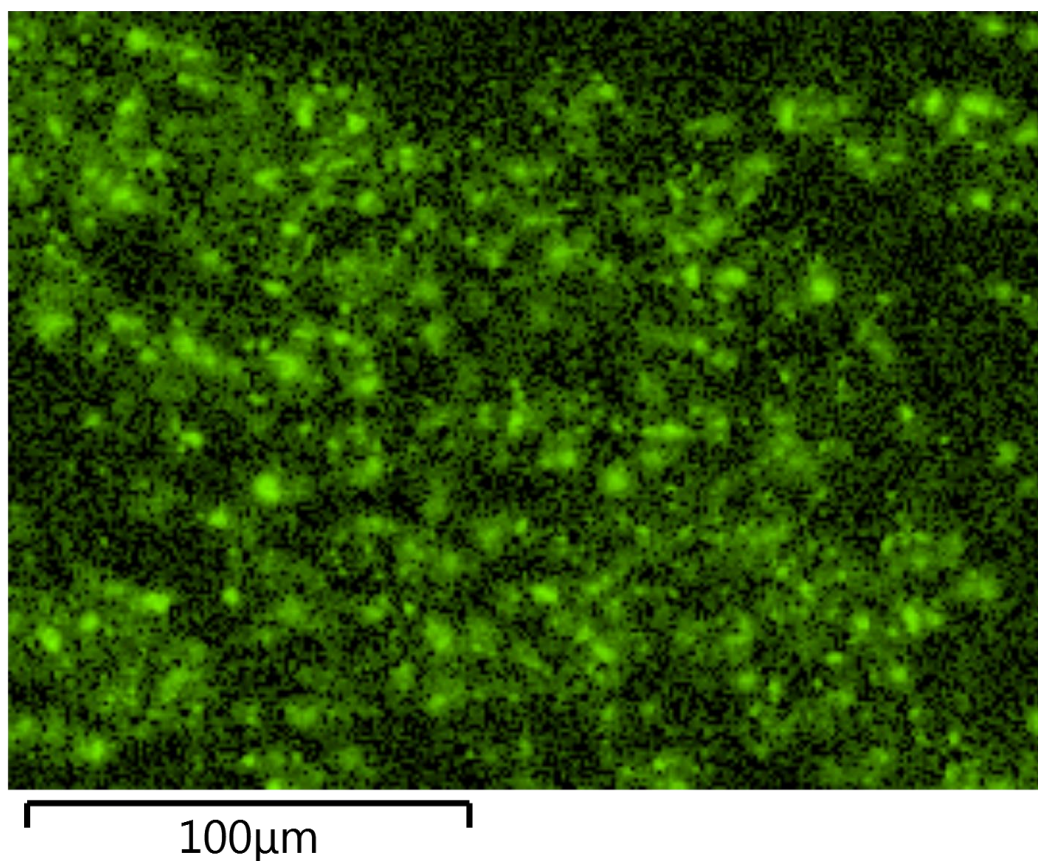
Figure 56: Ti spectrum from EDS image showing TiO<sub>2</sub> opacifier across Green sample and accumulations highlighted in SEM image

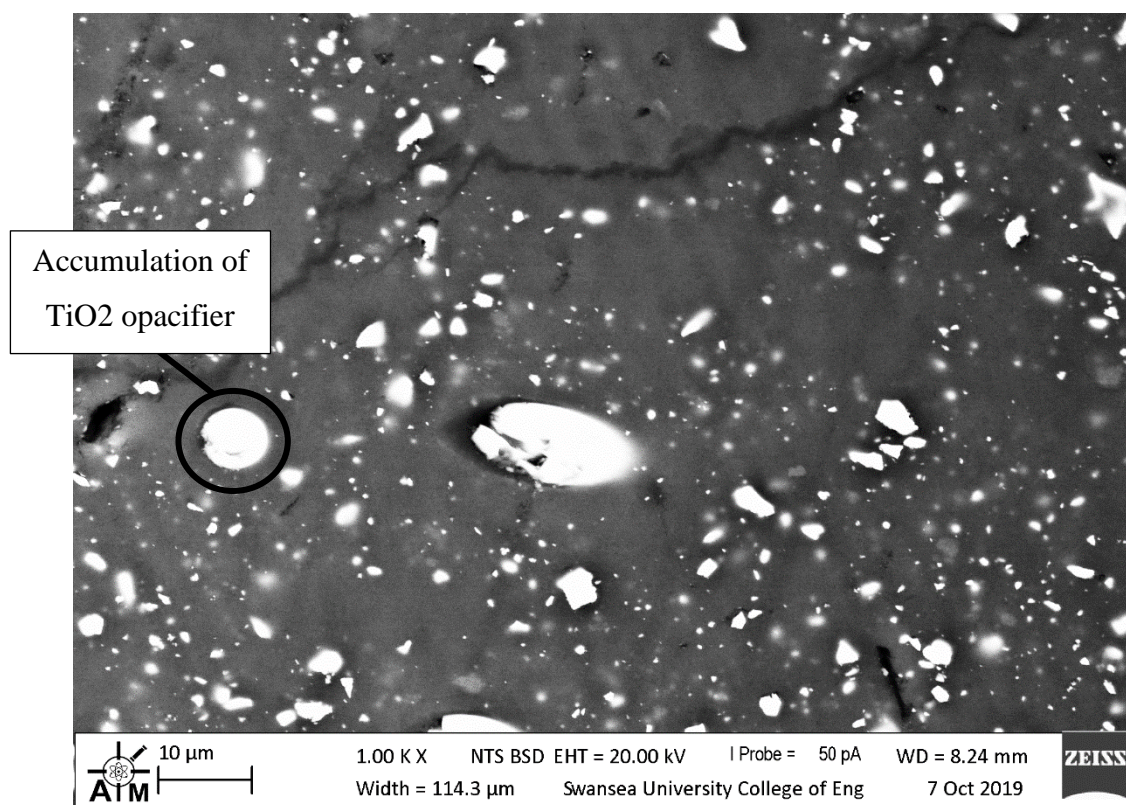
Figure 57: SEM image of PM155D.

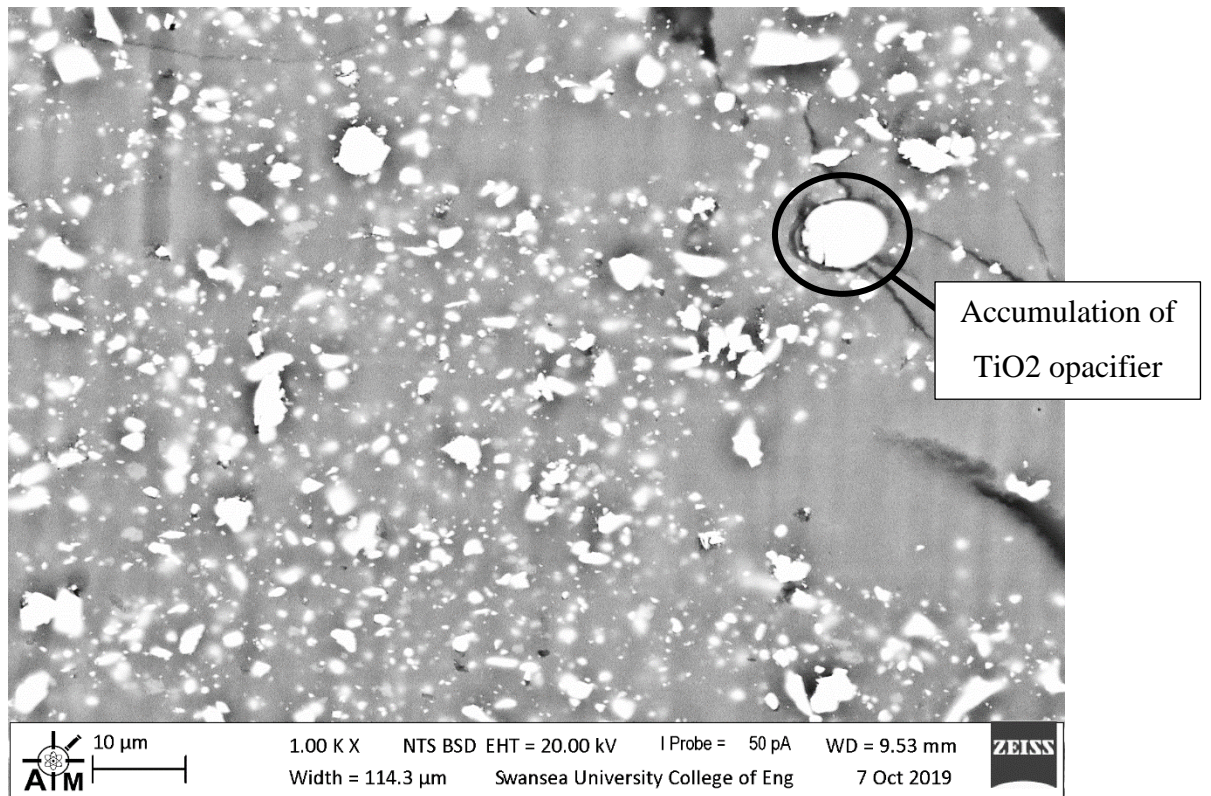
Figure 60: SEM image of PM155F.

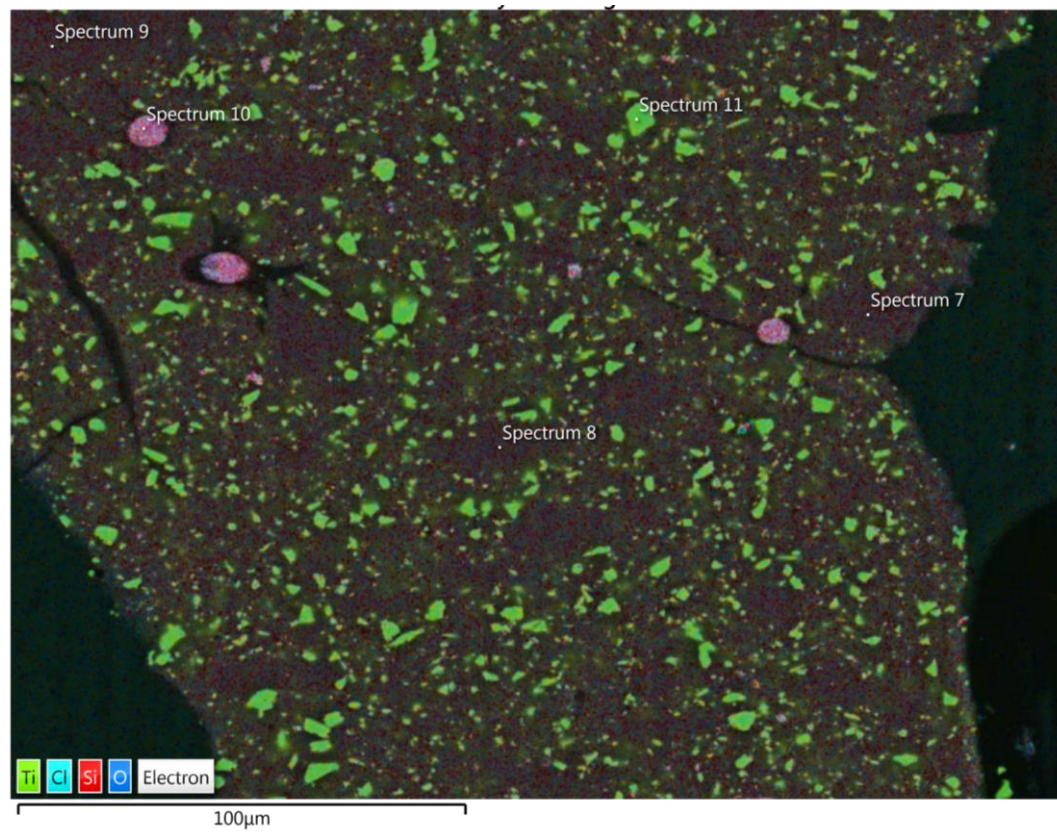
Figure 61: EDS image of PM155F with multiple spectrums

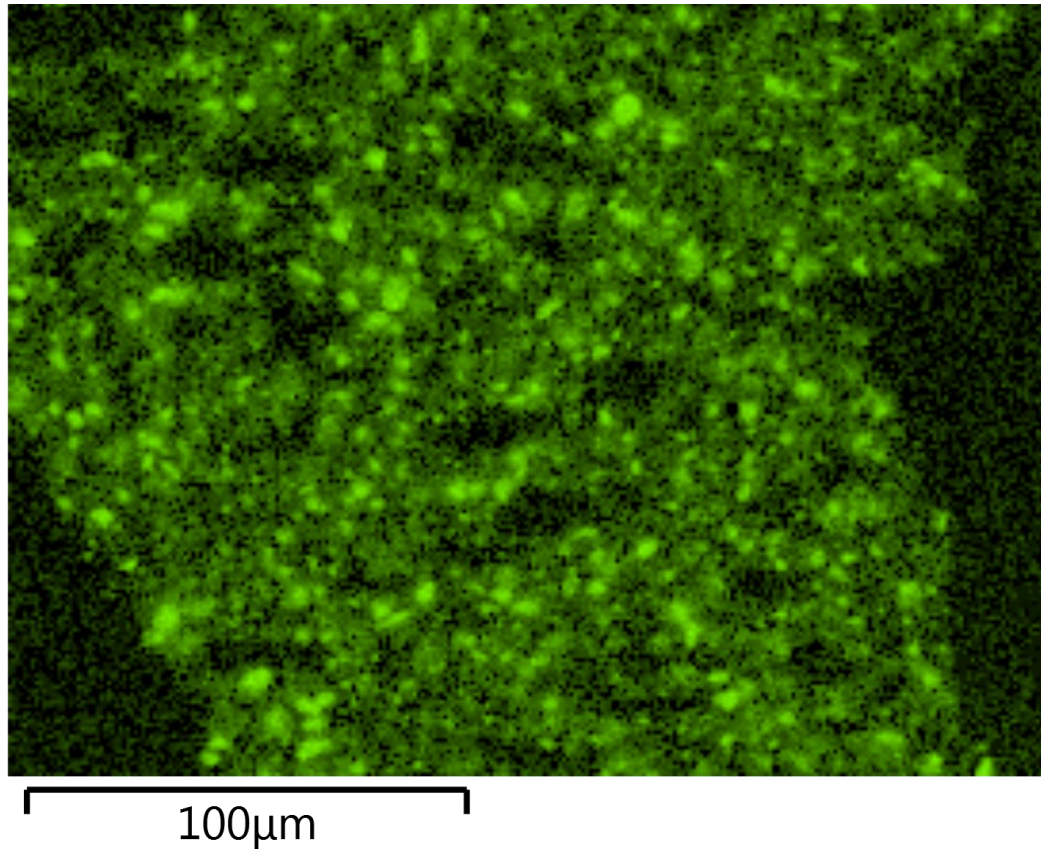
*Figure 62: Ti spectrum from EDS image showing TiO<sub>2</sub> opacifier across PM155F sample and accumulations highlighted in SEM image*

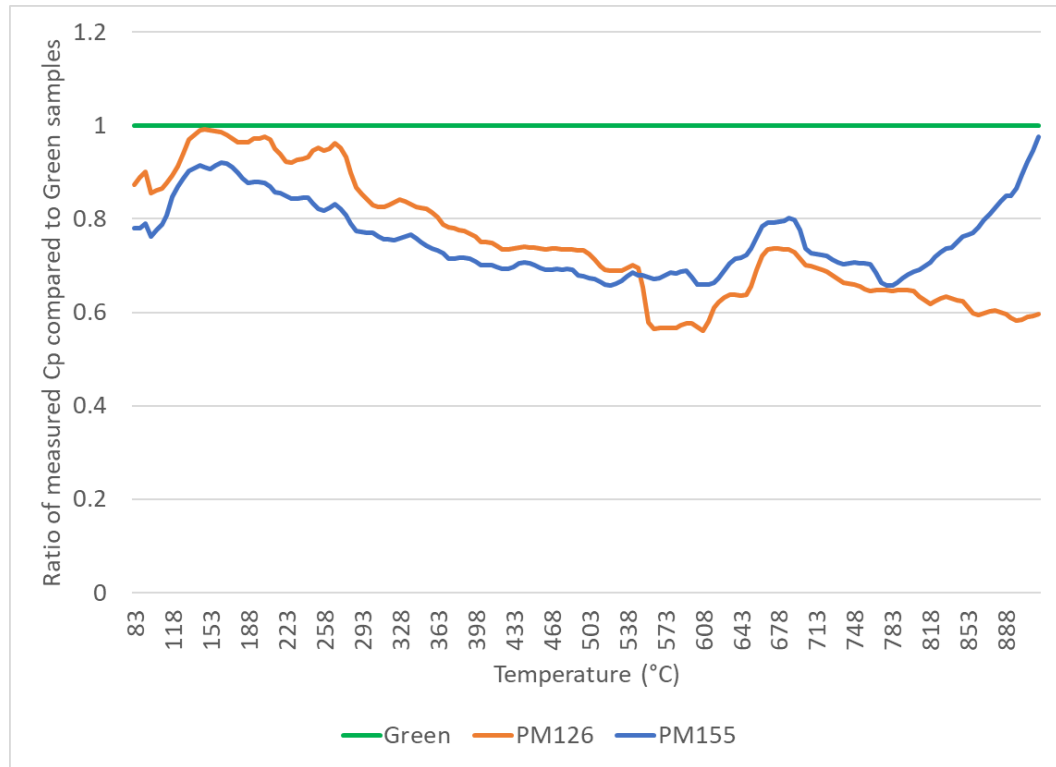
Figure 63: Specific heat ( $C_p$ ) of the Green and post-mortem insulation materials measured via DSC displayed as a ratio of the properties compared to the Green sample measurements.
