*Thermal measurement and  
degradation quantification of  
teeming ladle refractories and the  
effects on the process*

Submitted to Swansea University in fulfilment of the requirements for  
the Degree of Doctor of Engineering

September 2020

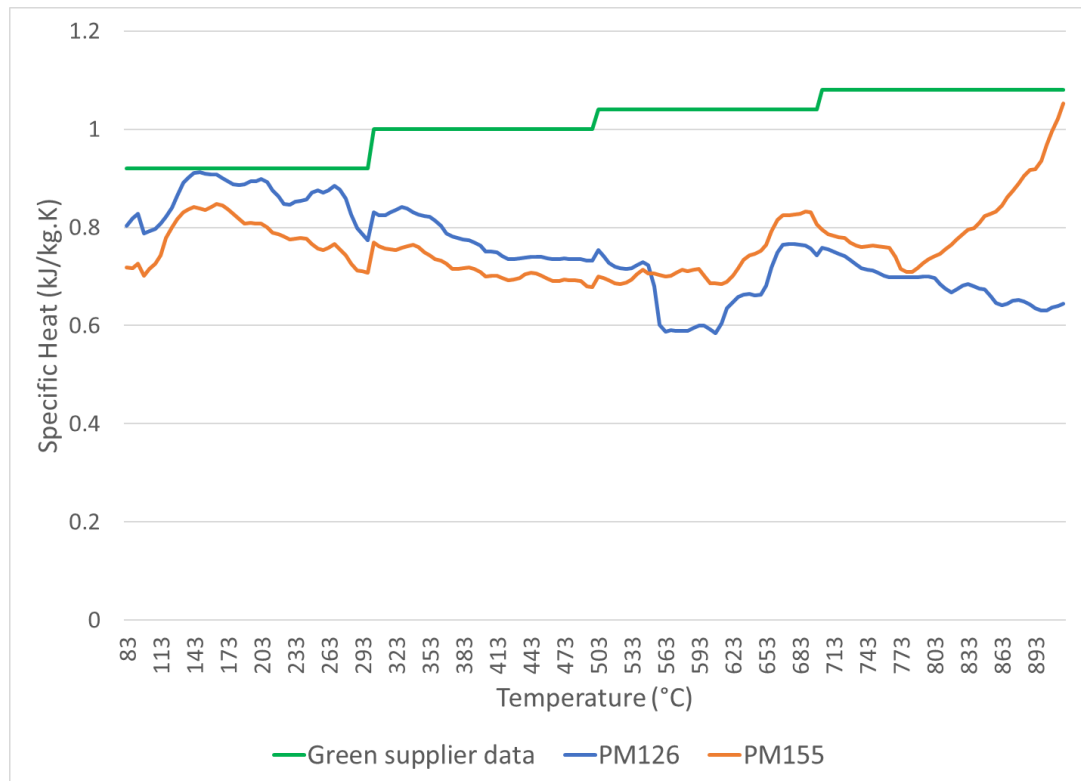
Figure 64: Specific heat of Green and post-mortem insulation materials calculated by ratio of measured samples and supplier data.

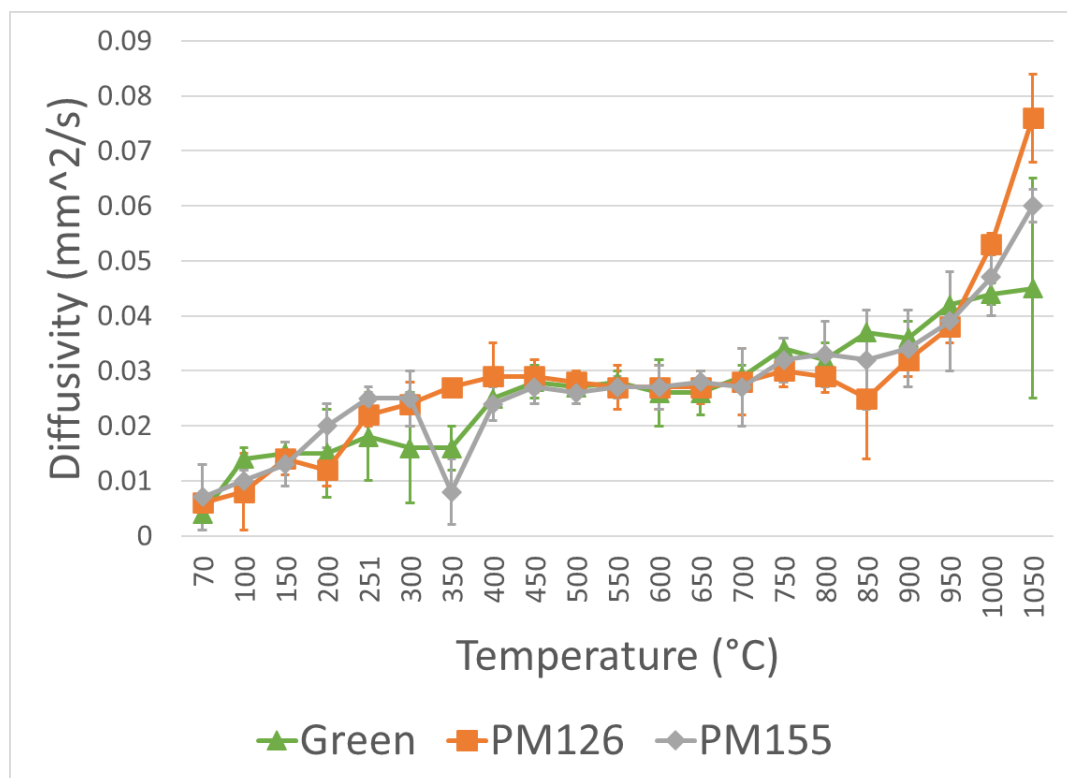
Figure 65: LFA results of powdered homogenised Green and post-mortem samples.

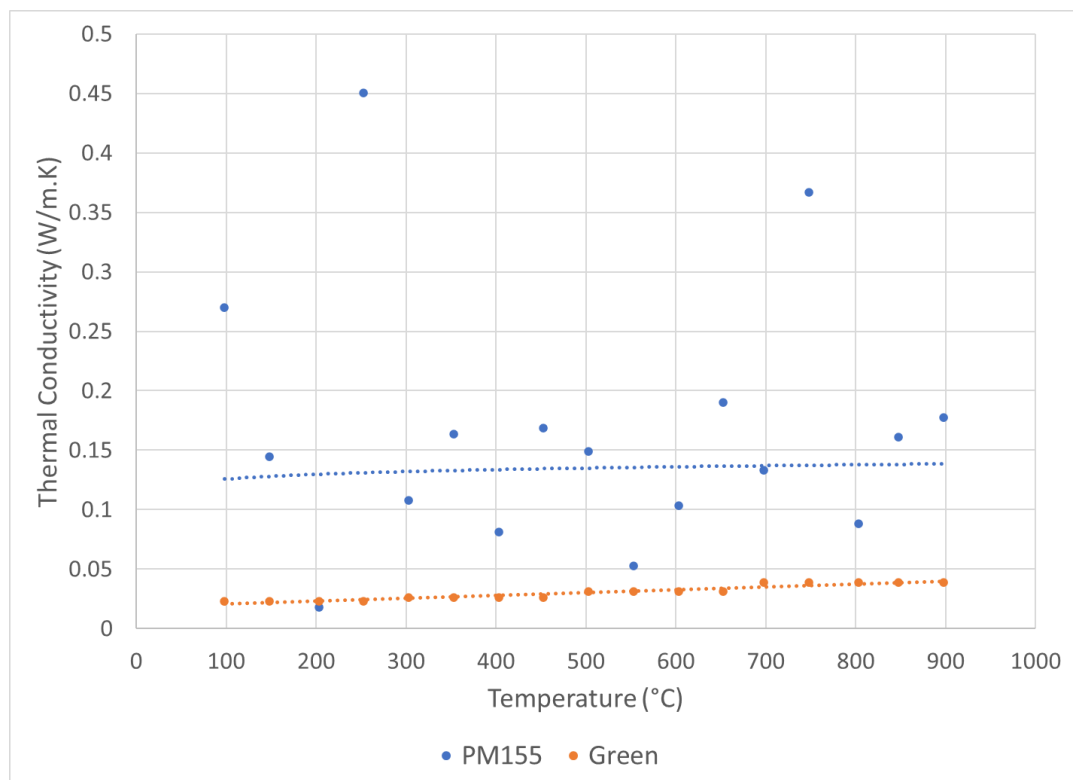
Figure 67: Thermal conductivity of the Green material from supplier data and the in-situ thermal conductivity of the insulation (PM155).

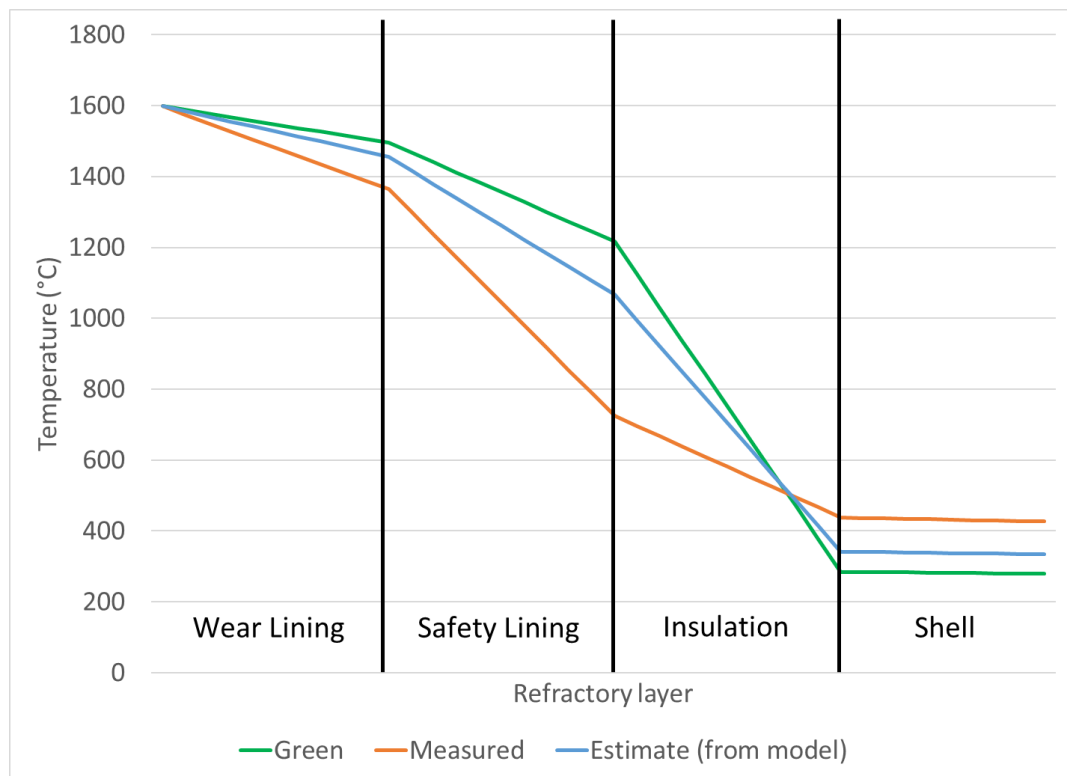
Figure 68: Ladle wall thermal profile fully saturated with Green, measured and estimated properties.

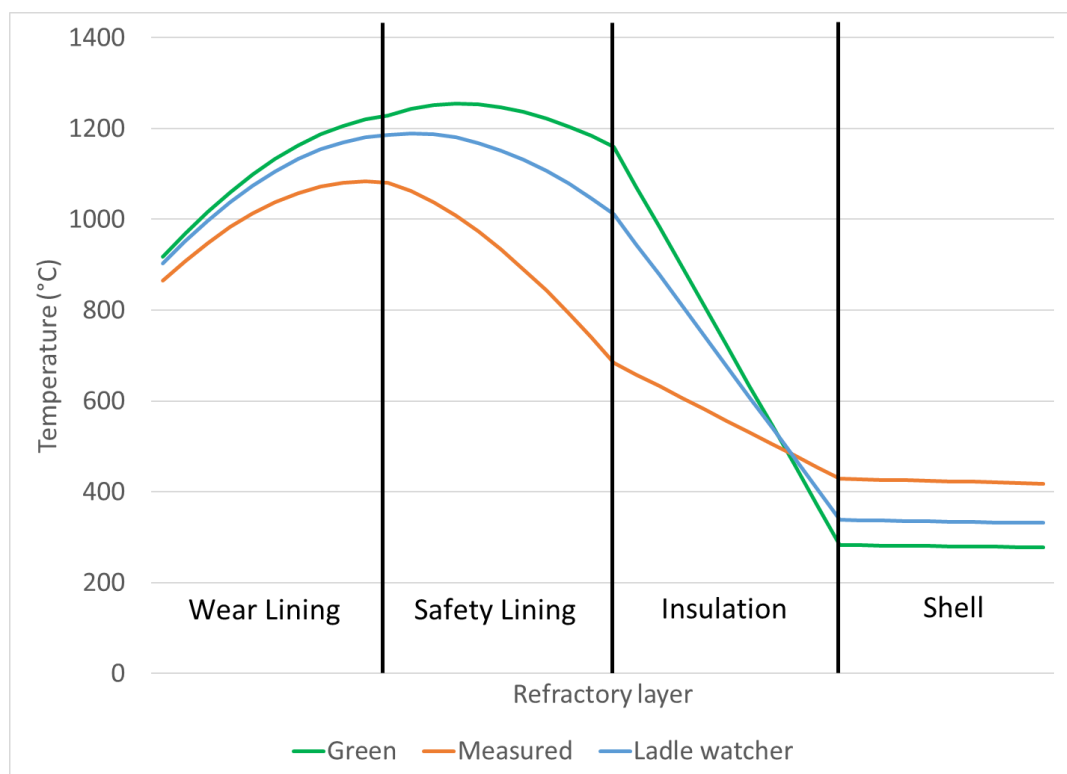
Figure 69: Ladle wall thermal profile empty 1.5 hours without a lid with Green, measured and estimated properties.

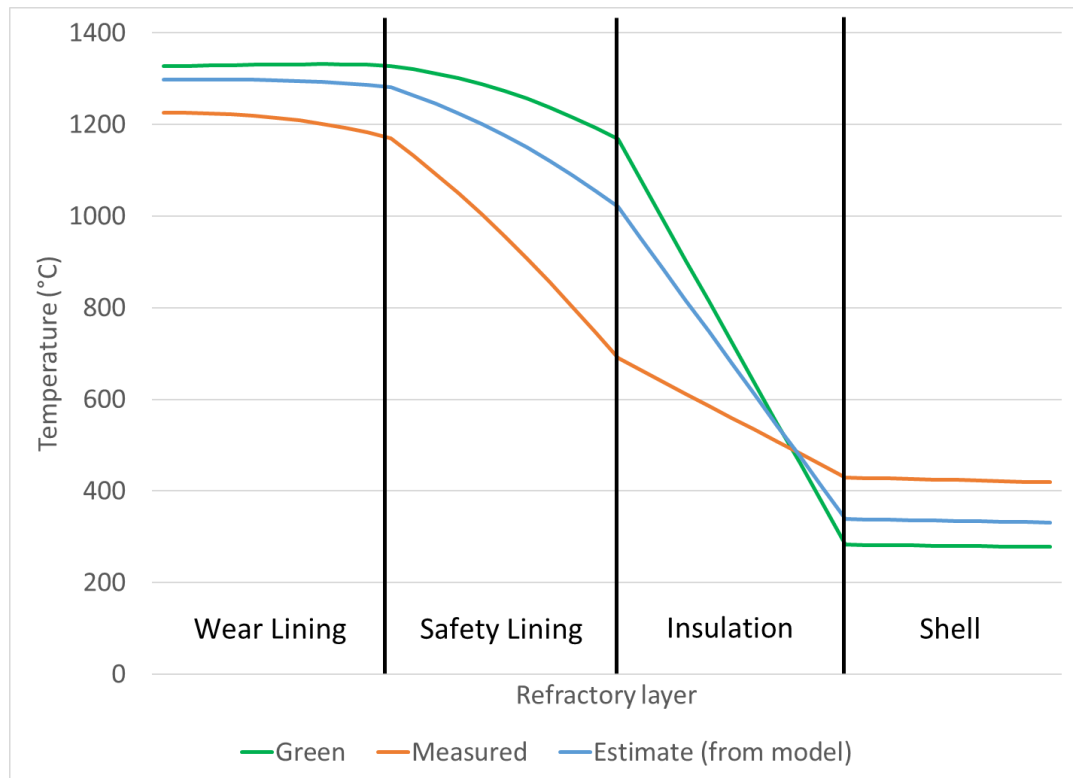
Figure 70: Difference of thermal storage for Green, measured and estimated properties of insulation.

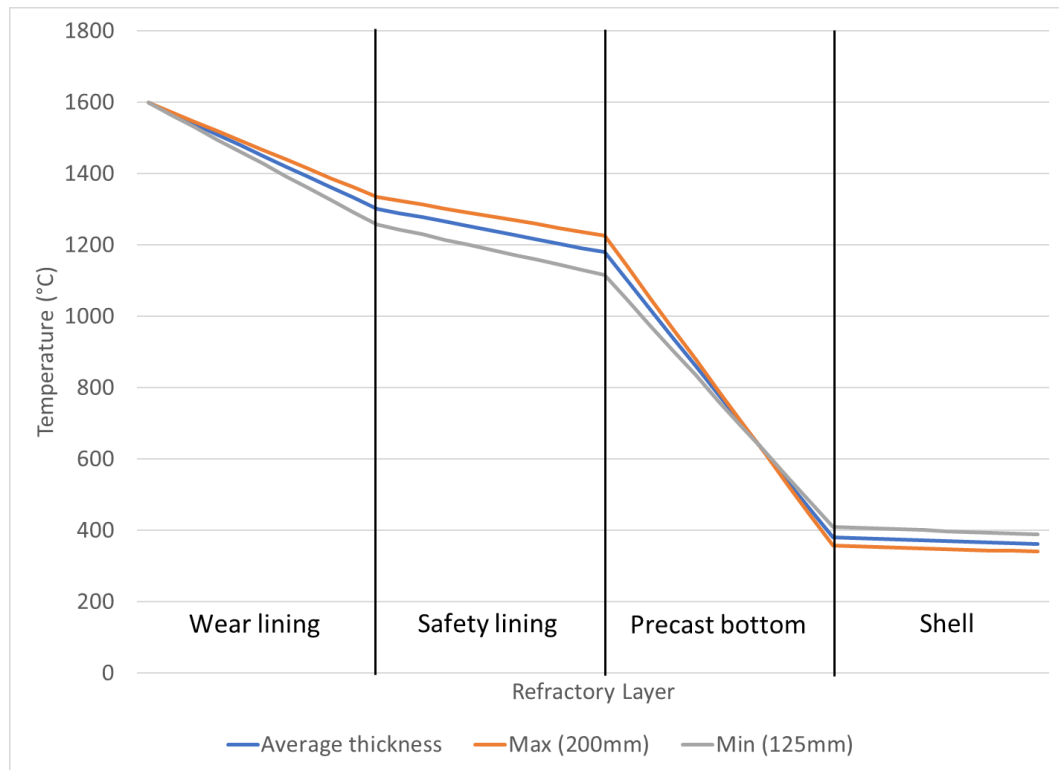
Figure 72: Ladle bottom with thermal equilibrium and variations in precast bottom thickness.

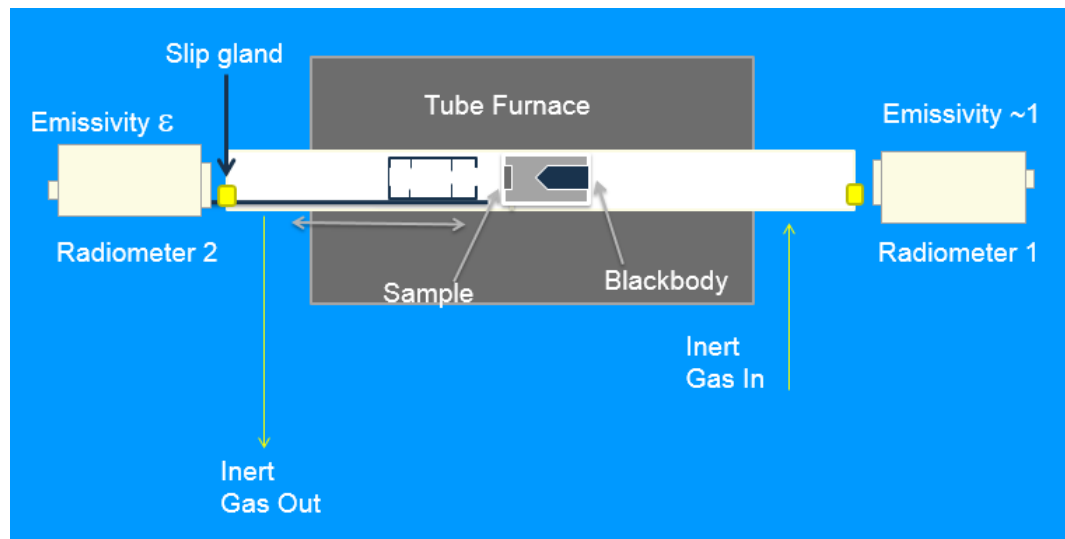
Figure 74: Equipment setup from Zhu et al. (2016) (61) Copyright of The University of Sheffield.

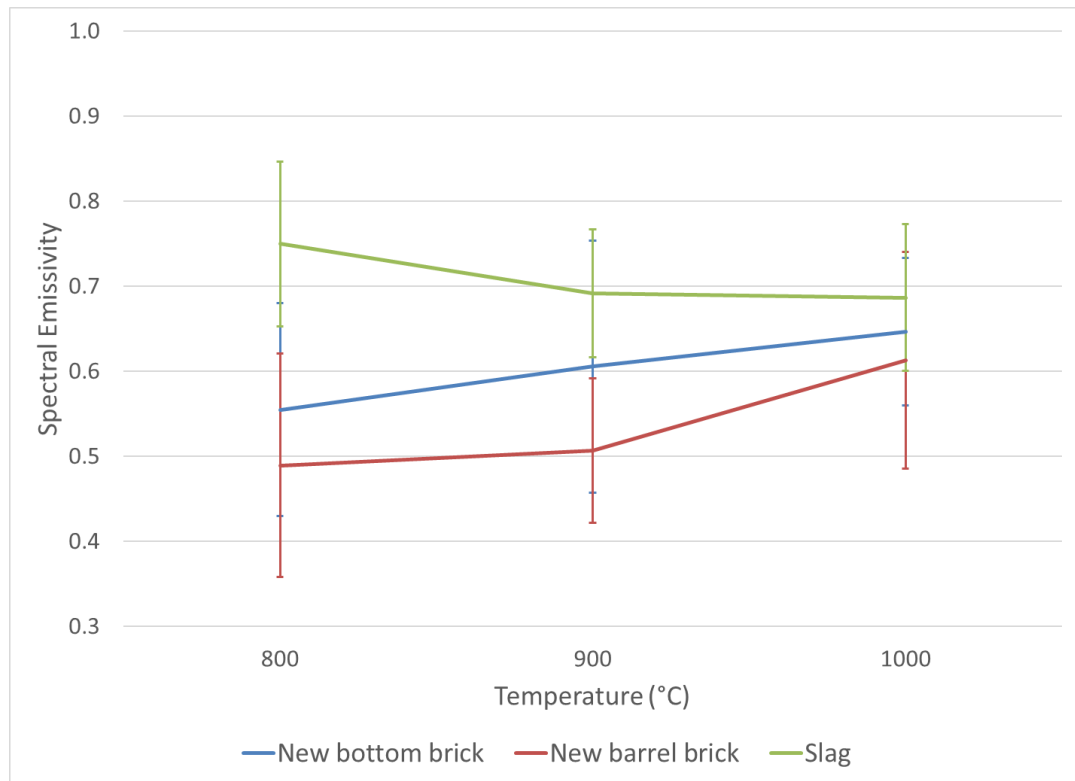
Figure 75: Spectral emissivities measured with error bars.

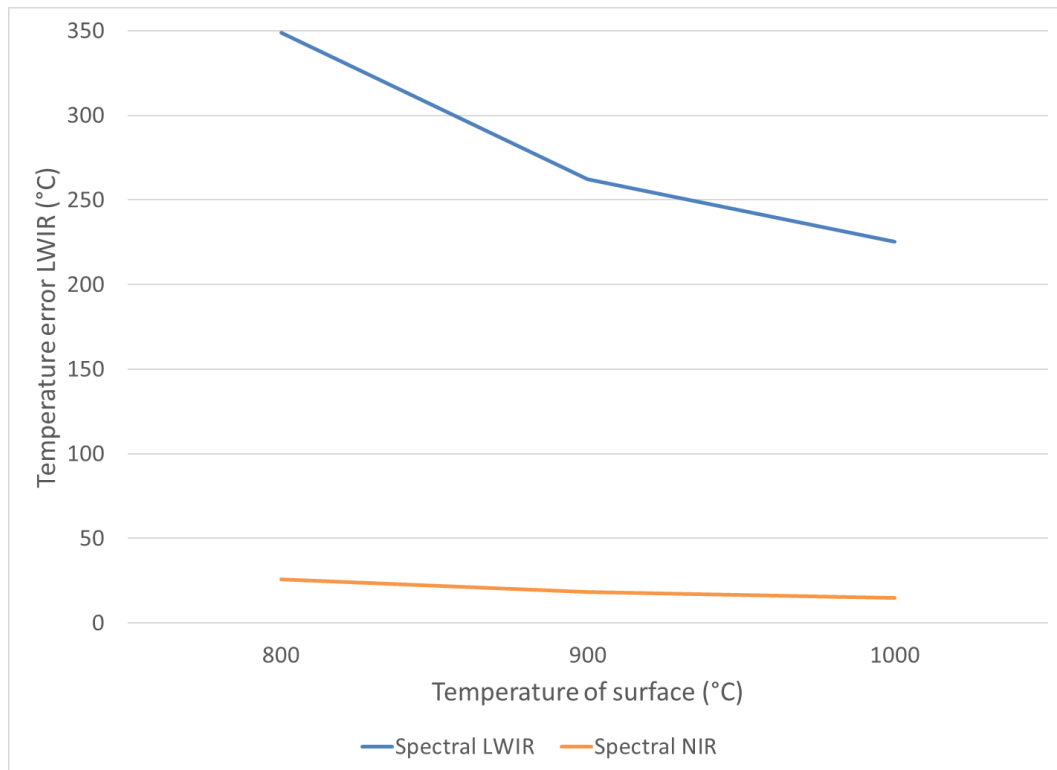
Figure 76: Max temperature error of refractory hot face due to differences in spectral emissivity measured for LWIR and NIR wavelengths.

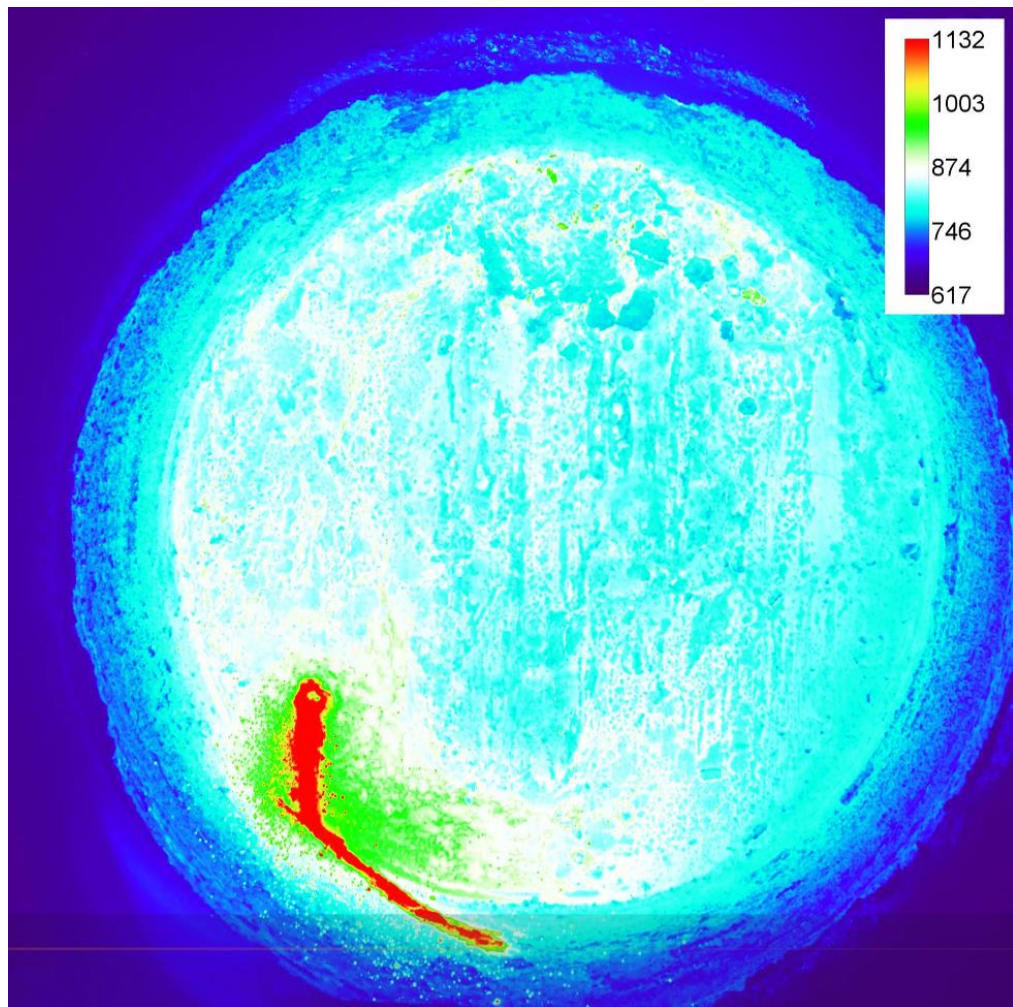
*Figure 82: Image of teeming ladle during melting of steel and slag in well block ready for re-sanding the ladle to greatly reduce the likelihood of losses of containment, scale shows temperature of object in °C.*
