# **Factors Limiting the In-Service Lifetime of CrMoV Steels and Weldments for Pressure Equipment**

**Giustino Manna**

**Submitted to the University of Wales in fulfilment of the requirements for the Degree of Doctor  
of Philosophy**

**University of Wales Swansea**

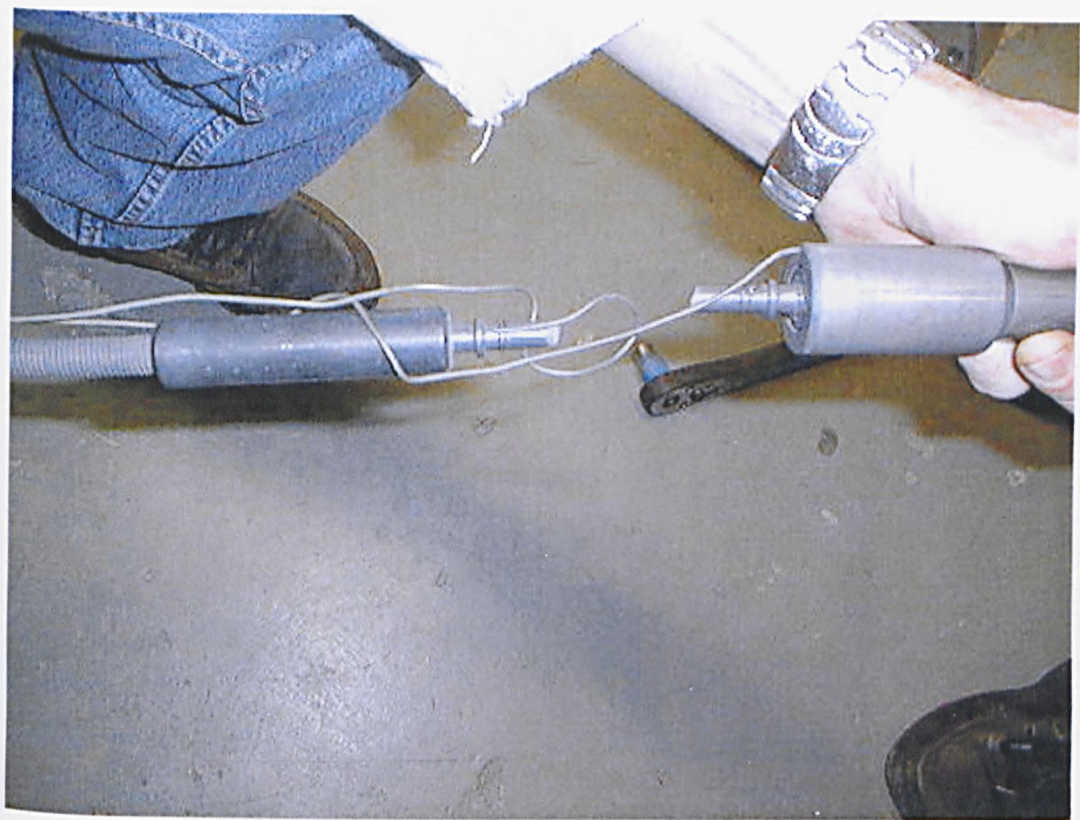
**Figure 4.2-7:** The load-train with a specimen, after test.

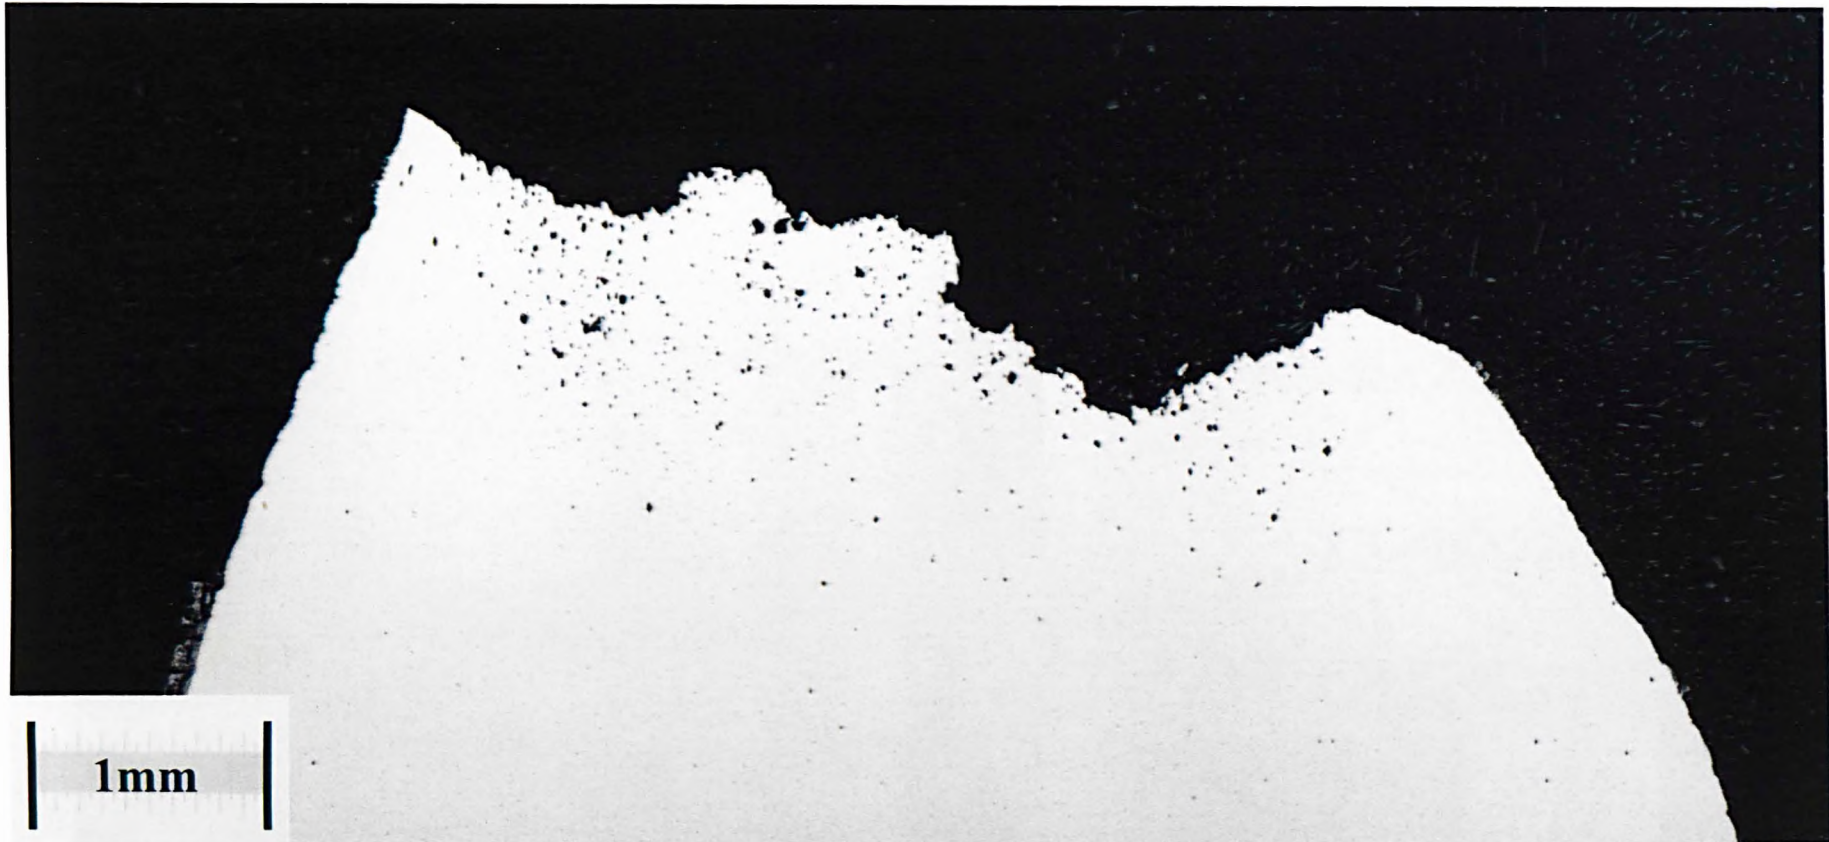
**Figure 5.2-6b:** *Material:* standard 2.25Cr-1Mo welded joint. *Test:* uniaxial creep in air. *Conditions:*  $T=843\text{K}$  ( $570^{\circ}\text{C}$ );  $\sigma = 100\text{MPa}$  (initial stress);  $t = 4646\text{h}$ . One half. Not etched.

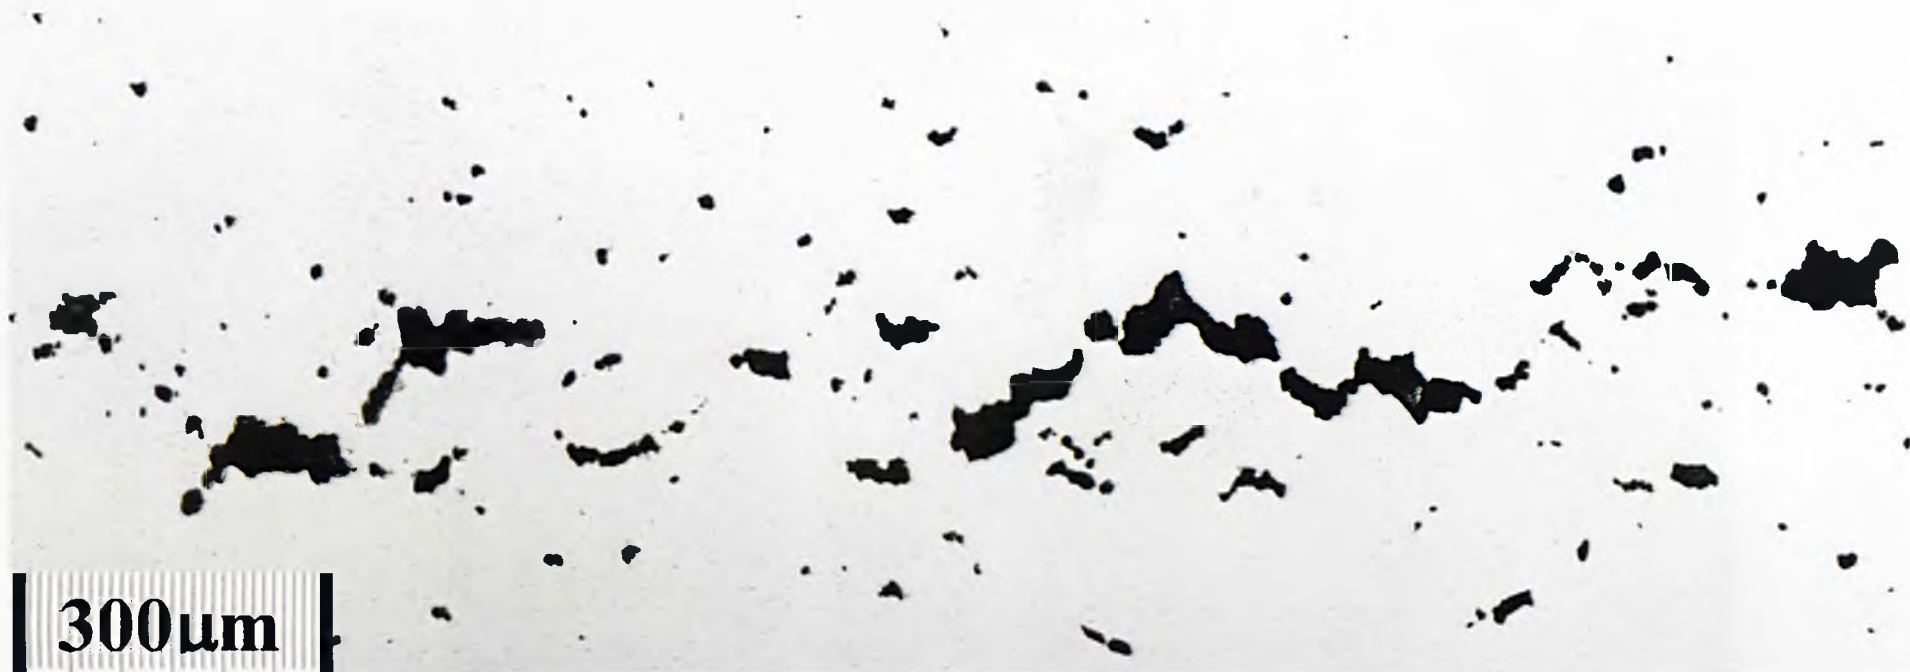
**Figure 5.2-6e:** Detail of Fig. 5.2-6d. Small cavities, void formation and coalescence of voids which leads to the formation of cracks.

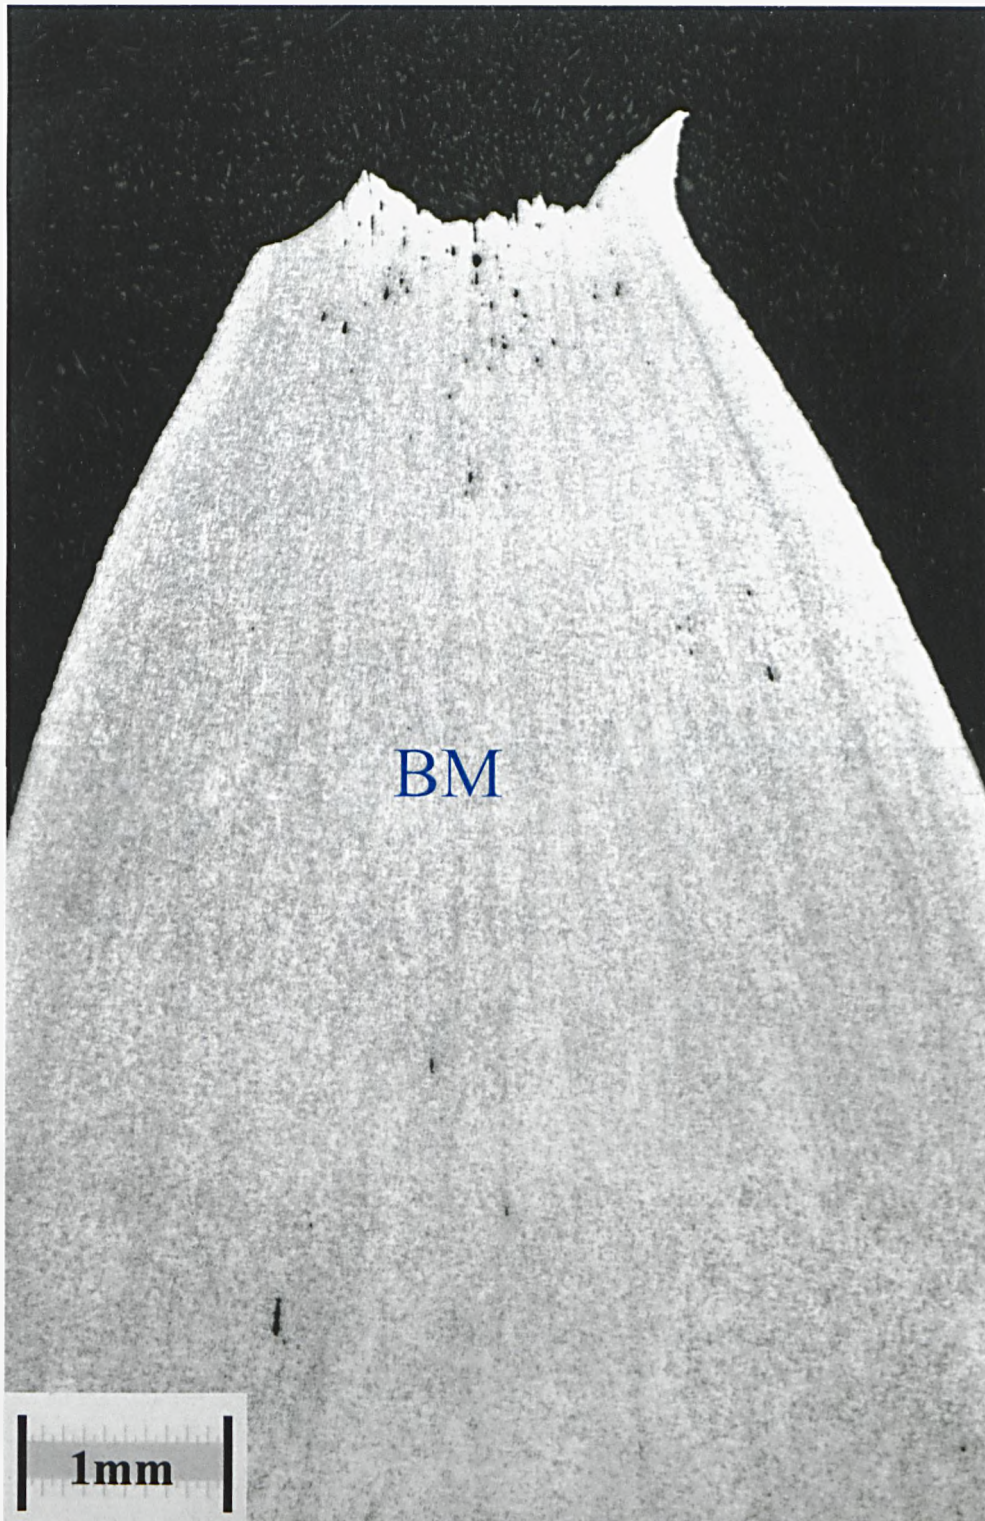
**Figure 5.4-10:** 3Cr-1Mo-V welded joint. Test conditions:  $T = 873\text{K}$  ( $600^{\circ}\text{C}$ ),  $\sigma = 100\text{MPa}$  (initial stress), hydrogen,  $P = 18\text{MPa}$  (180 bars). The figure gives an idea of the extent of the necking and of the elongation of the base metal (BM), before fracture.
