Development of sensors and non-destructive techniques to determine the performance of coatings in construction

By
Timothy John Savill

In fulfilment of the requirements for the degree of
Engineering Doctorate (EngD) in Materials Engineering

College of Engineering, Swansea University, 2023

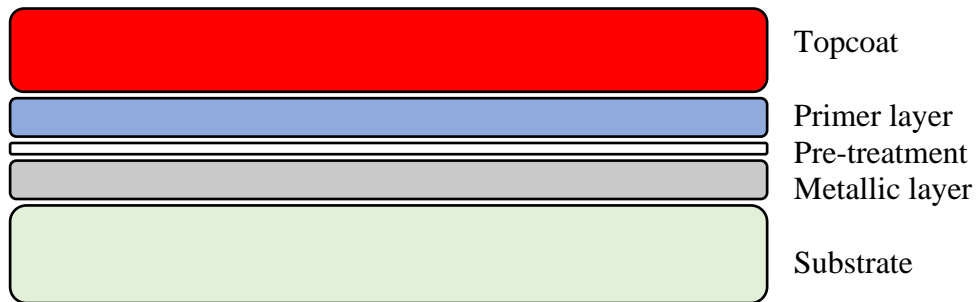
Figure 1.1. Generic Organic Coating Layers

The coating of a steel product can be simply achieved by applying a high weight molecular polymer film. Depending on the application this is known as lamination (if coated by a solid film) or a lacquer or paint (if coated by liquid precursor). However, in order to achieve the best mechanical and protective properties, coatings are composed of a number of layers, each with their own specific functionality. This is shown below in Figure 1.1.

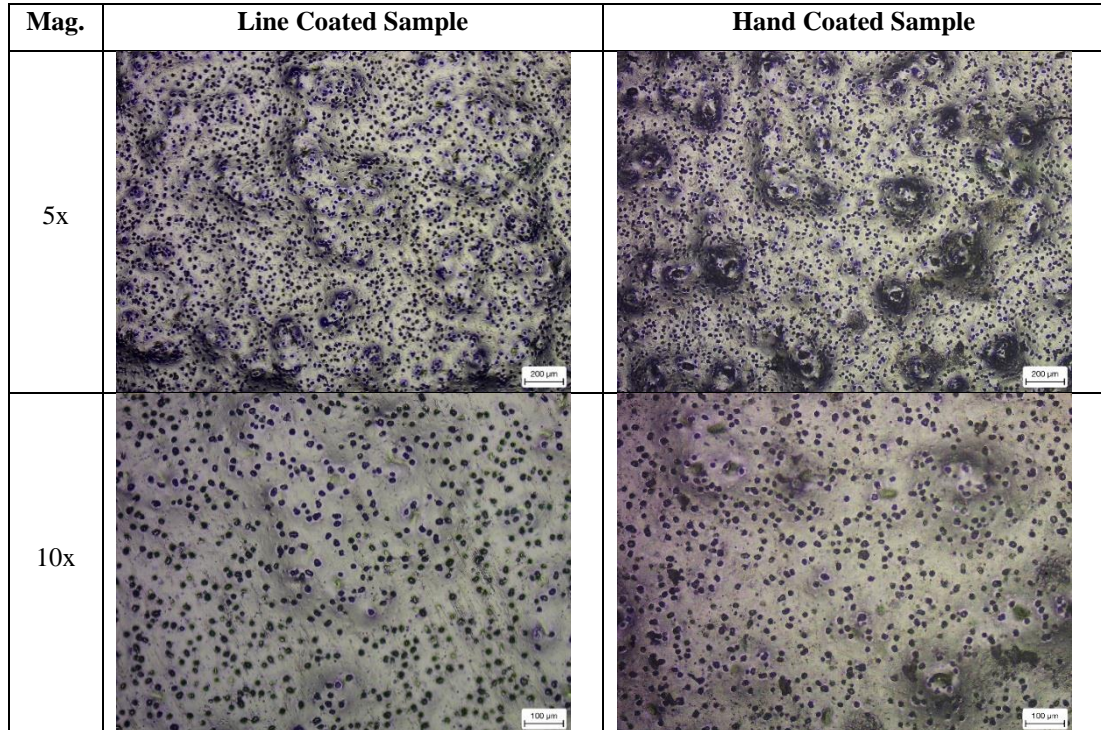
Figure 4.4. Microscopy comparison of line and hand PU samples

The hand and line samples were also compared via optical microscopy as shown in Figure 4.4. It is observed that the two systems generally appear similar however there is perhaps a slightly rougher surface finish, with what appears to be larger peaks, to the hand coated samples.

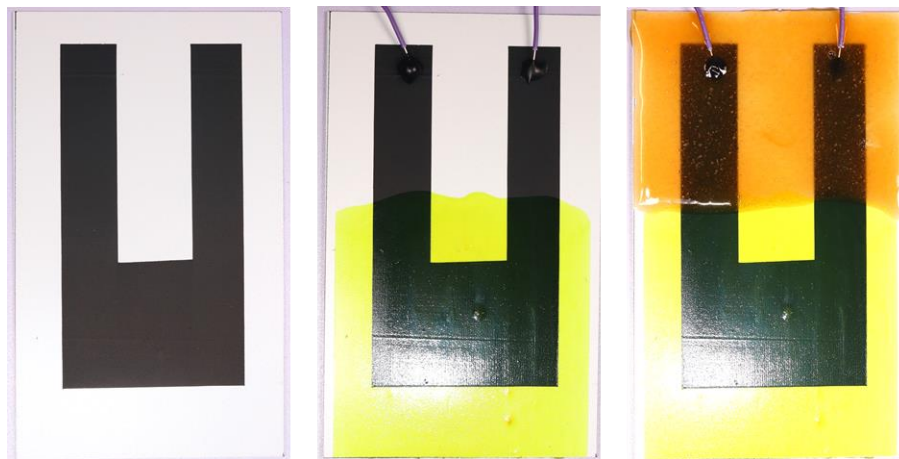
Figure 4.10. Application of the partially embedded sensor connection concept

This concept was tested as shown in Figure 4.10 and was found to be a relatively easy method to use at small scale. In this test the ‘sensing’ element was composed of an electrical paint deposited onto galvanised steel pre-coated with a primer via bar coating using a masking tape mask. This was then coated with a PVB layer containing yellow dye for ease of visual identification. The exposed contacts were then sealed off using an epoxy glue dyed orange. While the more complex paint systems would require more complex processing the idea of connecting to the embedded sensor via an extended protected track does seem, from this test, a viable concept.

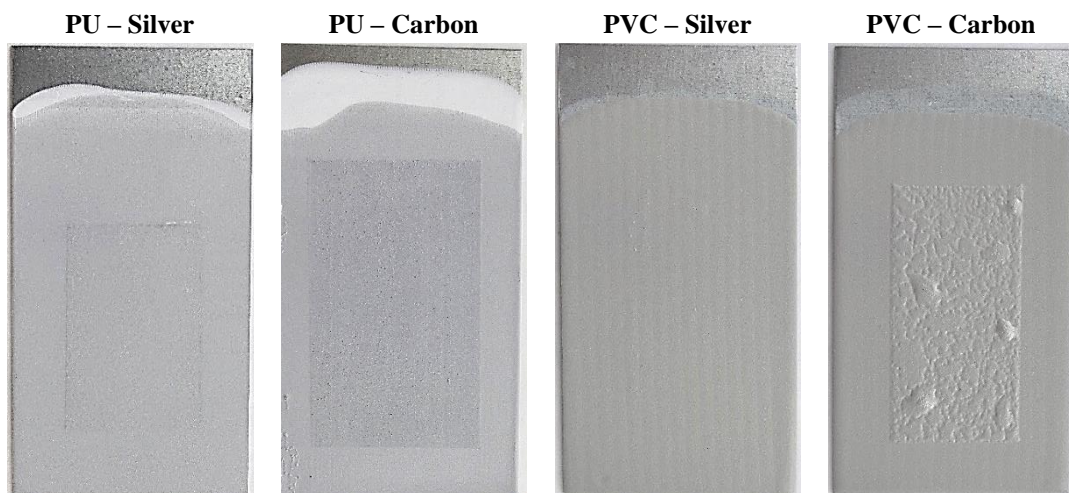
Figure 5.4. Visual appearance of each coating system with an embedded conductive paint layer

While it has been shown in the previous chapter that hand produced samples are representative of line produced product the effect of embedding the electrical paint systems needs also to be considered. If the embedding of the conductive paint leads to significantly different properties, then it is questionable whether an embedded sensor would be representative of the actual system and hence the usefulness may be limited. To assess the effect of the additional layer on the overall system properties, an approximately 7x4cm square of each conductive paint was deposited onto the primer layer of both paint systems. This was then overcoated with the required top and, in the case of the PU system, clear coat layers. The resulting samples are shown in Figure 5.4.

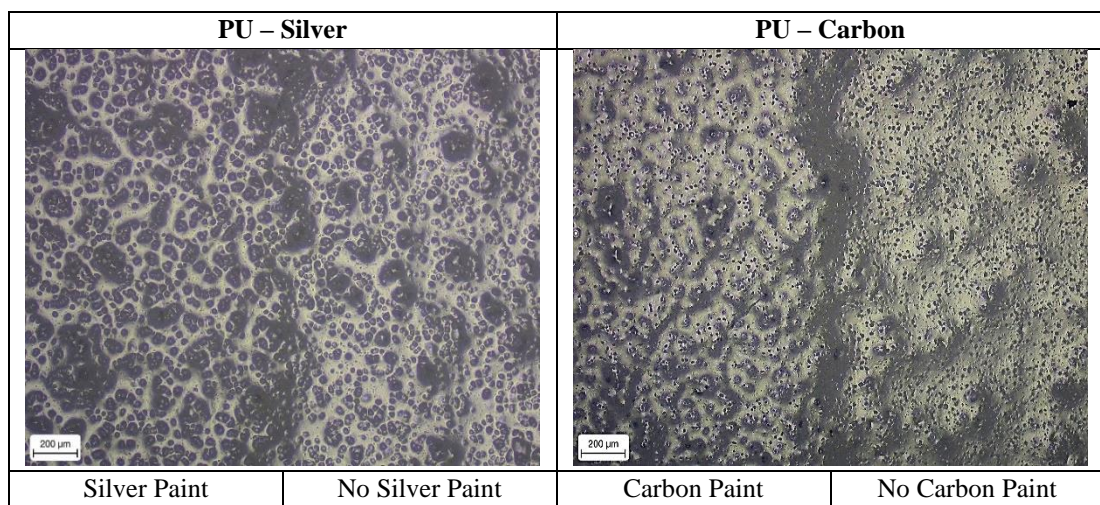
Figure 5.5. Appearance of the embedded electrical paint under the PU system at 5x magnification lens

The conductive paint boundaries were examined under a microscope, Figure 5.5, to observe the difference, if any, in the surface with conductive paint present as well as the appearance of the boundary. While a raised surface was observed where the conductive paint was present the overall appearance of this region was similar to that without the conductive paint. Perhaps, however, there was a slight increase in the number of distinguishable features suggesting increased surface roughness. The boundary between the two regions appears to be free of any significant defects.

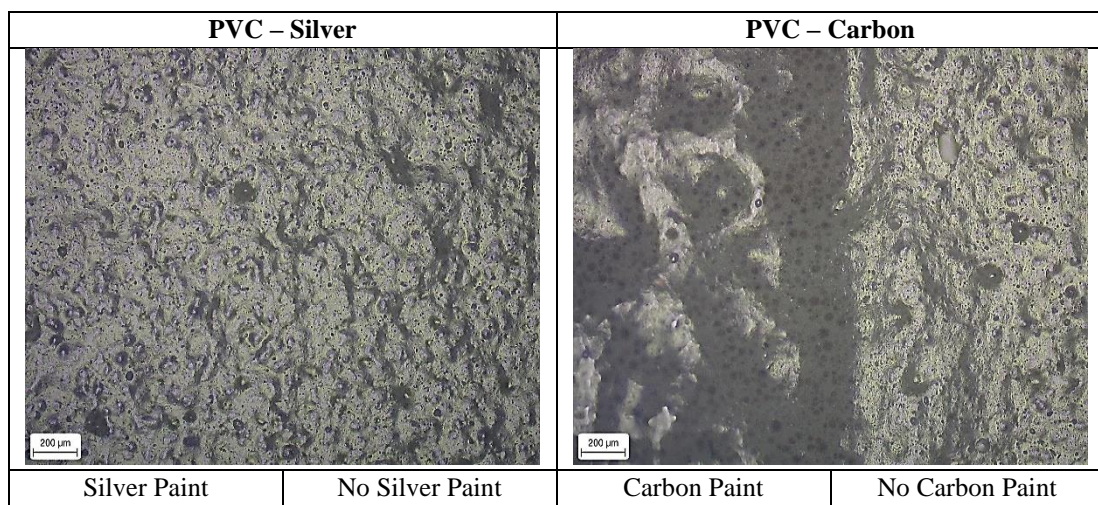
Figure 5.7. Appearance of the embedded electrical paint under the PVC system at 5x magnification lens

In comparison to the previous system the thicker PVC system fully encapsulated the silver conductive paint leading to no visible boundary under microscope examination, Figure 5.7. There was no observed change in the surface of the coating applied to the silver paint suggesting no immediate compatibility issues. As previously mentioned, the carbon paint seemed to be in-compatible with the curing of the PVC paint and hence a mottled surface was produced with large sections where the PVC coating had de-adhered completely from the carbon paint during curing.

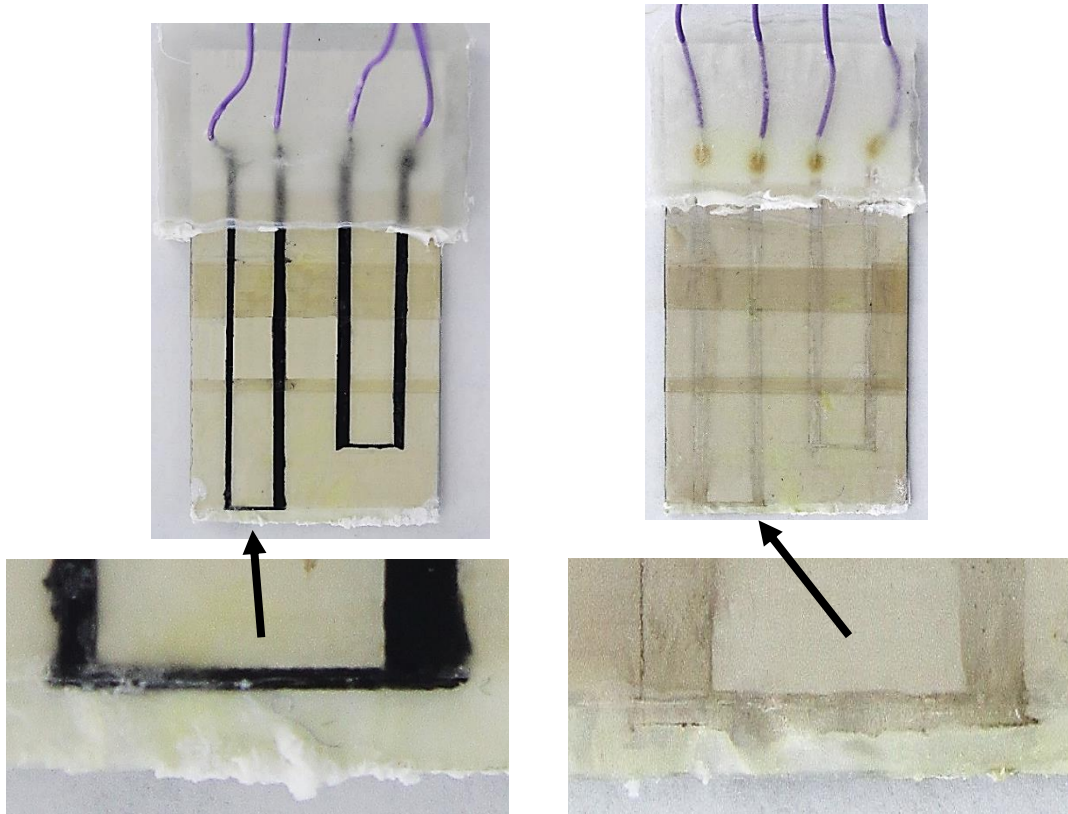
Figure 5.14. Condition of the PTFE tape covered cut edge corrosion sensors during the test including close up of the sensing element broken as a result of cut edge defect spread

that it was a combination of dissolution, environmental attack, and mechanical stress due to blistering and corrosion product production. What was evident though, was that at the distance of spread of blistering, cut edge corrosion and or water uptake from the cut edge had been detected by this method. More accurate results would be ascertained by the use of the actual coating system, but this proved the overall concept.

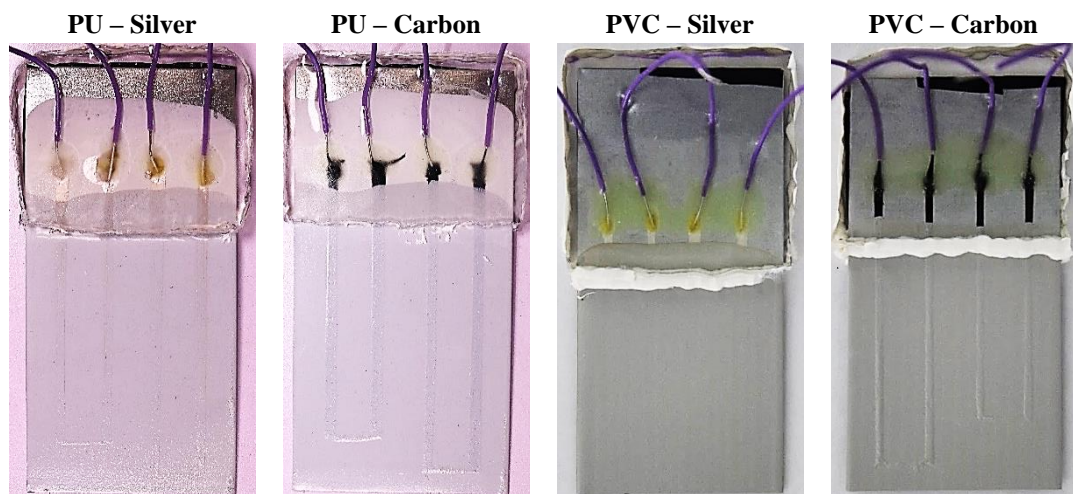
Figure 5.15. The cut edge corrosion sensors produced for testing. Green discoloration around the wires is from epoxy glue used to hold the wires in place before encapsulation.

The required connections were then made to these samples and protected with casting resin. Furthermore, the uncoated rear of the sample was also protected using PTFE tape. Finally, the bottom edge of the sample was cut using a guillotine to provide a fresh cut edge 5mm from the lower sensing tracks. The samples, Figure 5.15, were then placed under the same salt spray test as the previous samples and periodically examined and the sensing element connection tested.

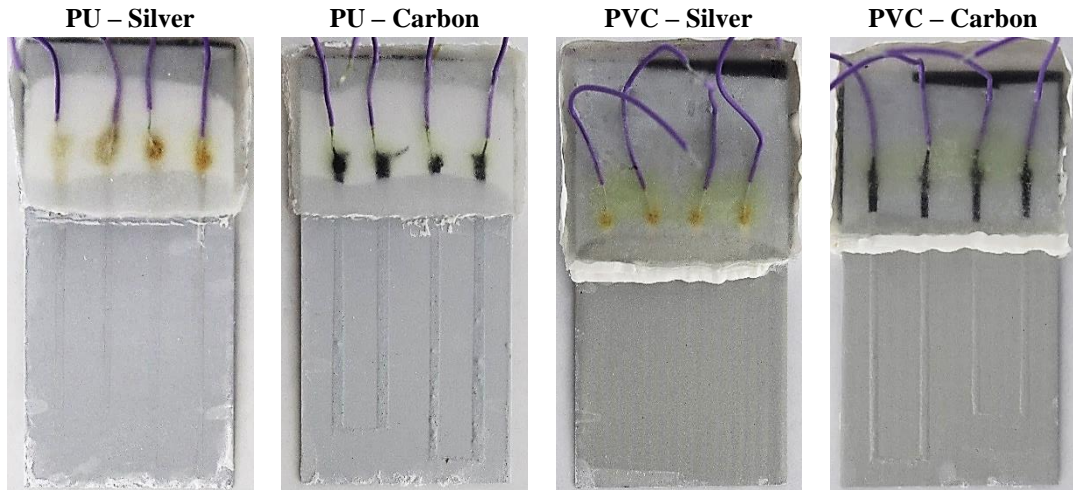
Figure 5.16. The cut edge corrosion sensors after 4 weeks exposure

After approximately 4 weeks cut edge corrosion and defects were present on the exposed edge as is shown in Figure 5.16. However, as the defect has not reached the sensing element, Figure 5.17, it there was no change in the connection between sensing tracks and hence it was undetected.

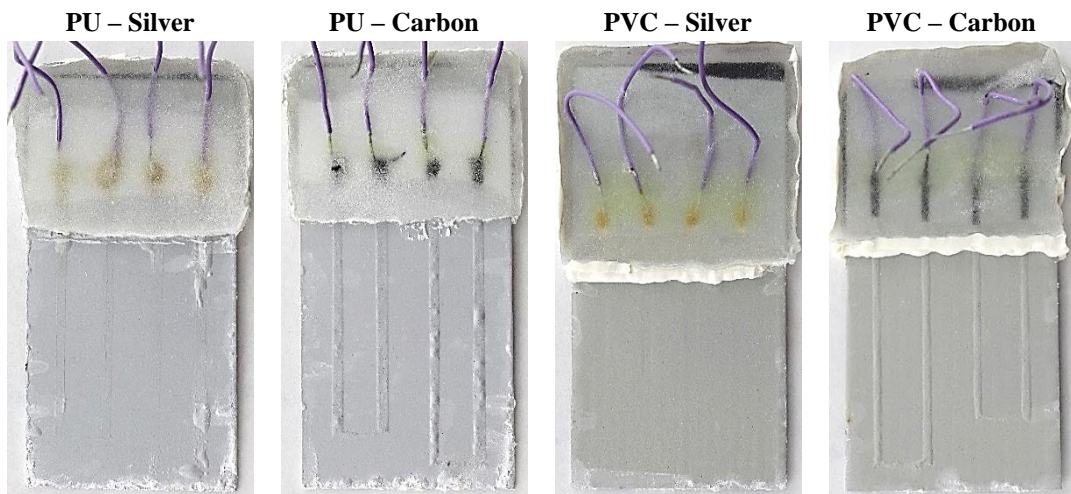
Figure 5.18. The cut edge corrosion sensors after 8 weeks exposure

Less significant corrosion was observed on the PVC samples and in fact the sensing element was still providing connection, Figure 5.18. The extra protection offered by the thick coating required further exposure to determine the effectiveness of the sensing element.

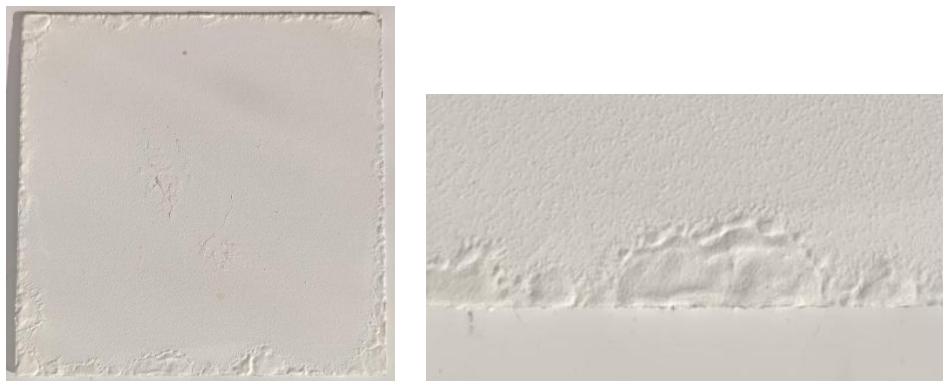
Figure 5.19. Reference PU sample (left) and cut edge close up (right)

Control samples of line manufactured material, with no embedded sensing elements, were also exposed to 8 weeks of salt spray exposure. Similar cut edge performance was observed for both PU and PVC samples; PU sample shown in Figure 5.19.

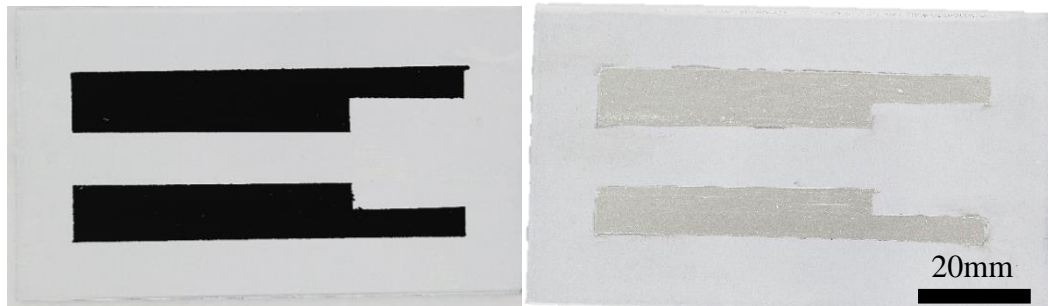
Figure 5.21. Examples of the printed capacitive coating sensor produced using carbon (left) and silver (right) paints

The sensor was printed onto pre-primed galvanised steel samples of approximately 12x6cm allowing approximately 15mm between the edges of the sample and the printed sensor. Examples of the printed sensor in both conductive inks are shown in Figure 5.21.

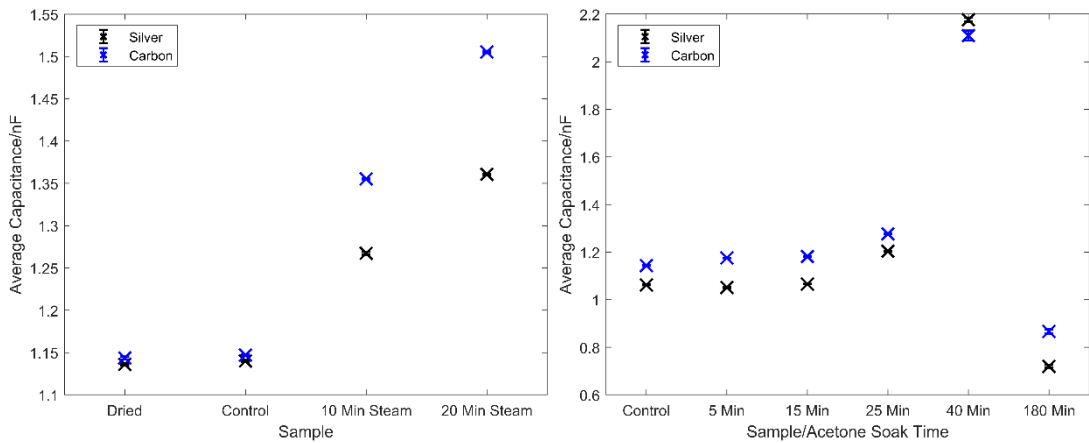
Figure 5.24. Effect of steam exposure (left) and acetone immersion (right) on the epoxy embedded sensors

In comparison the acetone shows a similar increase in capacitance for the first 40 minutes but a significant decrease capacitance at the 180-minute measurement. This, however, is also explainable from theory. It was thought that up to the 40-minute mark a small amount of acetone was absorbed into the coating which was not fully evaporated when measured leading to an increased capacitance. At 180 minutes the epoxy coating had begun to blister and slightly delaminate from the substrate explaining the decrease in capacitance as the coating ($\epsilon_r \approx 3.5$) is somewhat removed and replaced with air ($\epsilon_r \approx 1$). It was not clear why the capacitance increase, as a result of the testing, was larger for the carbon sample compared to silver.

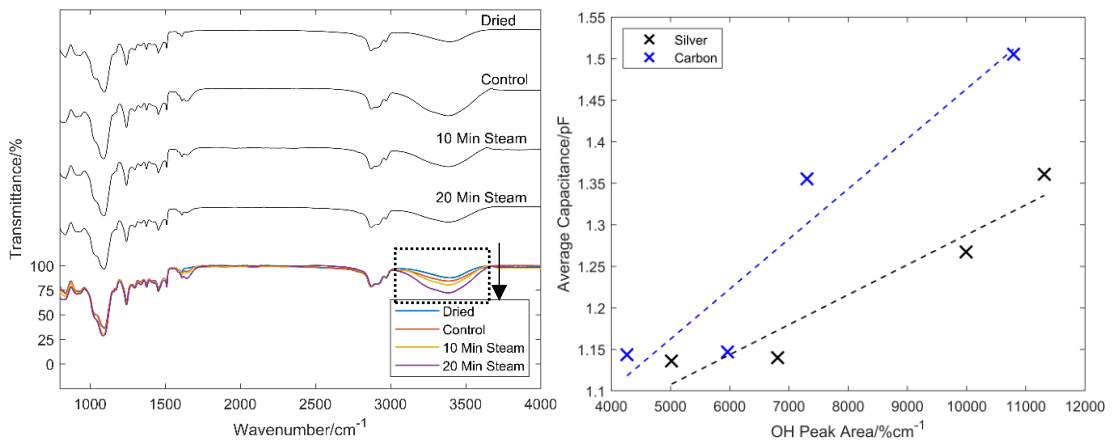
Figure 5.25. FTIR analysis of the epoxy coated carbon (left) showing an increase in the magnitude of the OH peak as a result of steam exposure (arrow) and comparison of the trend between peak area and measured capacitance for both samples (right)

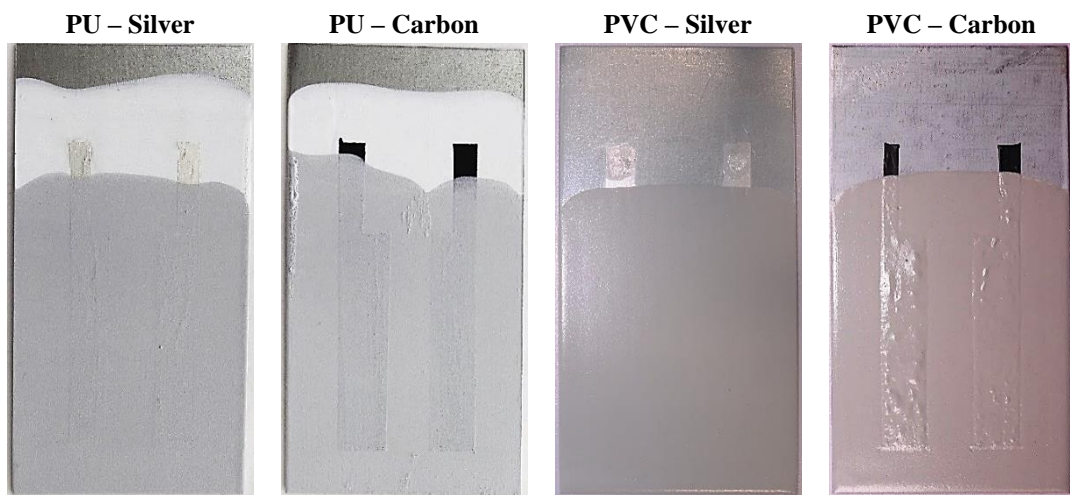
Figure 5.26. The embedded capacitive sensors produced using the two industrial coatings

design was used due to the positive results in previous tests and the increased ease at which samples could be produced. Once the electrical paint was correctly cured this was overcoated with the top and, if required, clear coat. This gave the samples shown in Figure 5.26. At this point the PVC-Carbon sample was discarded due to the poor compatibility of the two systems leading to a heavily defective coated product not though to be representable of the actual system. Furthermore, due to the results of the cut edge corrosion sensor the PU-Carbon sample was also discarded due to poor stability in aggressive environments due to low adhesion. This therefore left the two silver paint samples.

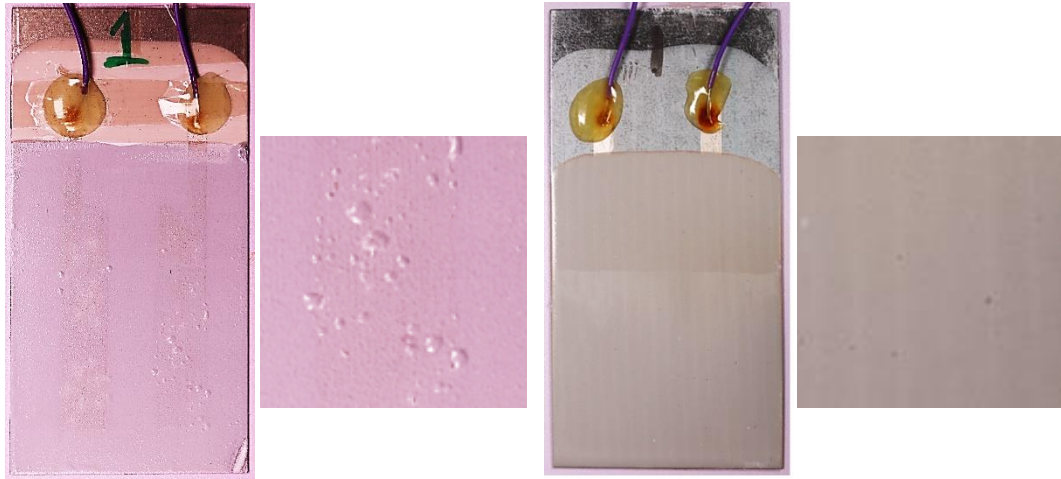
Figure 5.28. Post immersion testing sample appearance including close up

During immersion testing the PVC sample appeared to change little in appearance however the PU sample did experience a small amount of blister formation from week 3-5, Figure 5.28. These blisters mainly formed on the regions where conductive paint was or the boundaries of the conductive paint. It is possible this is due to the slightly decreased adhesion shown by the embedded areas. While this may suggest a reduced durability of the embedded samples the immersion test is not well representative of real-life conditions and hence not an immediate cause for concern.

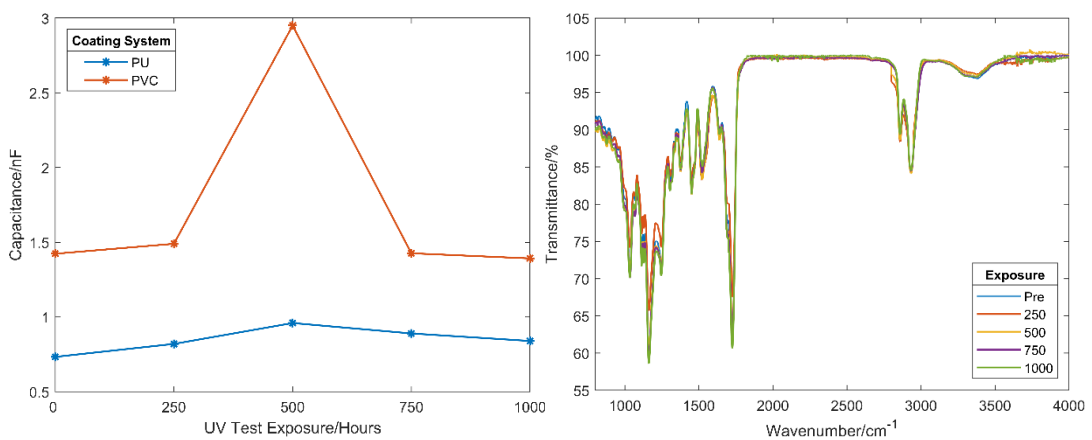
Figure 5.35. Measured capacitance of the embedded sensors during the UV test (left) and example FTIR with no obvious OH peak change (right)

In terms of the measured capacitance during the test, shown in Figure 5.35, both samples showed a similar pattern of an increased capacitance up to 500 hours before capacitance decreased to pre-exposure levels at 1000 hours. For the PVC sample the 500 hours showed an exceptionally large increase. It is likely that any increases in capacitance are due to water uptake and any decrease would be due to coating degradation and breakdown via UV. It was thought that perhaps the reason for an increase up to 500 hours is that water uptake is dominating the capacitance changes whereas after 500 hours some coating degradation is occurring leading to a decrease. However, considering changes in sample appearance due to degradation were low and there was no significant change in OH peak areas across the test period, Figure 5.35, it was concluded that the results were due to natural variation rather than detection of any particular changes. The PVC result at 500 hours was considered due to improper drying of the sample before test.

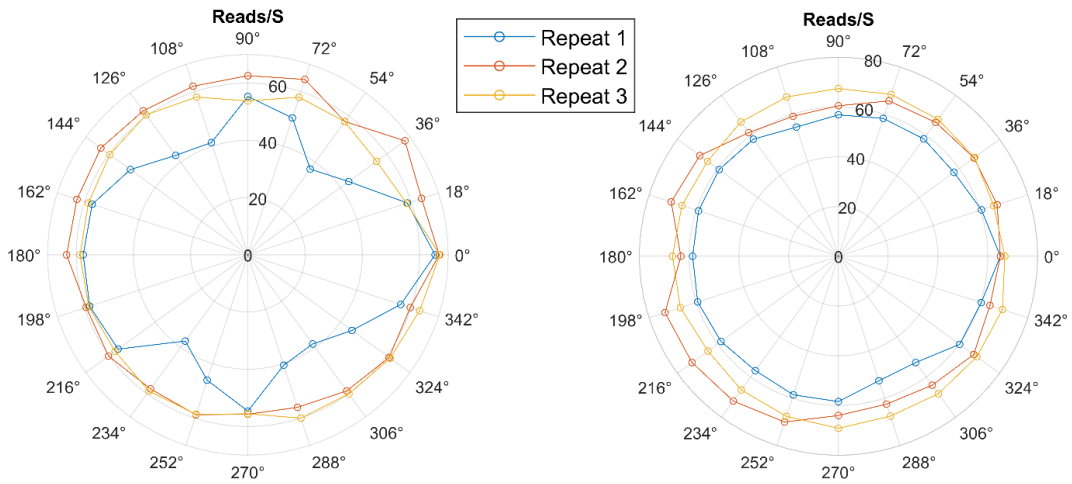
Figure 6.6. Comparison of the SR/s at each angle for the system with no backing metal (left) and a 100cm² backing metal (right)

Furthermore, the second concept would likely improve the performance of the tag as previous work and manufacturers guidelines state that on-metal tags have the greatest range when placed onto a large piece of backing metal. This was verified for the initial tags used by comparing the tag metrics measured for a naked tag (not mounted on metal) and a tag mounted onto a 10x10cm galvanised steel backing metal (BM) at 25cm. A comparison of the measured RSSI and SR/s is shown in Figure 6.6 and Figure 6.7.

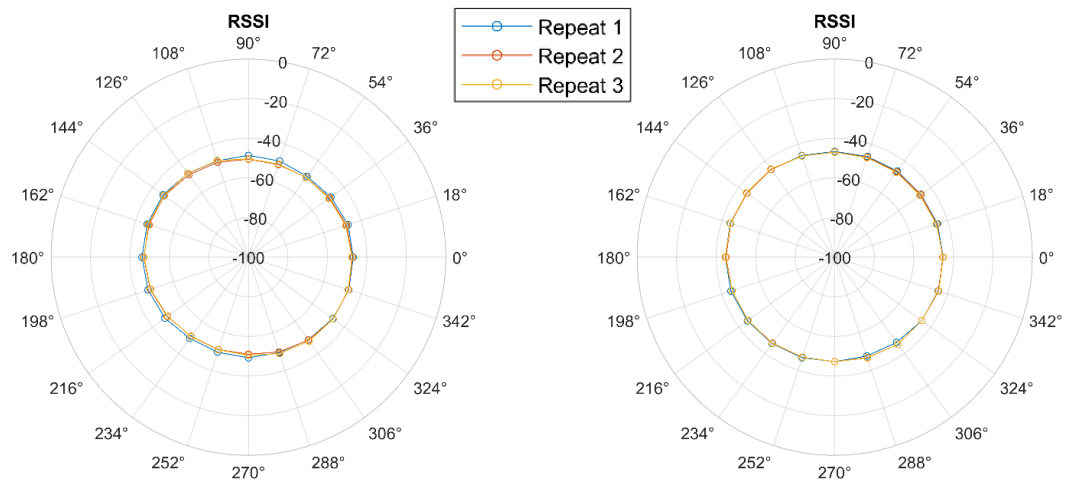
Figure 6.7. Comparison of the RSSI at each angle for the system with no backing metal (left) and a 100cm² backing metal (right)

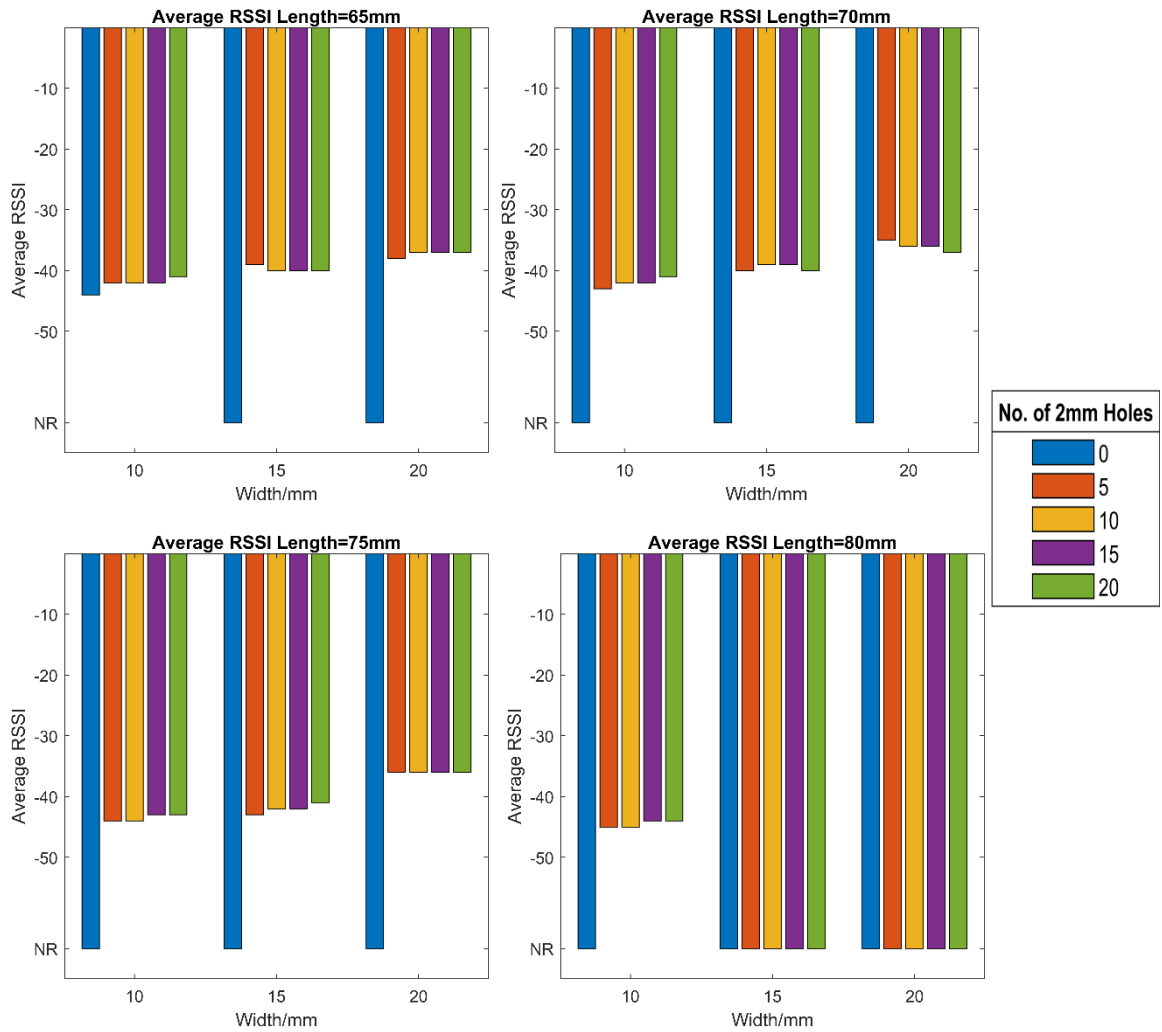
Figure 6.12. Average RSSI recorded for each PVC blocker size under the artificial damage test

The resulting RSSI measurements for the PVC samples are shown in Figure 6.12 from which it was observed that a general trend of improvement of signal with increased artificial damage exists. However, it was also concluded that the accumulation of damage is not well detected. For example, there was a large signal improvement for most blocking layers when comparing 0 to 20 holes however the transition from 5 to 10 to 15 was not fully represented as incremental improvements in signal for many of the samples. This may be due to the metric itself being unsuitable for detecting changes such as those imposed in this test. Certainly it seemed that once the RSSI has reached a level of approximately -40 to -45 the addition of more holes had little effect. It is important to note that the two largest size blocking layers produced no response at all confirming that if the blocking layer is too large, even significant material removal will not facilitate communication. When comparing the other sizes of blocking layer there appeared to be no significant difference in the levels of detection.

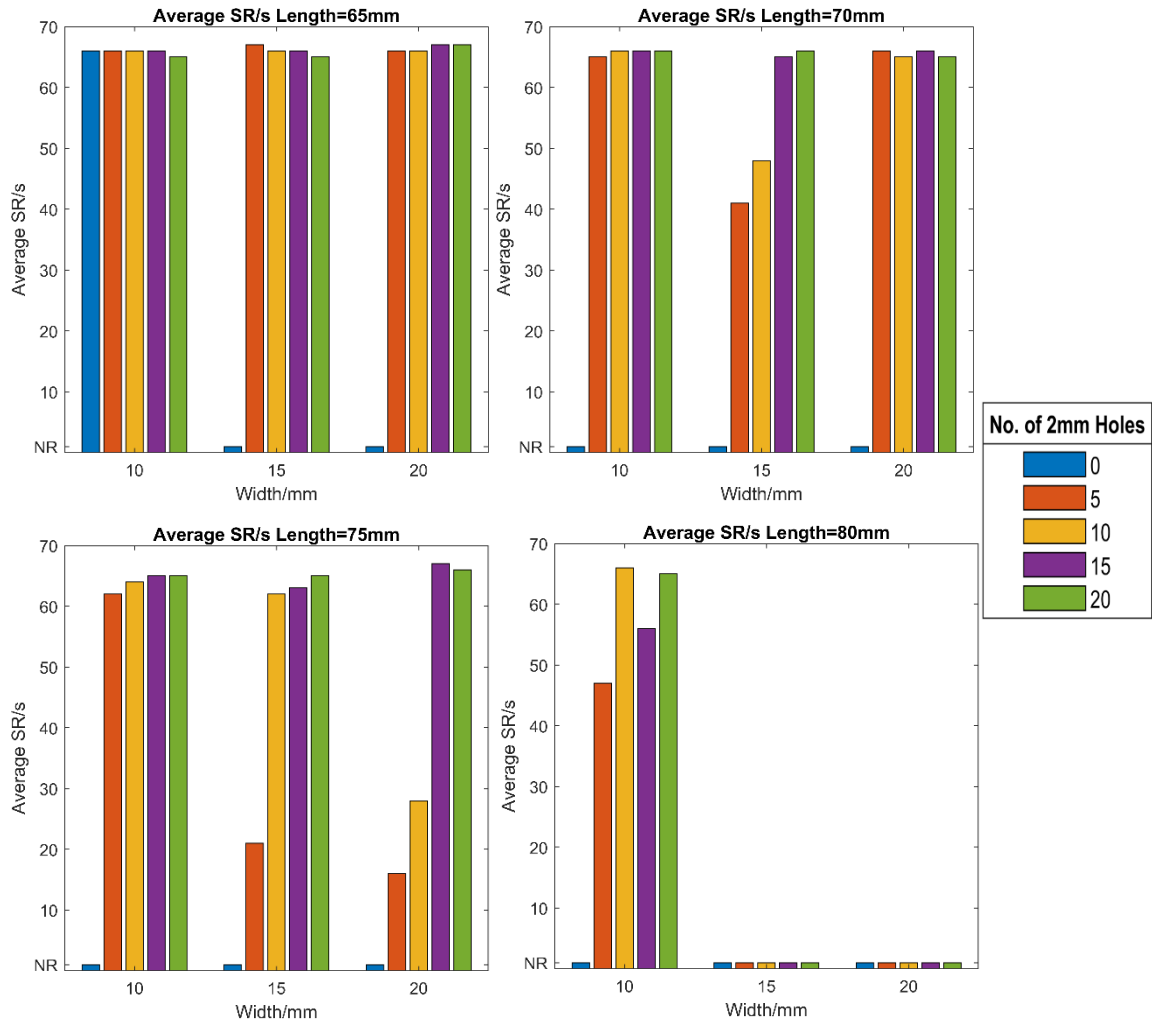
Figure 6.13. Average SR/s recorded for each PVC blocker size under the artificial damage test

may be poor at detecting very slight damage but better at detecting accumulation of significant damage.

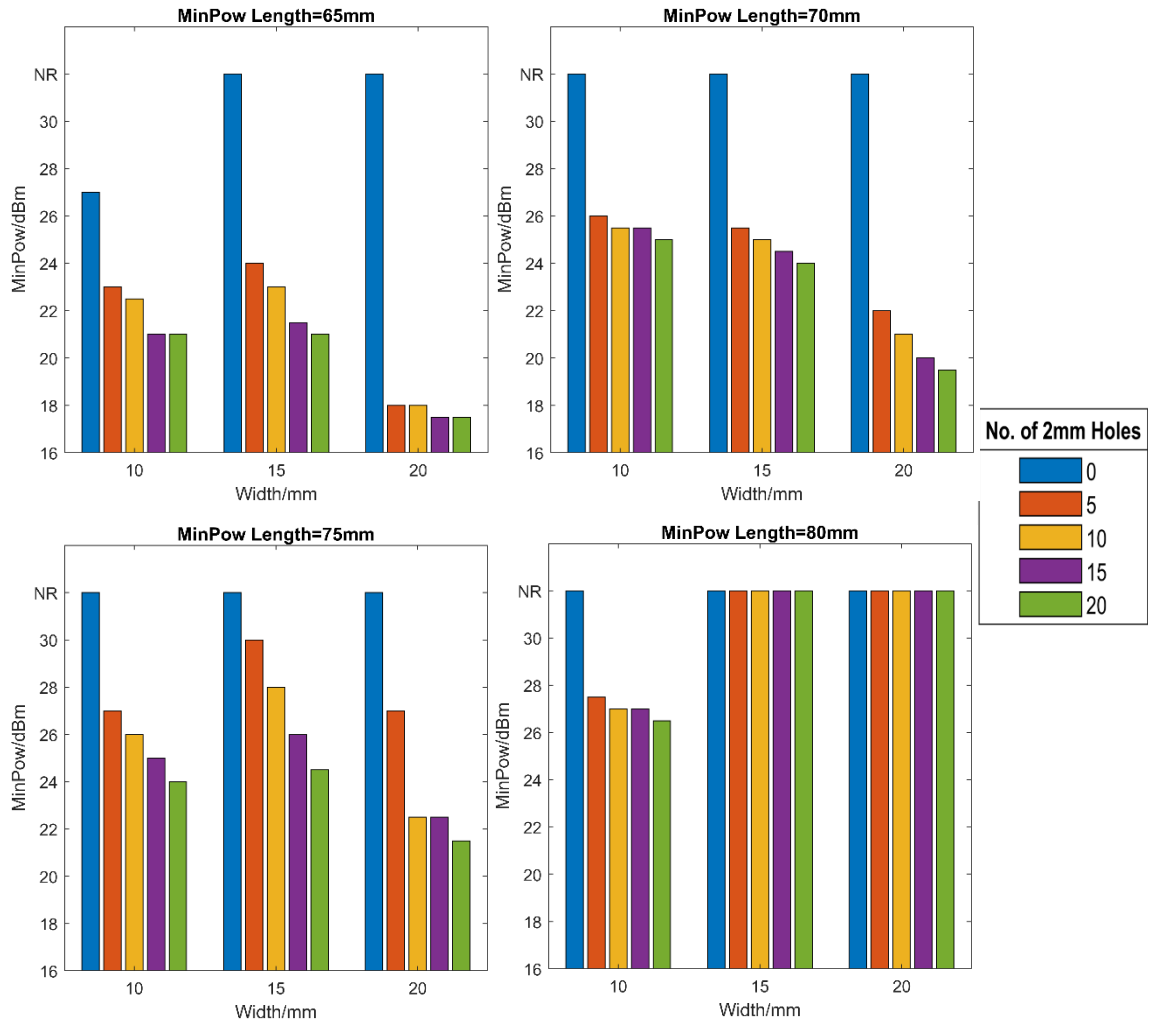
Figure 6.14. The MinPow recorded for each PVC blocker size under the artificial damage test

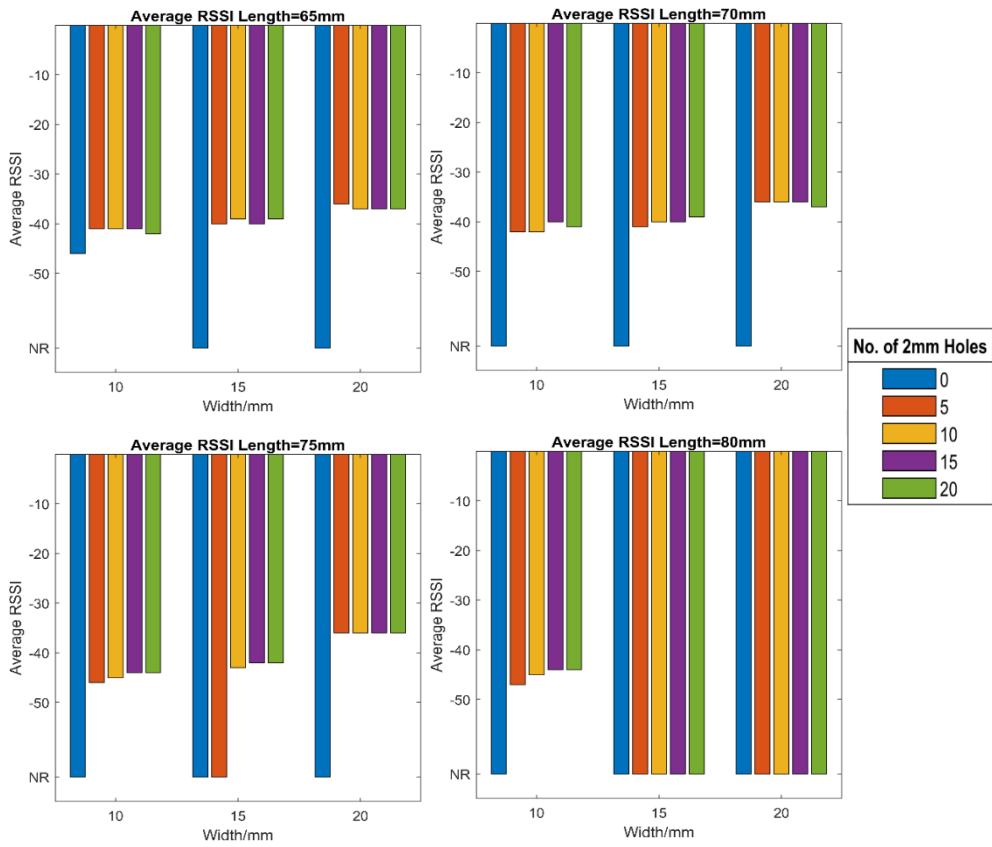
Figure 6.15. Average RSSI recorded for each PU blocker size under the artificial damage test

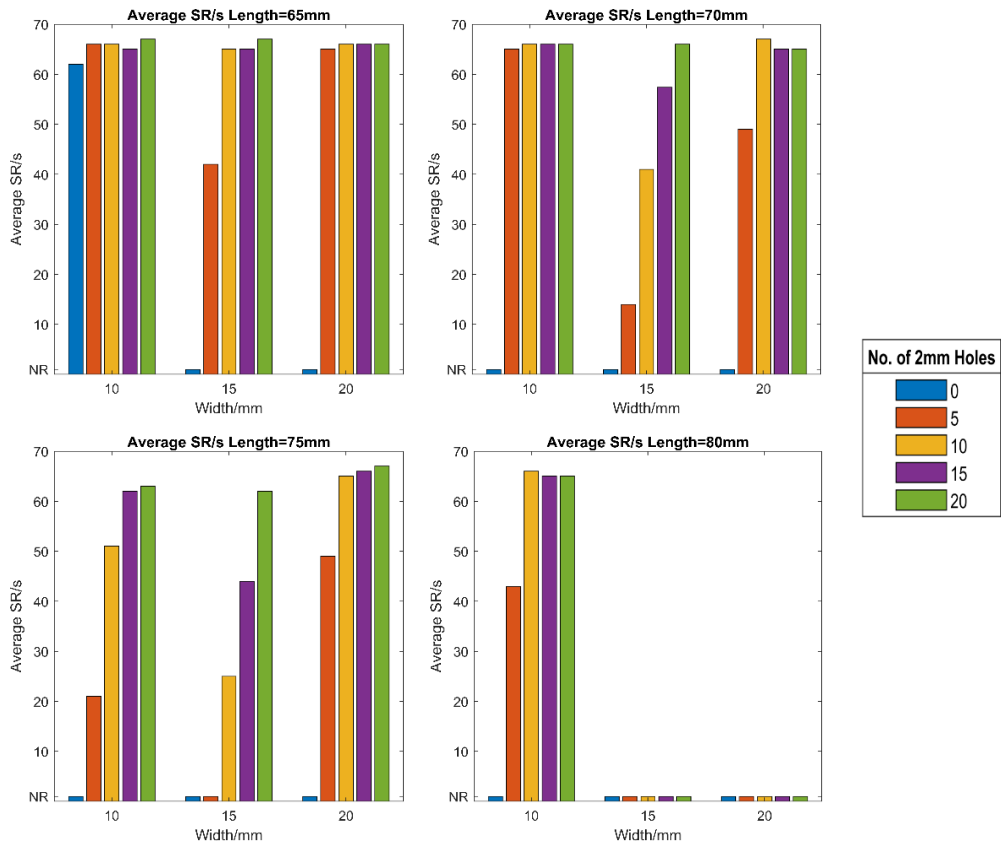
Figure 6.16. Average SR/s recorded for each PU blocker size under the artificial damage test

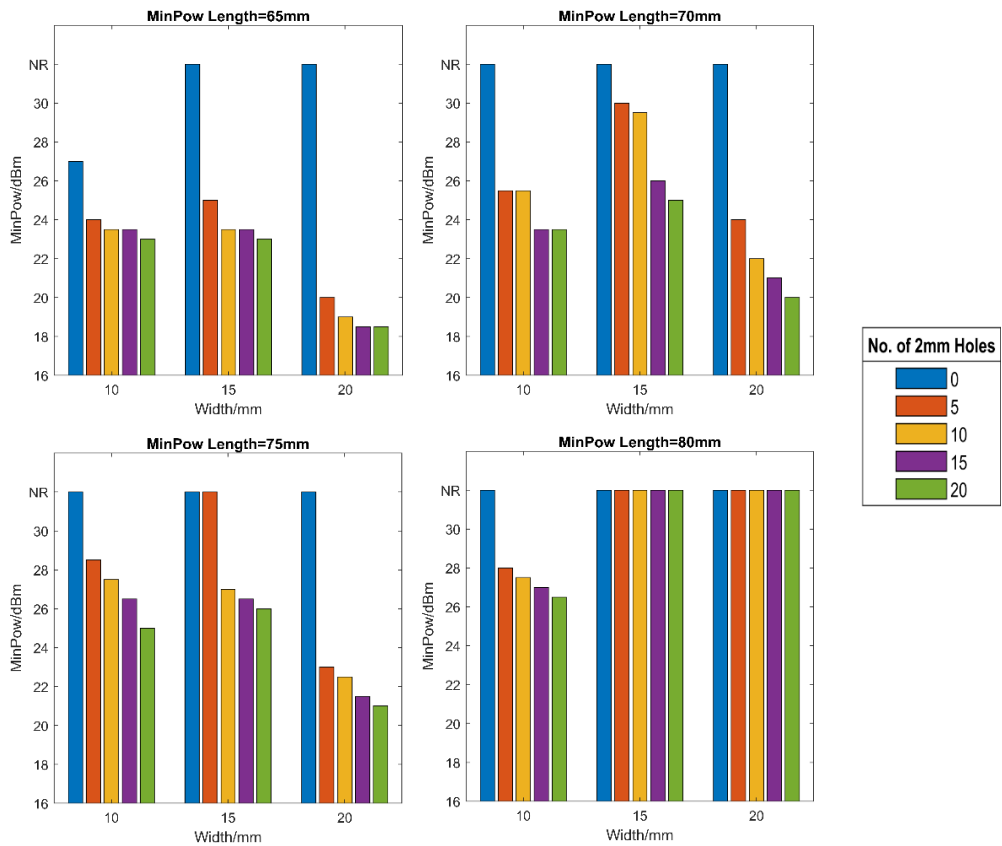
Figure 6.17. The MinPow recorded for each PU blocker size under the artificial damage test

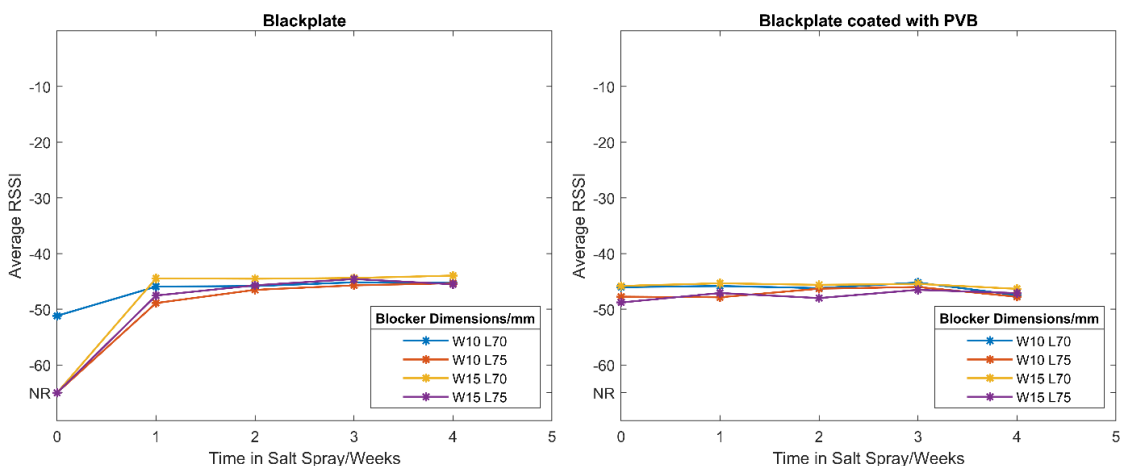
Figure 6.20. Average RSSI recorded during the corrosion test for the blackplate substrate samples

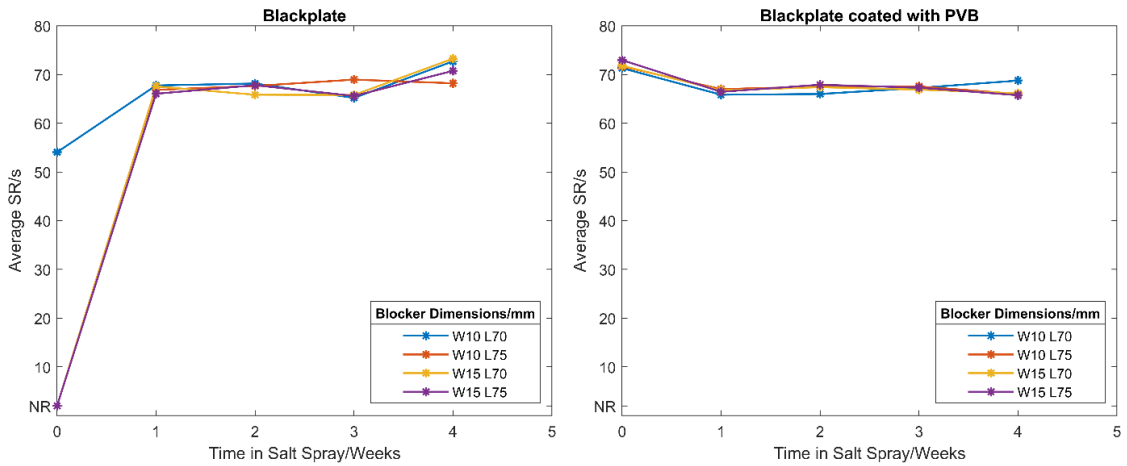
Figure 6.21. Average SR/s recorded during the corrosion test for the blackplate substrate samples

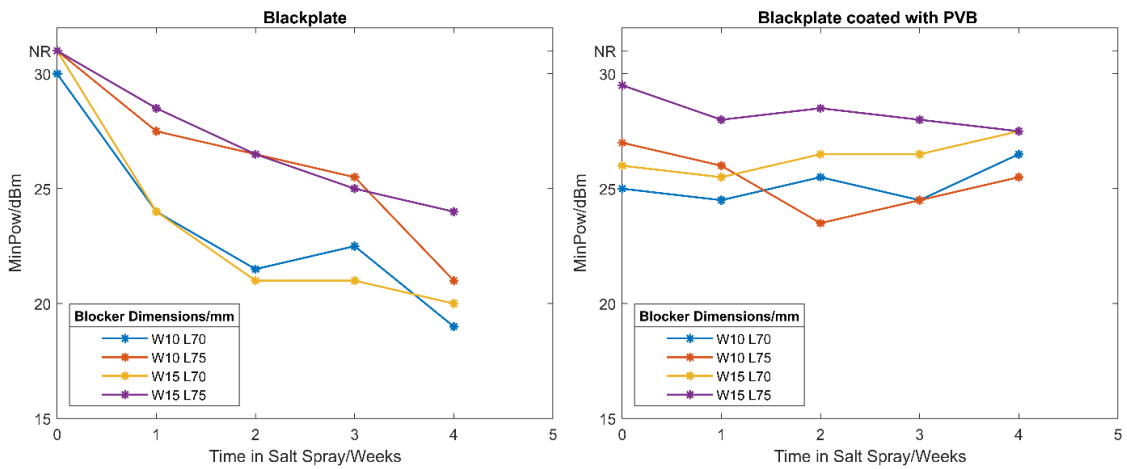
Figure 6.22. The MinPow recorded during the corrosion test for the blackplate substrate samples

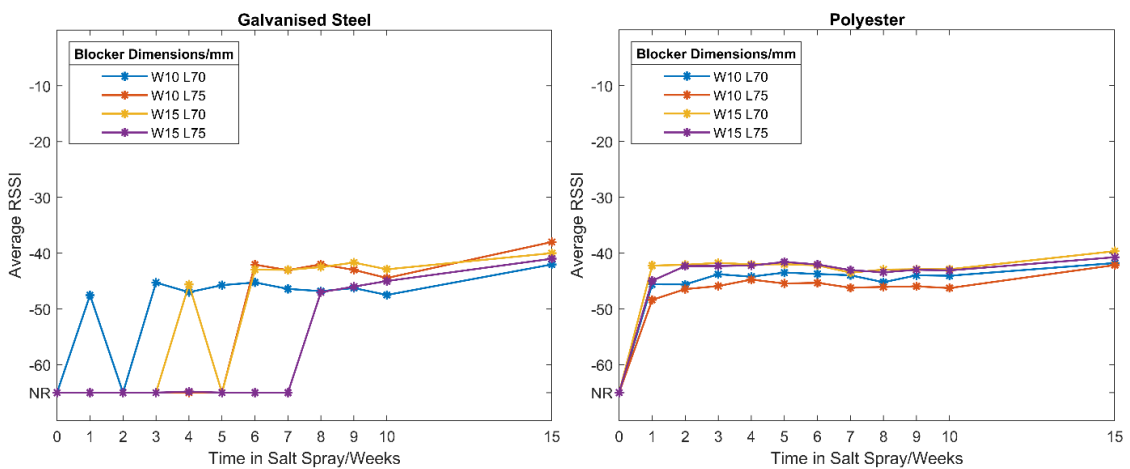
Figure 6.28. Average RSSI recorded during the corrosion test for the galvanised steel substrate samples

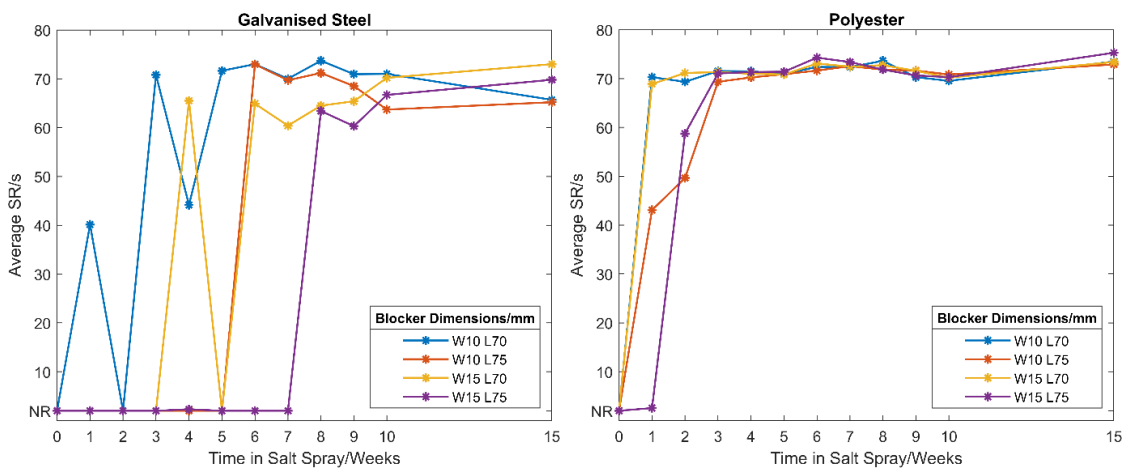
Figure 6.29. Average SR/s recorded during the corrosion test for the galvanised steel substrate samples

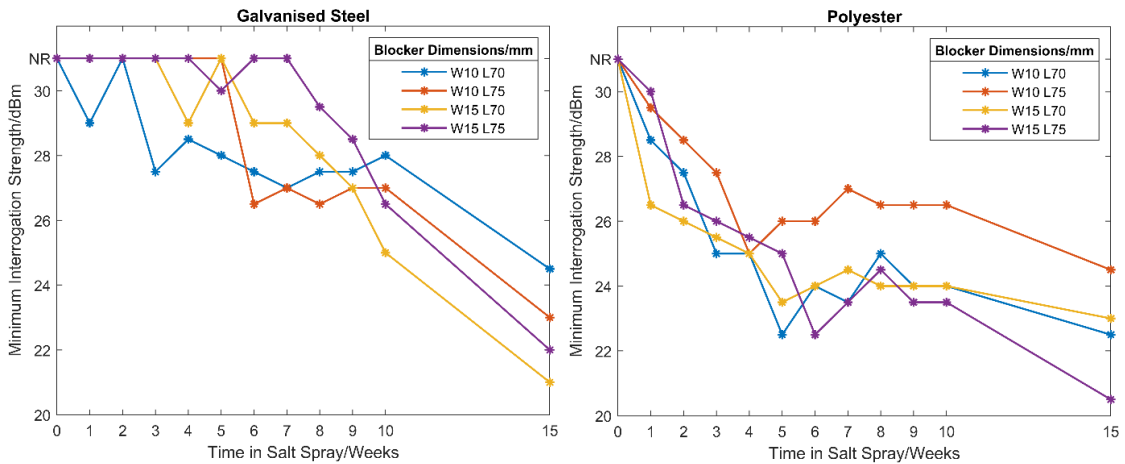
Figure 6.30. The MinPow recorded during the corrosion test for the galvanised steel substrate samples
