Development of sensors and non-destructive techniques to determine the performance of coatings in construction

By
Timothy John Savill

In fulfilment of the requirements for the degree of
Engineering Doctorate (EngD) in Materials Engineering

College of Engineering, Swansea University, 2023

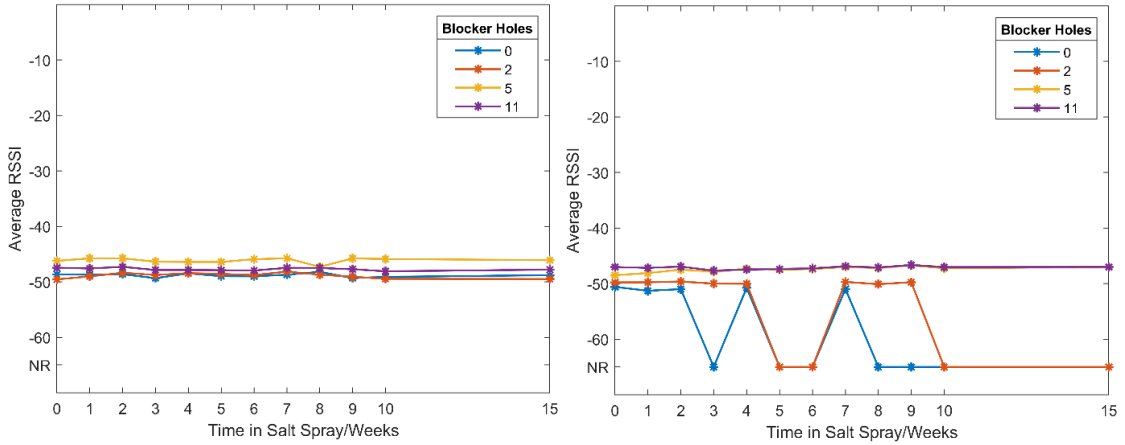
Figure 6.39. Average RSSI recorded during the corrosion test for the hole punched samples: PVC (left) and PU (right)

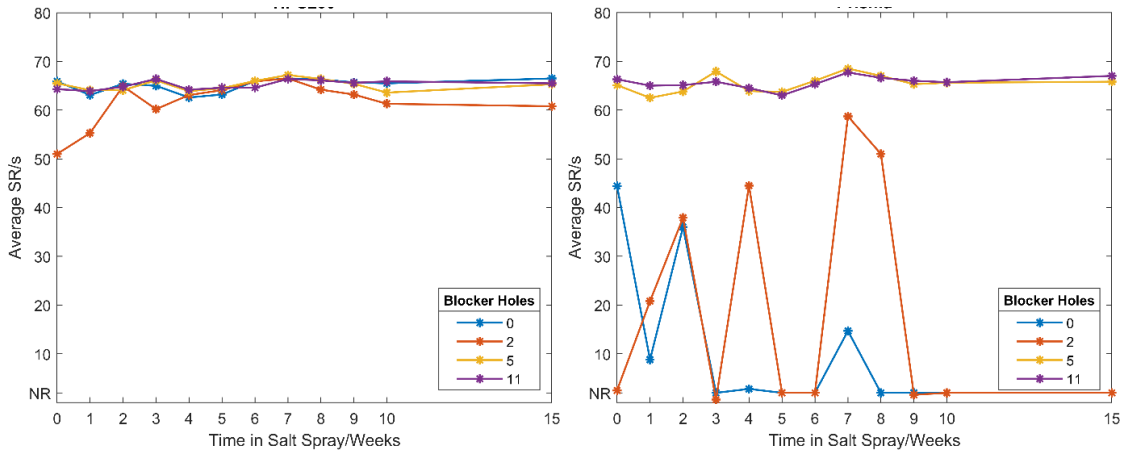
Figure 6.40. Average SR/s recorded during the corrosion test for the hole punched samples: PVC (left) and PU (right)

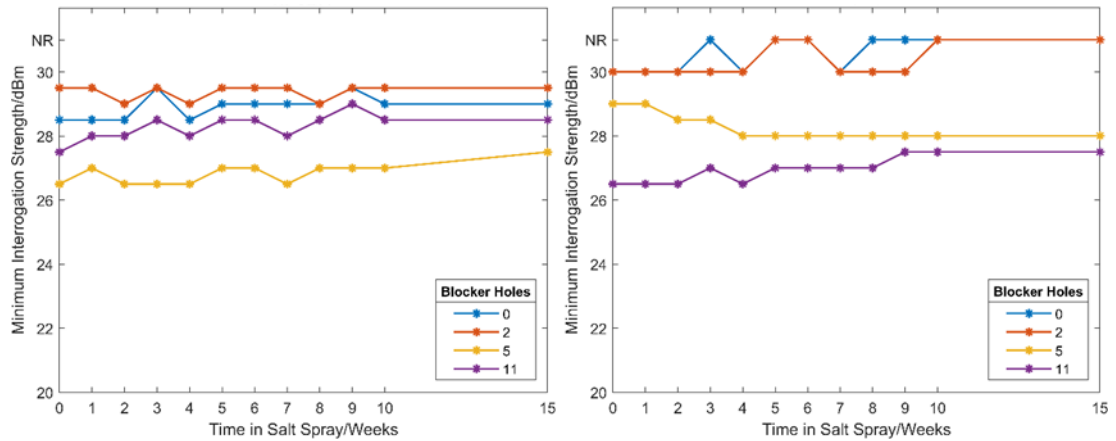
Figure 6.41. The MinPow recorded during the corrosion test for the hole punched samples: PVC (left) and PU (right)

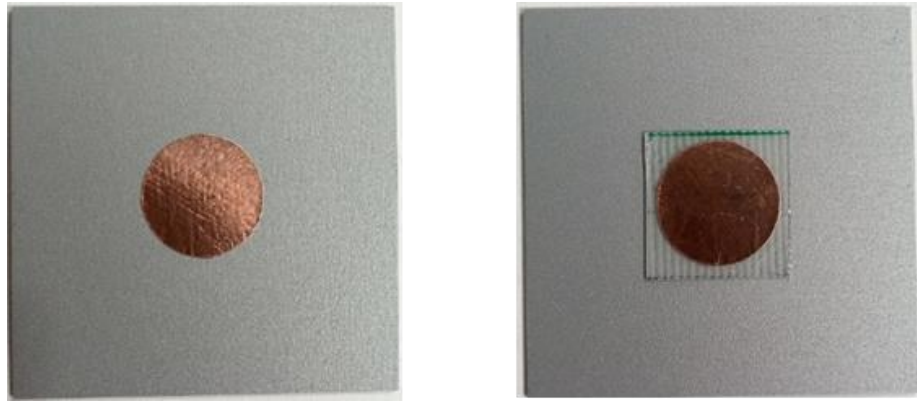
Figure 7.7. The manufactured Chipless RFID Tag deployed onto the same without (left) and with (right) the substrate layer.

In order to validate the simulations, several tags were produced, as shown in Figure 7. The antennae were manufactured from adhesive copper tape (RS Pro foil, thickness 0.035 mm, from RS Components, Ireland) using a 20 mm paper punch. This method was initially used for simplicity and because it gave reasonable cut quality and uniformity. As copper rapidly tarnishes antennae were also produced from adhesive aluminium tape (RS Pro foil thickness 0.04 mm), this is a far more environmentally resilient substrate and hence it was considered as an alternative. The 20-mm circles were then either attached directly to the sample, or to the Fr-4 substrate, which was attached to the sample via thin double sided adhesive tape. An example of the two produced antenna systems is shown in Figure 7.7. A number of coated steel samples were used in this study with the colours used including white, anthracite, grey (PVC only), and silver (PU only). This was done to understand the effect the different coating colours may or may not have on the measured resonant frequencies. The samples used are shown in Figure 7.8.

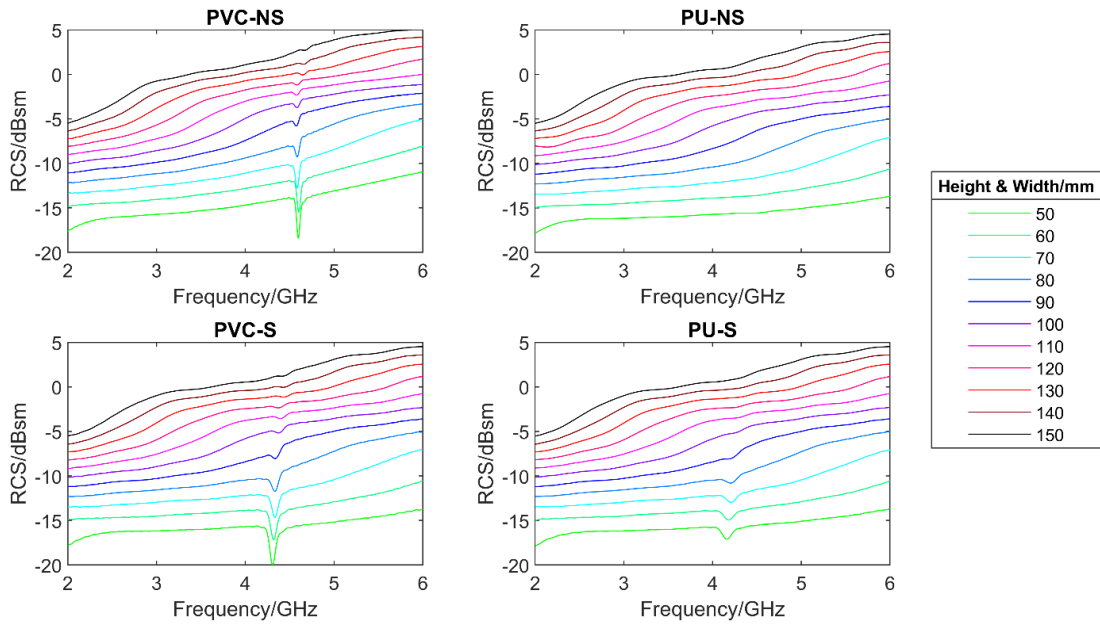
Figure 7.14. The effect of sample size on the simulated RCS response

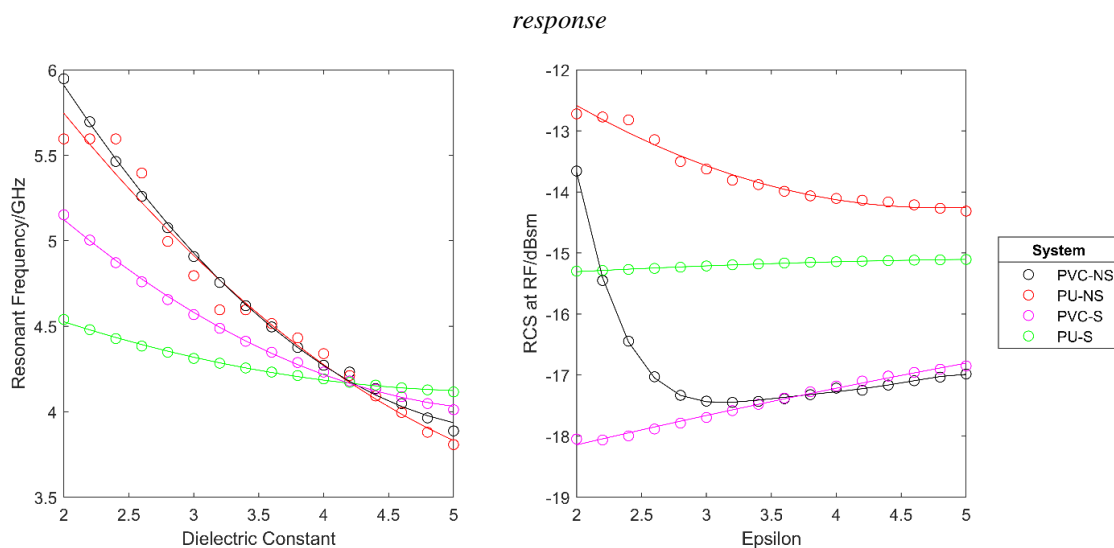
Figure 7.16. The effect of changes in the dielectric constant of the paint layer on the resonant frequency and the RCS at resonant frequency of each system

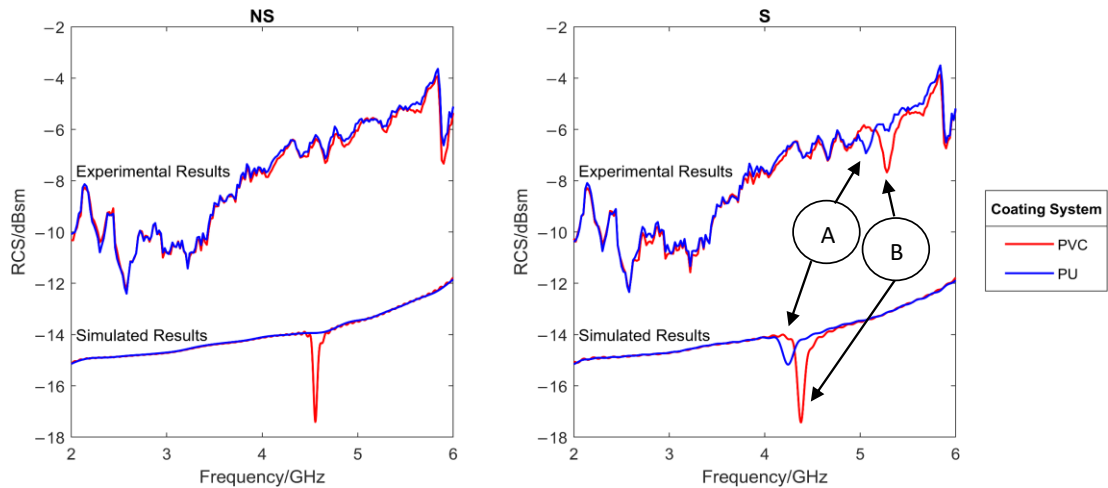
Figure 7.19. Comparison of the simulated and measured RCS response of sensors mounted directly on coated system (NS, right) and sensors mounted on an additional substrate (S, left). Identifiable peaks are matched between simulated and experimental results with designators A and B.

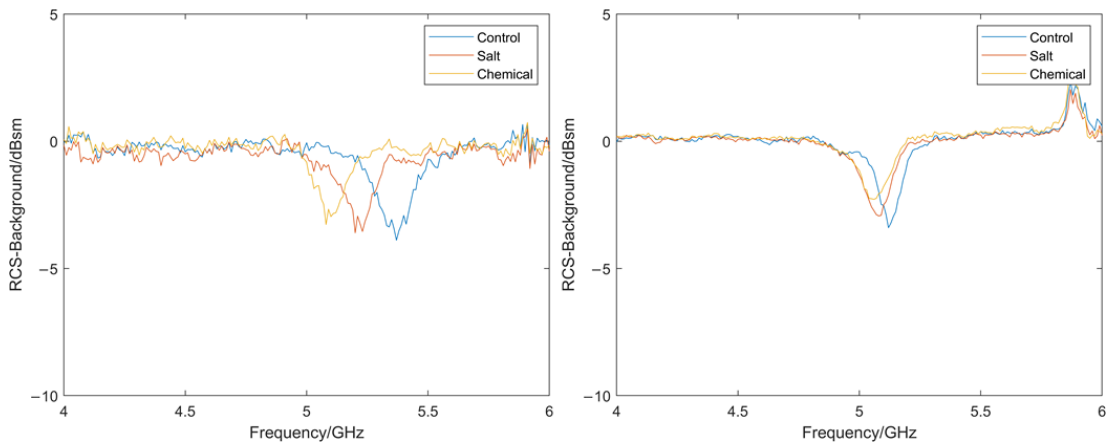
Figure 7.22. Measured RCS for a PVC coating system (left) and a PU coating system (right) samples exposed to salt and chemical degradation.

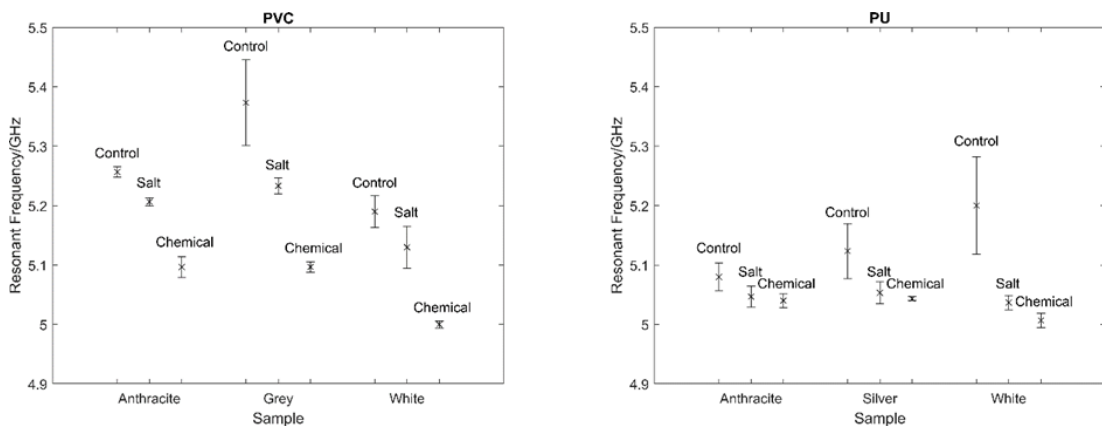
Figure 7.23. Measured resonant frequency for each PVC (left) and PU (right) sample tested and the associated standard error.

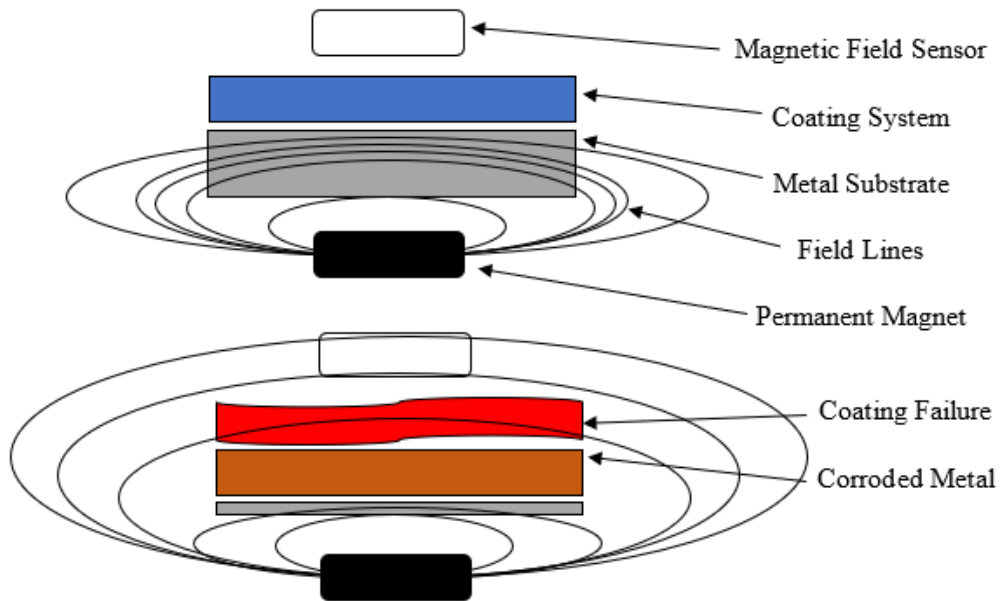
Figure 8.2. Demonstration of magnetic field testing on uncorroded (top) and corroded (bottom) coated steel

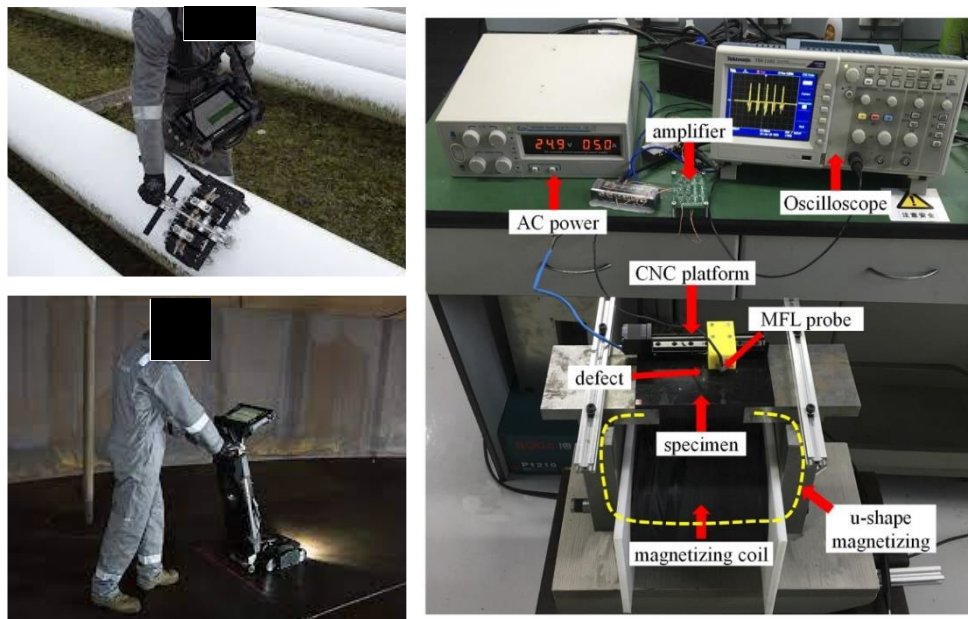
Figure 8.3. Different MFL testing methods including commercially available handheld (top left) roller (bottom left) and research-based CNC (right) [7,8]

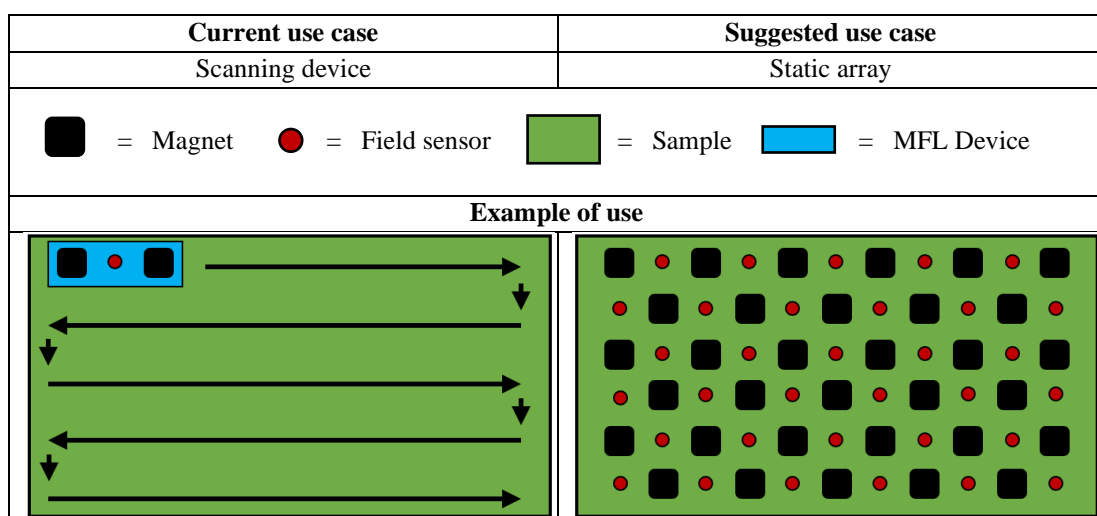
Figure 8.4. Suggested adaptation to the technique for this application.

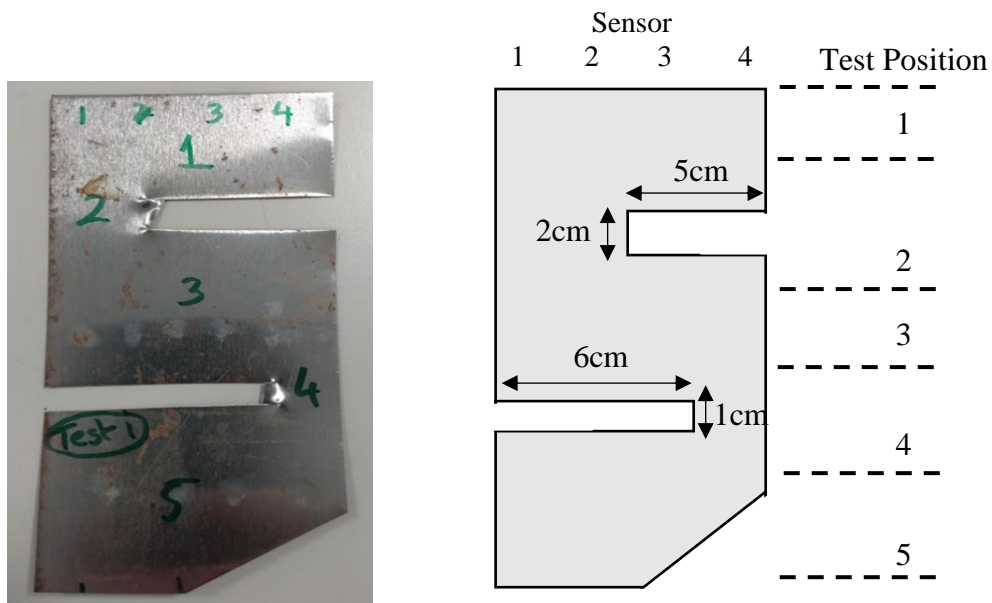
Figure 8.7. Test sample 1 image (left) and dimensions (right)

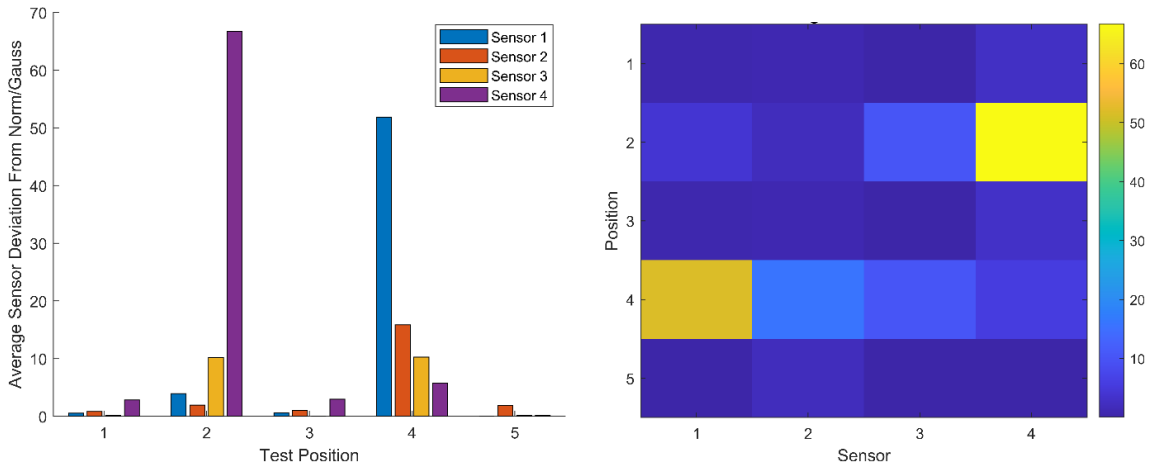
Figure 8.10. Average sensor deviation for each position (Left) and 2D Plot of the average deviation (Right)

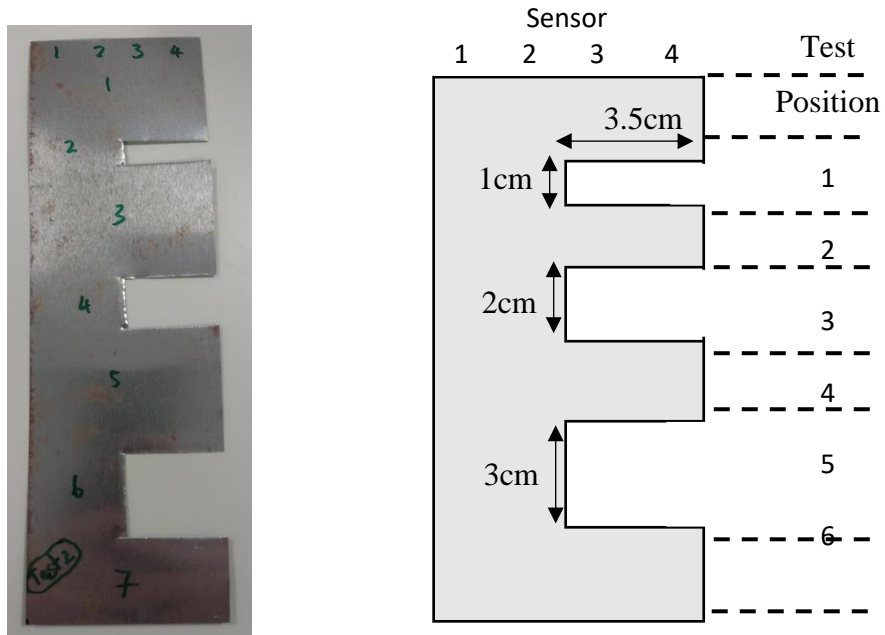
Figure 8.11. Test sample 2 image (left) and dimensions (right)

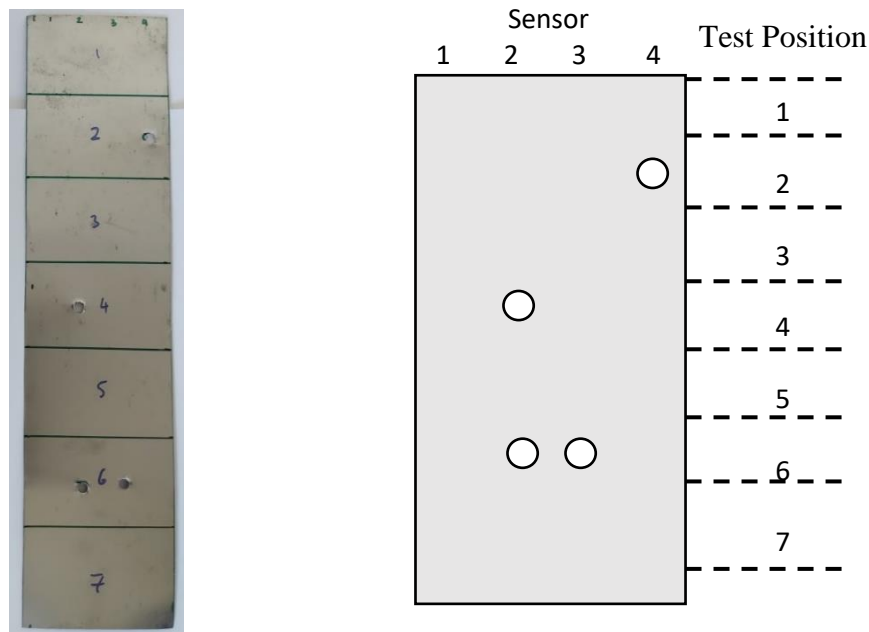
Figure 8.13. Test sample 3 image (left) and layout (right)

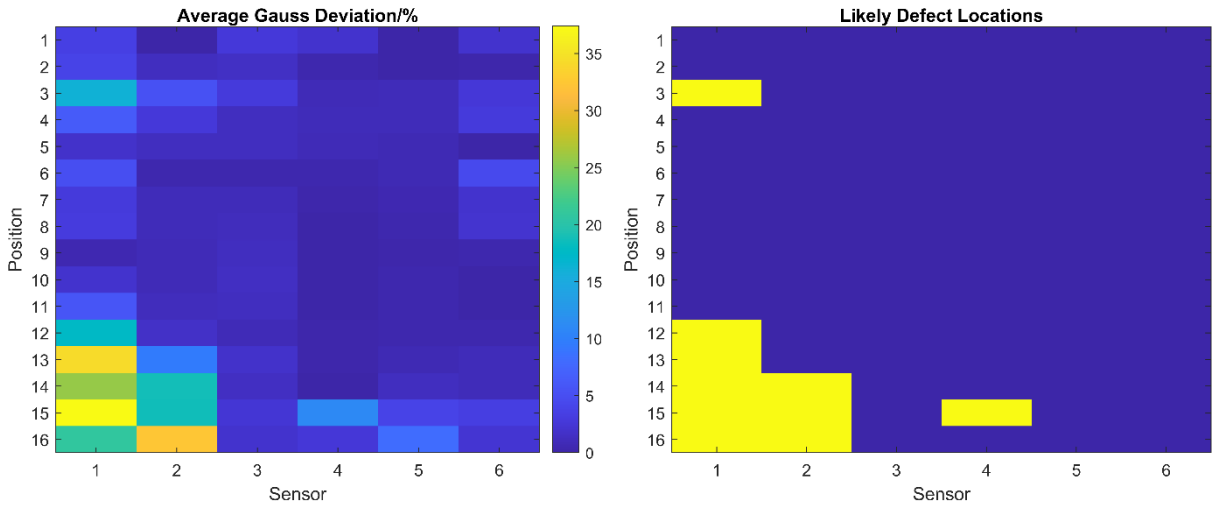
Figure 8.23. Measured Gauss percentage deviation (left) and likely defect locations based on a 5% threshold value (right)

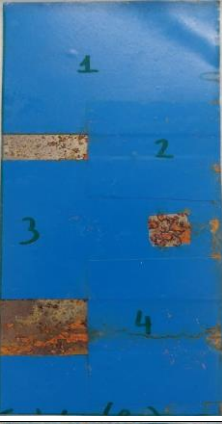
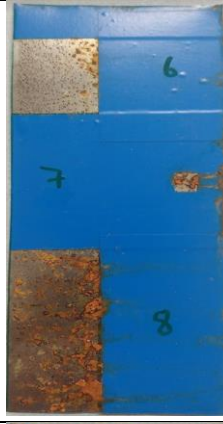
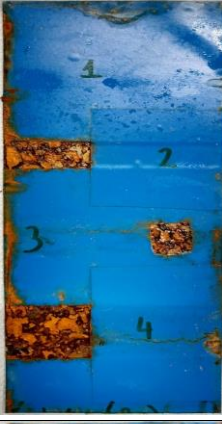
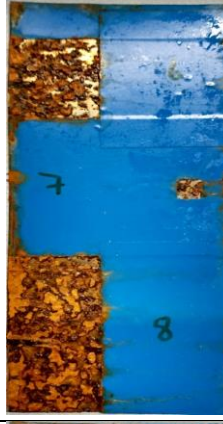
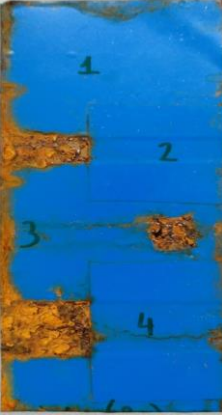
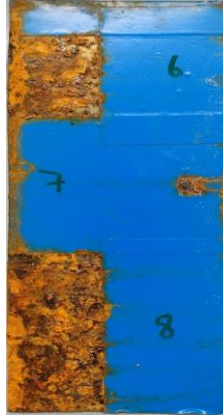
Figure 8.25. Sample condition at each week exposure

shown in Figure 8.25 and show that corrosion develops slowly week by week until a heavily corroded sample was produced by 3 weeks exposure. The test was stopped at the 3 week point as it was decided that the sample was significantly corroded and if this corrosion was below the limit of detection the method was insufficiently accurate at detecting corrosion. After the final measurement was completed, the tape was removed to check if any corrosion had occurred under the tape which may have been picked up. It was seen that generally the tape did an excellent job of preventing corrosion on the covered sections with only a small amount of corrosion around tape seams and edges.

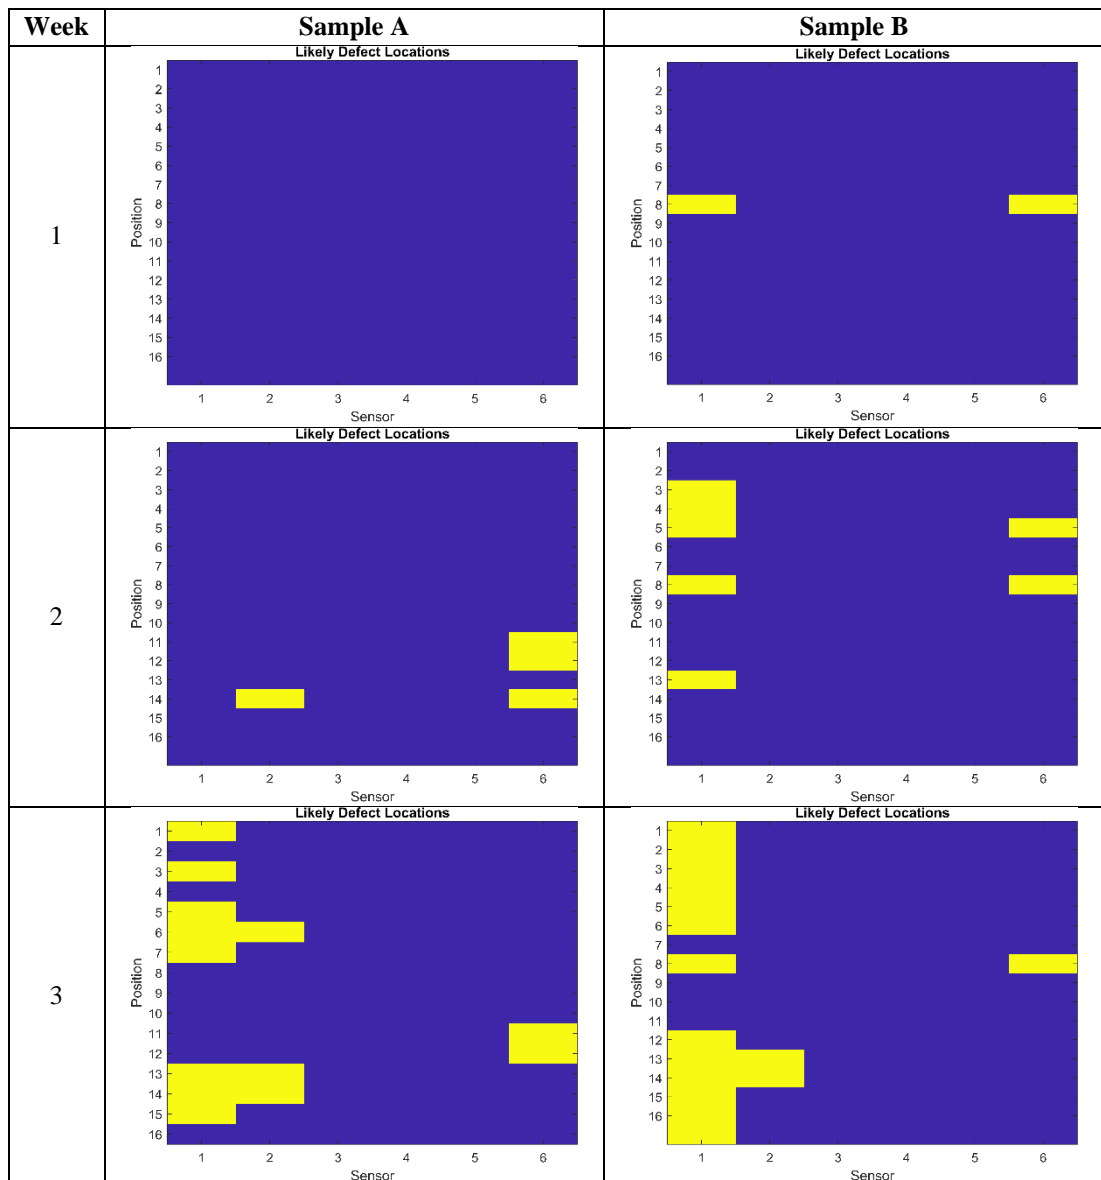
Figure 8.27. Likely defect locations based on the recorded data using a threshold value of 5%

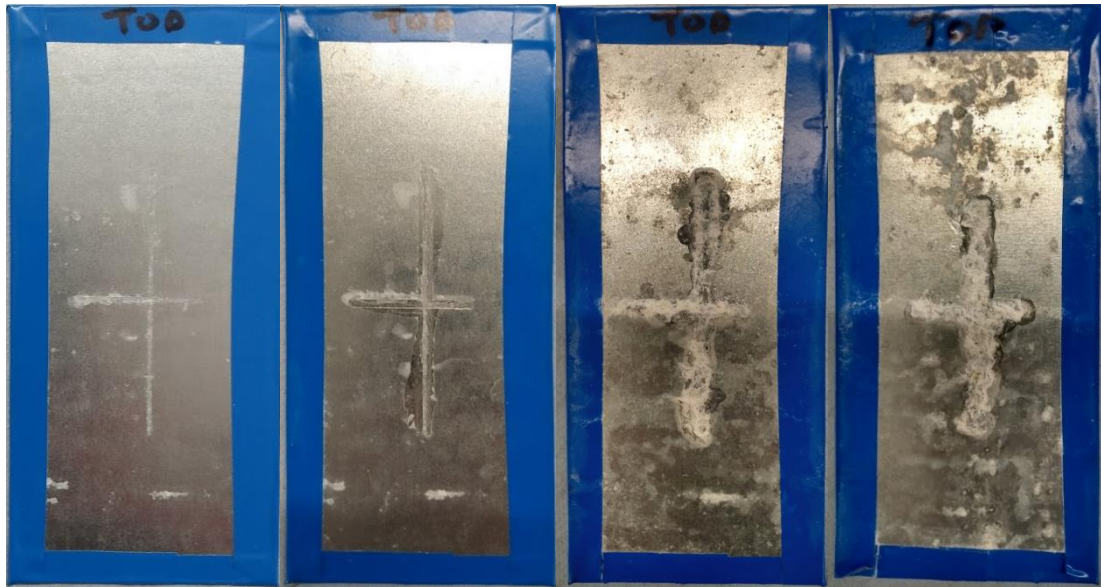
Figure 8.29. Condition of the sample during the test from 1 week exposure (far left), 2-week exposure, 4-week exposure and 6-weeks exposure (far right)

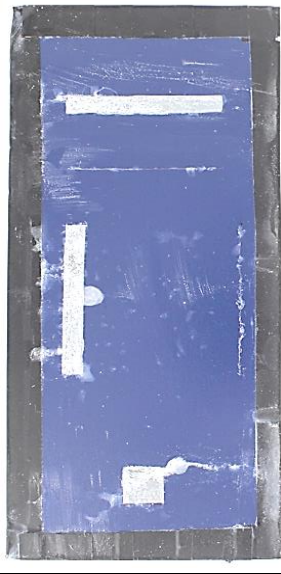
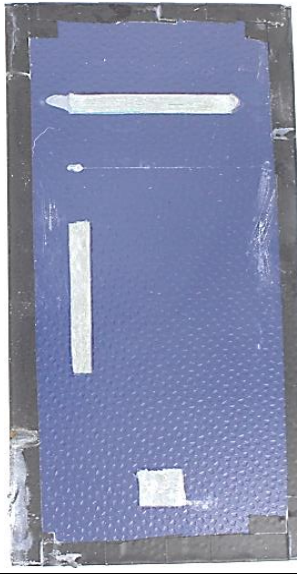
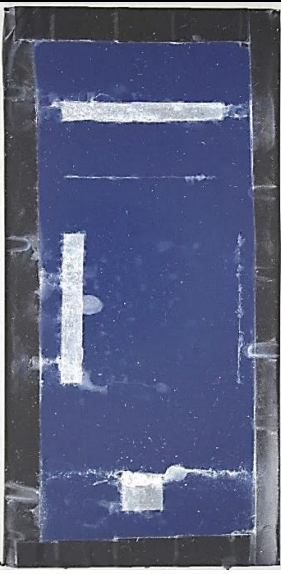
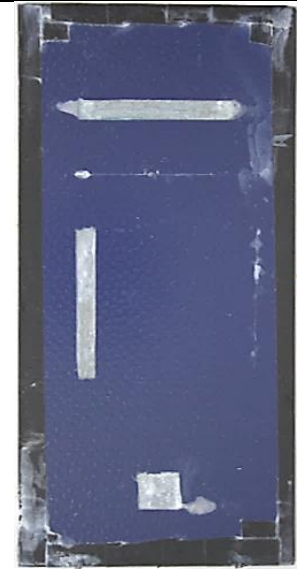
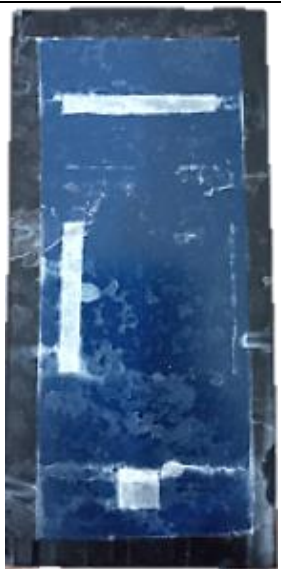
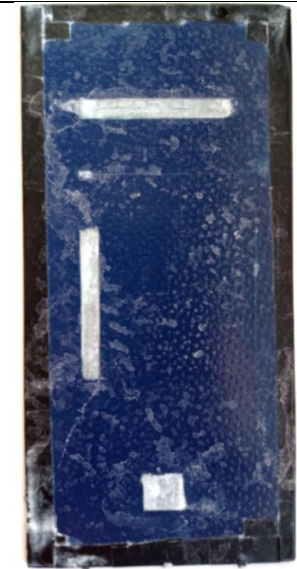
Figure 8.33. Condition of the coated steel samples during the test

The samples were exposed to the salt spray chamber as the previous samples had been. Due to the expected resistance of the sample to corrosion, measurements were made at 4-week intervals. In Figure 8.33 the condition of the samples during the test are shown. White rust was observed to form as the test progressed, although this is at a slower rate to the previous galvanised samples due to the more resistant metallic coating present of these samples. However, by 12 weeks exposure there was a significant quantity of white rust present suggesting considerable attack; it is of note, however, that no red rust was present indicating this was still ‘early-stages’ of degradation.

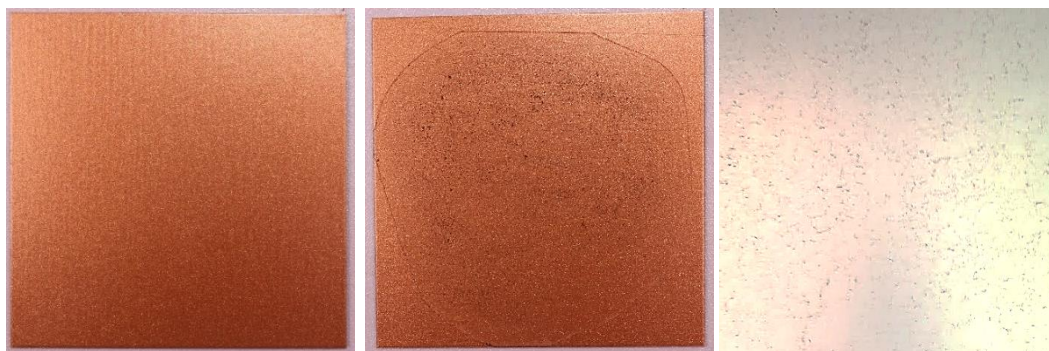
Figure 9.4. Initially clean PVDF sample (left), PVDF sample with wet-applied 4000 mgm⁻² of deposit (middle), and observed natural deposit on the building (right).

In this work, the effect of natural deposit build-up was examined on a number of commonly used organic coating systems for steel cladding, namely a PVC-based system, a PU-based system, and a PVDF-based system. Samples 5 cm × 5 cm in size were used to create the fouled samples; 5 and 10 mg of building deposit was added to each sample to give two samples with a deposit coverage of approximately 2000 and 4000 mgm⁻², respectively. The deposit was dissolved in approximately 5 mL of deionised water and was pipetted onto the sample and allowed to dry on a hot plate at 50 °C. This produced visually similar fouling to that observed on the actual building, as shown in Figure 9.4. To ensure this process did not affect the results, the clean samples also went through the same procedure of water addition and heating.

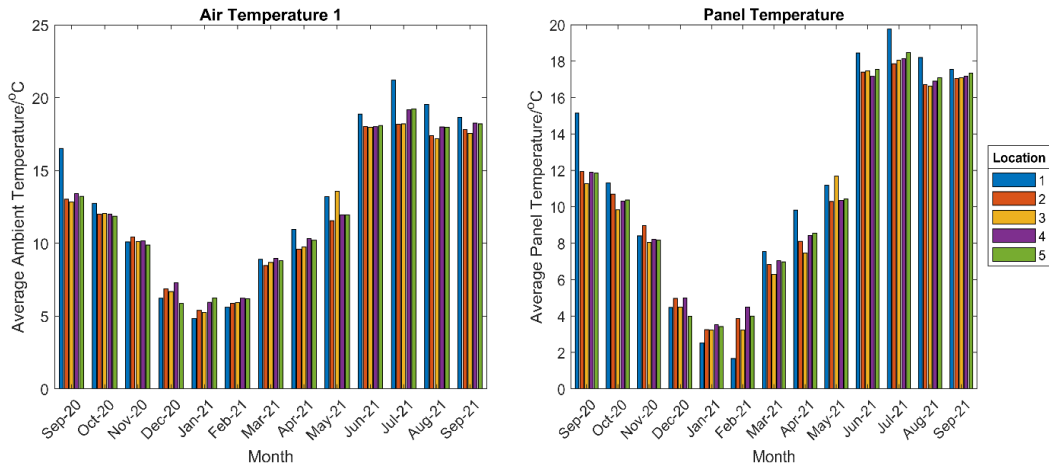
Figure 9.12. Comparison of air (left) and panel (right) temperatures recorded at each location.

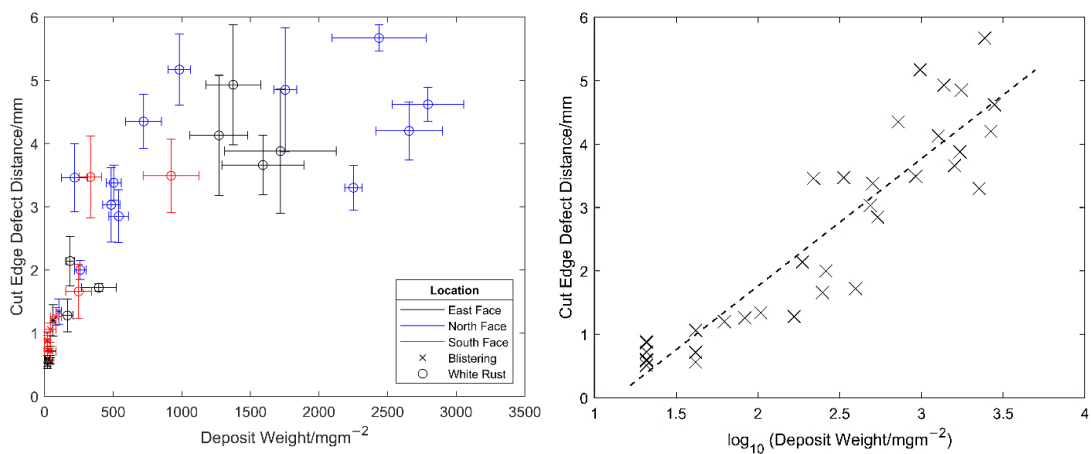
Figure 9.18. Comparison of the cut edge defect distance to the measured deposit weight in each location (left) and a demonstration of the logarithmic trend between the two factors (right).

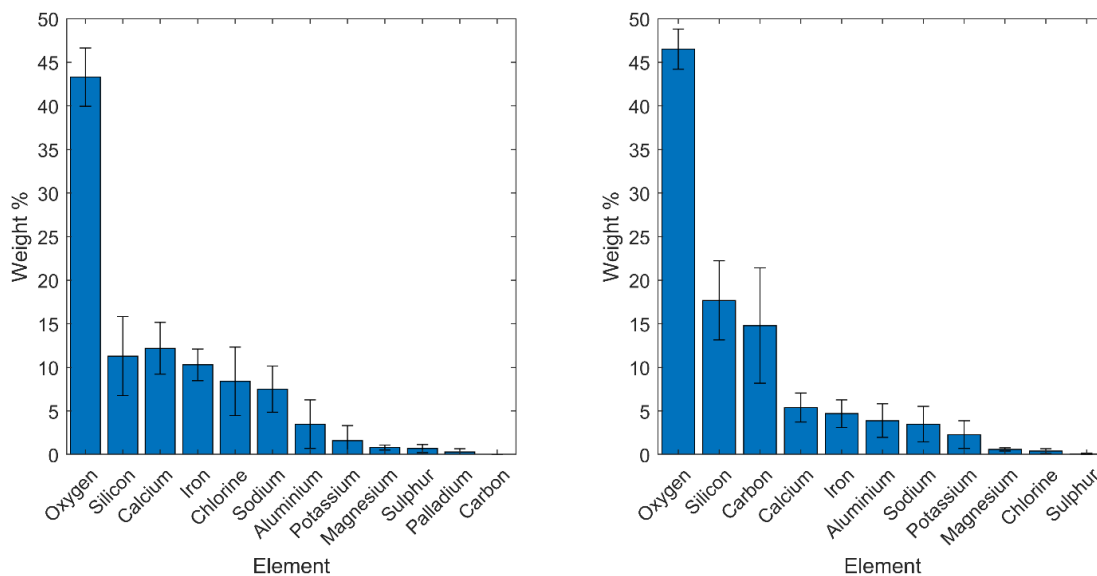
Figure 9.19. EDS analysis of the SP sample (left) and the P sample (right).

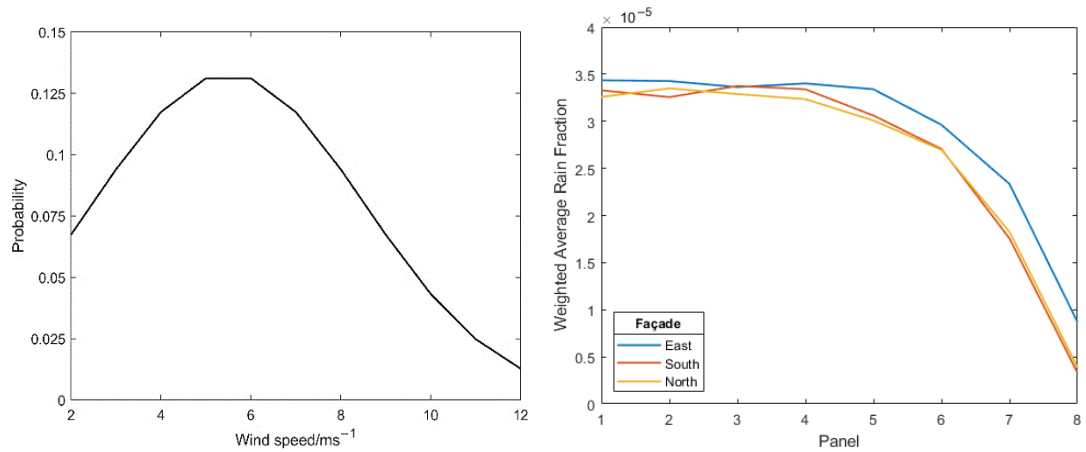
Figure 9.31. Wind-speed probability distribution used (left) to calculate wind-speed weighted averaged rain fraction for each panel on each façade (right).

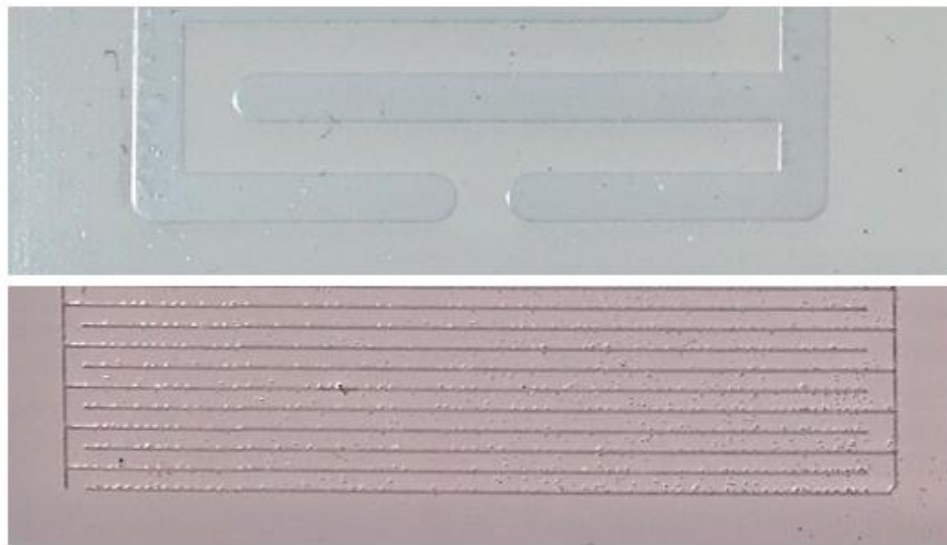
Figure 10.8. Appearance of the traces after primer application and cure for samples 1 (top) and 2 (bottom).

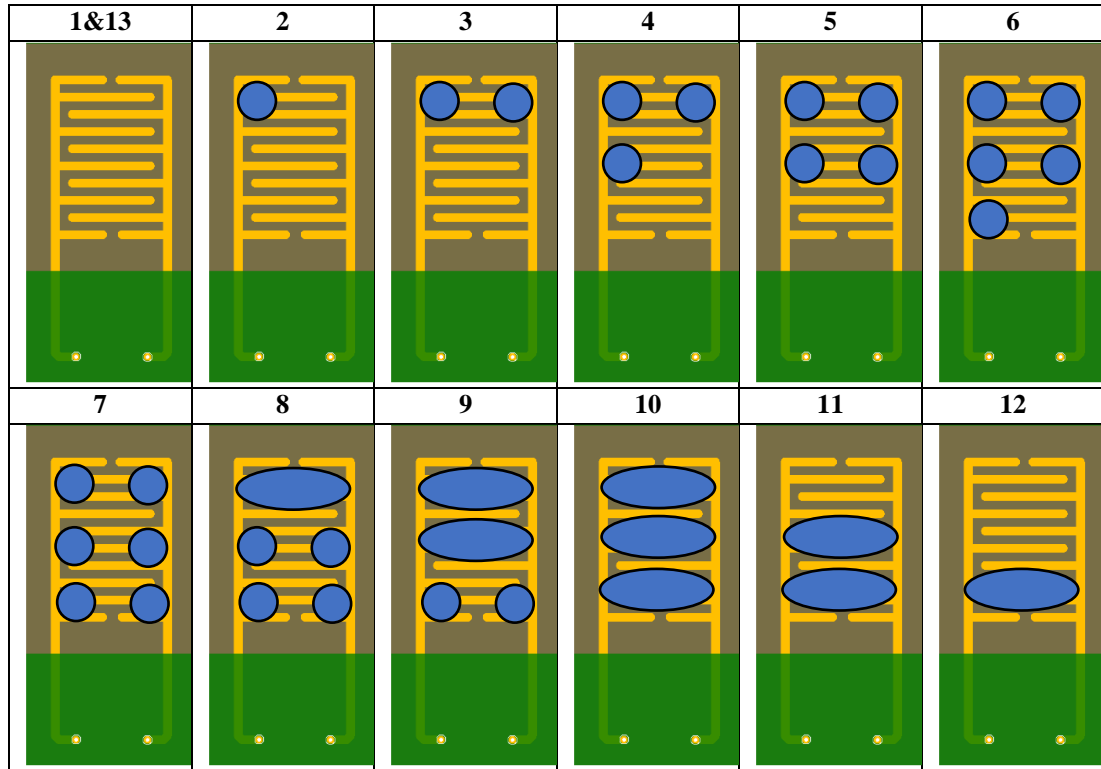
Figure 10.15. Each test condition for the moisture test, the blue regions indicate de-ionised water was placed in these regions

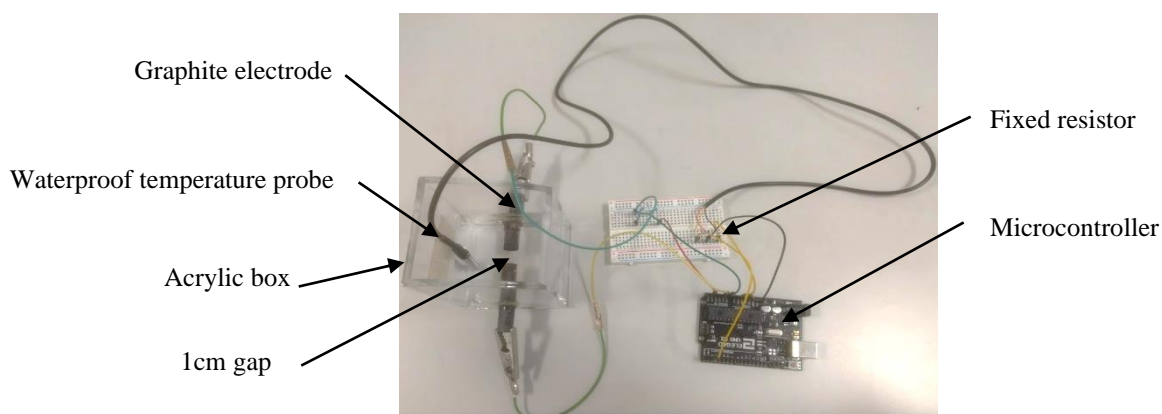
Figure B.II. Initial electrical conductivity device
