OPTIMISATION OF NEXT GENERATION GALVANISING POT HARDWARE

Thesis submitted to Swansea University in fulfilment of the
requirements for the Degree of Doctor of Philosophy

Swansea University, November 2024

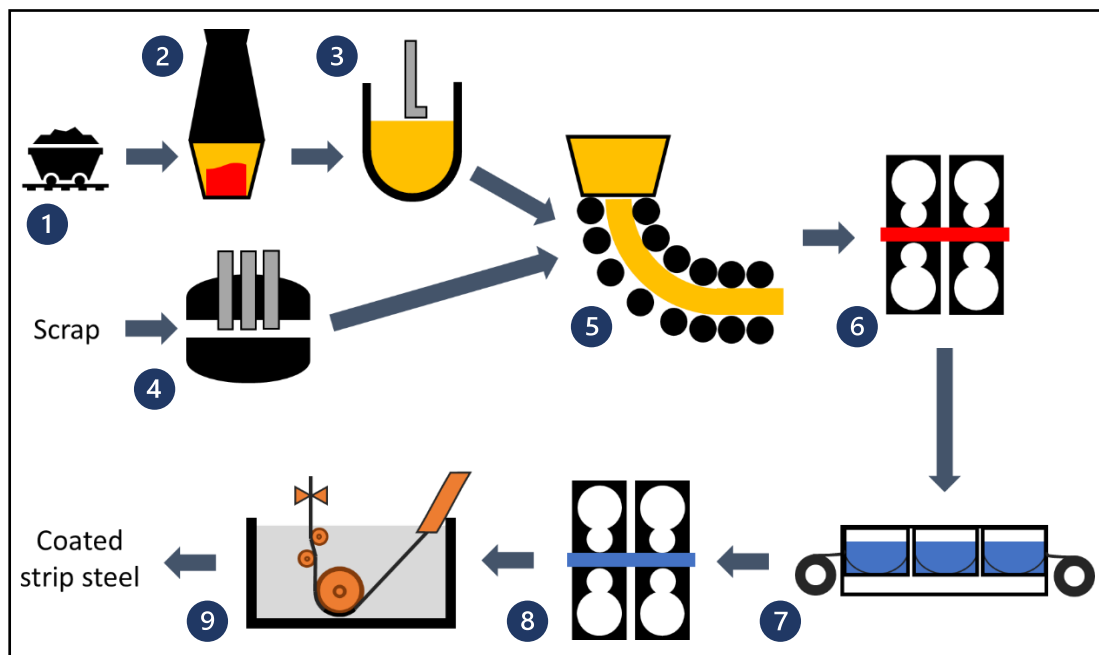
Figure 1.5 Main stages involved in galvanised steel production: (1) raw materials, (2) blast furnace, (3) basic oxygen furnace, (4) electric arc furnace, (5) casting, (6) hot rolling, (7) pickling, (8) cold rolling, (9) continuous galvanising.

of coated coil from raw materials or steel scrap are schematically shown in Figure 1.5. The first process occurs in a tall, vertical shaft furnace called 'blast furnace', where iron ore is reduced by means of coke to produce 'pig iron'. Subsequently, the hot metal is refined into steel in the BOS (basic oxygen steelmaking) plant. This process route is often replaced with steel production from scrap utilising an electric arc furnace. This is followed by continuous casting to transform liquid steel into slabs, which undergo shaping in rolling machines containing cylindrical rolls. Modern integrated steel plants are equipped with facilities which further process the uncoated strip product through the applications of coatings to the steel strip to impart corrosion resistance properties to the product. These coatings are produced on galvanising lines, such as the ZODIAC plant, which is Tata Steel's world-class coil galvanising line at Llanwern. ZODIAC serves the automotive industry, producing thin strips which automotive customers use for body panels.

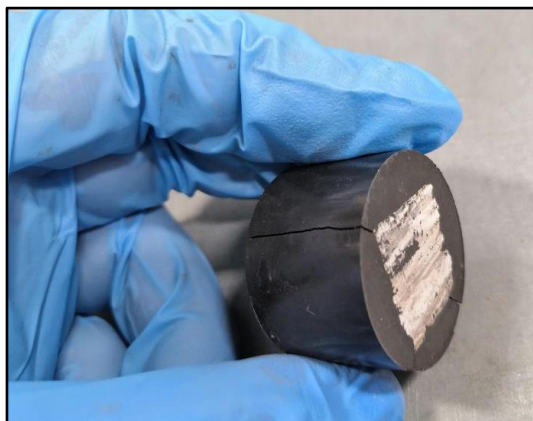
Figure 2.3 Cracks formed after hot mounting a ceramic specimen.

If necessary, samples were first cut to size. Metallic materials were precision cut with electrical discharge machining (EDM) and hard ceramic materials required the use of a diamond wheel. Stainless steel and Co-based alloys were hot mounted in Bakelite conductive resin before grinding and polishing were performed. Due to cracking of the samples after hot mounting (Figure 2.3), brittle ceramic materials were cold mounted using a conductive acrylic resin (CEM3070, Cloeren Technology GmbH) based on methyl methacrylate. Samples were ground using SiC grinding papers and diamond grinding discs, depending on the hardness of the materials being prepared. Polishing was carried out using polishing pads and solutions specific to the materials to be polished. Examples of the sample preparation procedures followed are outlined in Table 2.3 and Table 2.4. Samples were rinsed in warm water and cleaned with ethanol in between each grinding and polishing step, in order to minimise any possible contamination from the samples. Polishing cloth pads were washed thoroughly using water and detergent before each usage to avoid cross contamination of grinding and polishing debris.

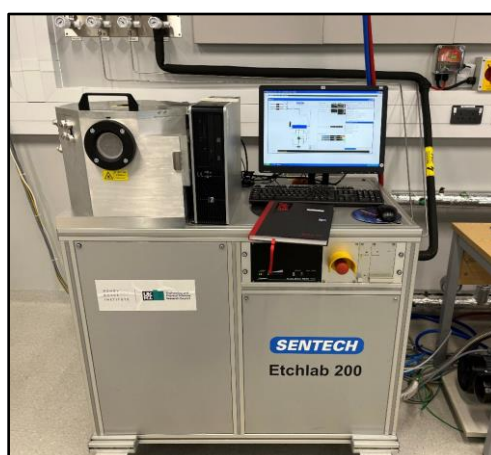
Figure 2.4 Sentech RIE apparatus for plasma etching available at Imperial College, London.

Plasma etching was carried out using the SENTECH (Berlin, Germany) Etchlab Reactive Ion Etching (RIE) setup located at the Department of Materials at Imperial College (London, UK) through the Royce Institute. The apparatus, which is shown in Figure 2.4, is capable of etching materials through bombardment of ions and the use of multiple gases, including C_4F_8 , Ar, O_2 and N_2 . The literature showed that ceramics such as Sialons and Si_3N_4 were plasma etched from superheated $CF_4 + O_2$ gas (Chinn & Chinn, 2002). As the RIE apparatus did not have a CF_4 gas supply, etching was conducted using C_4F_8 gas at 50 Pa pressure and 70 W forward power for 3 minutes. During the plasma etching process, the gas mixture was admitted into the vacuum chamber and ionised to form a plasma, which attacked the grains in the ceramic. At the end of the etching process, the chamber was cleaned with O_2 gas to remove volatile etch products before opening the chamber.

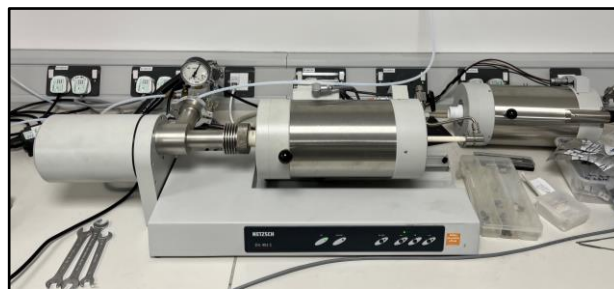
Figure 2.10 Experimental set-up used to measure the coefficients of thermal expansion.

The coefficients of thermal expansion (CTEs) were measured with dilatometry, using a NETZSCH (Selb, Germany) DIL402C dilatometer. The experimental set-up is shown in Figure 2.10. Samples were sectioned into bars with a diameter of 5 mm and a length of 20 mm. The length change of the bars was analysed in the temperature range between room temperature and 465 °C on heating at a rate of 10 K min⁻¹. Curves were acquired to illustrate the variation of the CTE as a function of temperature.

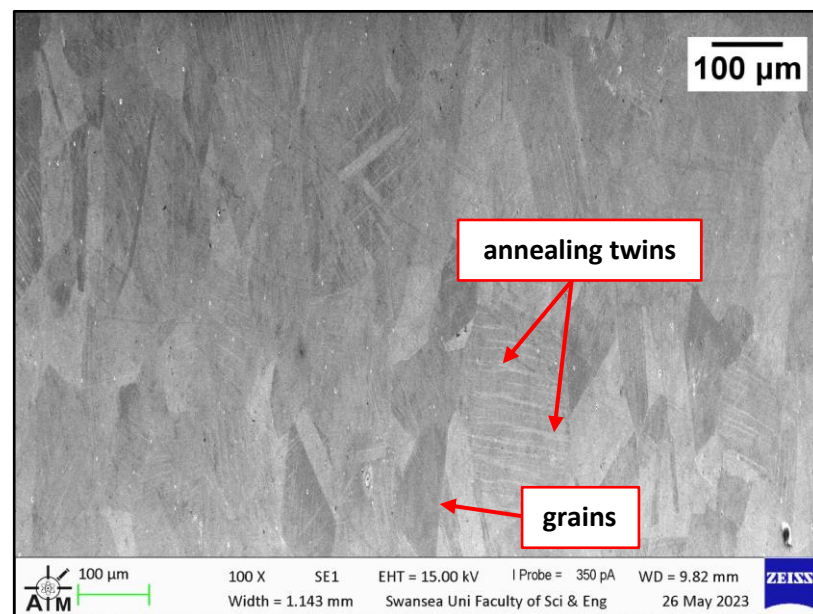
Figure 3.1 Microstructure of SS 316L after etching with Carpenter's solution.

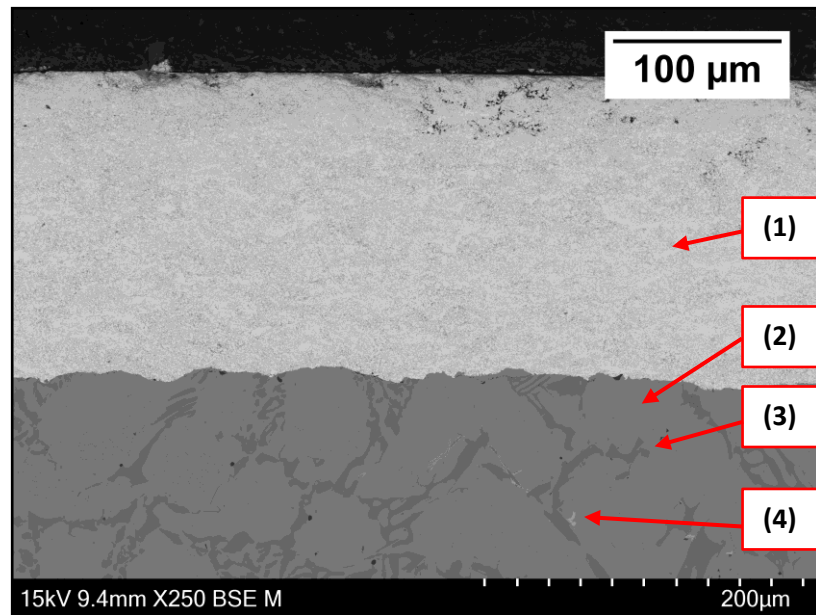
Figure 3.2 SEM image of Wallex6™ coated with HVOF WC-Co coating.

Figure 3.2 and Figure 3.3 show that Wallex6™ is coated with a WC-Co layer that is of uniform thickness and free of cracks (1). The alloy is characterised by a Co solid solution matrix phase (2), with Co, Cr and W as the main constituents. EDS found that the average element composition of this phase is Co (61.3 ± 0.8 wt.%), Cr (23.8 ± 0.6 wt.%) and W (9.3 ± 1.5 wt.%). Two eutectic phases were observed in the Co matrix phase: a primary CrCoWMo phase (3) and a secondary eutectic phase of CoWCr (4). The results of EDS elemental analysis showed that the primary eutectic phase comprised of Cr (69.6 ± 7.8 wt.%), Co (17.3 ± 2.8 wt.%), W (10.6 ± 4.6 wt.%) and Mo ($1.4 \pm$ Mo wt.%) with traces of Fe and Ni. The secondary phase mainly contained Co (49.2 ± 8.1 wt.%), W (23.2 ± 8.4 wt.%) and Cr (21.6 ± 2.5 wt.%). Details of both eutectic phases are shown in Figure 3.4.

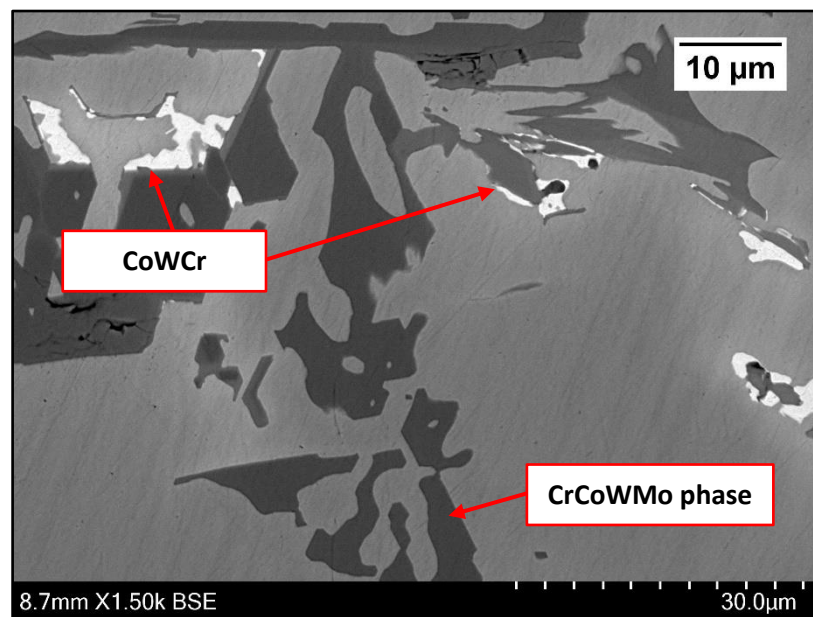
Figure 3.4 SEM image showing the CrCoWMo and CoWCr eutectic phases observed in Wallex6™.

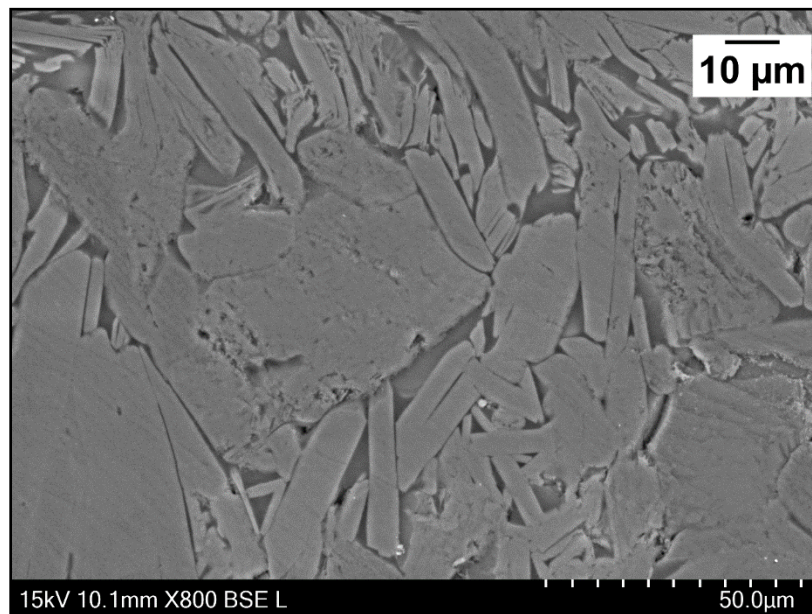
Figure 3.5 Microstructure of as-received pure hexagonal BN.

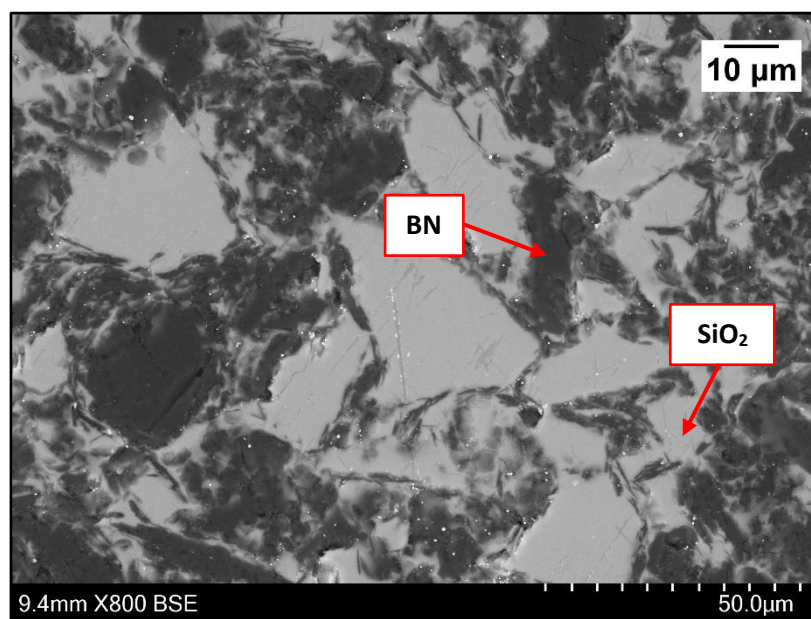
Figure 3.6 Microstructure of as-received BN Grade M26.

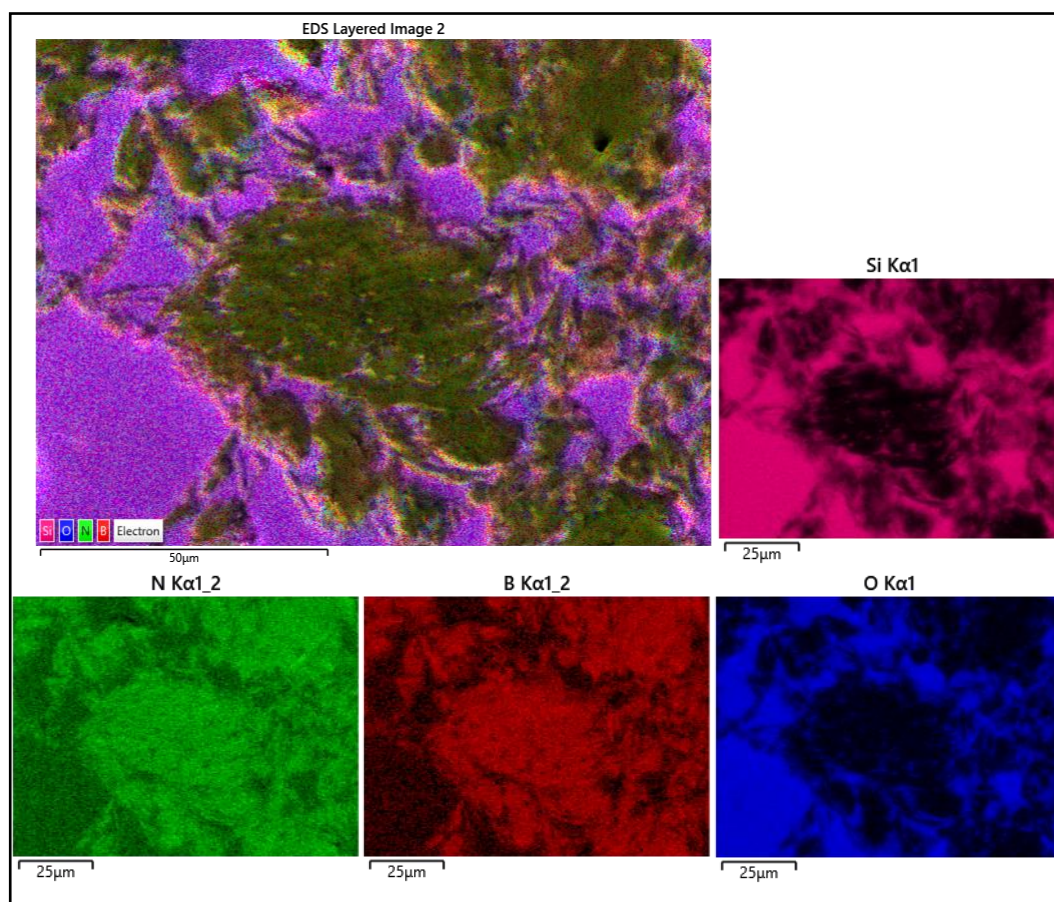
Figure 3.7 EDS maps of as-received BN grade M26.

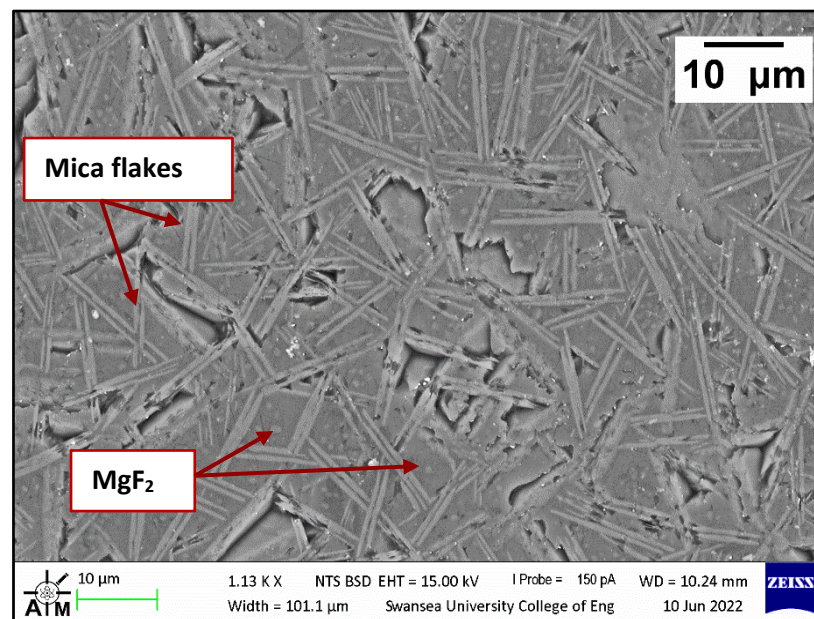
Figure 3. 8 Microstructure of as-received Macor[®] Machinable Glass Ceramic.

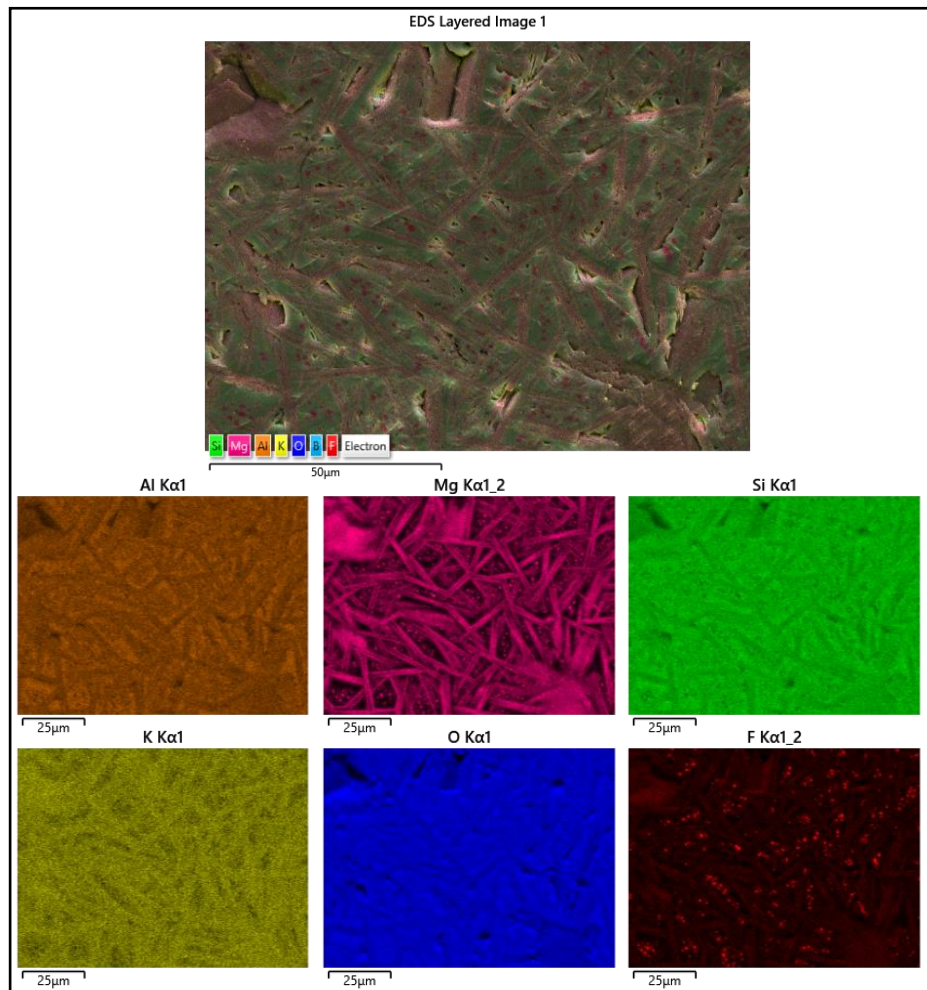
Figure 3.9 EDS maps of as-received Macor® Machinable Glass Ceramic.

Macor[®] is a machinable glass ceramic containing 55% fluorophlogopite ($\text{KMg}_3\text{AlSi}_3\text{O}_{10}\text{F}_2$) mica and 45% borosilicate glass (Eiceman et al., 2013). The microstructure of the as-received Macor[®] specimen is found in Figure 3.8. The SEM image shows the presence of randomly-oriented flakes embedded in a glass matrix. This type of structure is typically referred to as ‘house of cards’ microstructure and it makes the material machinable by means of conventional tooling (Henry et al., 2018). In addition to this, the SEM image shows the presence of areas free from flakes or laths. EDS maps (Figure 3.9) confirm that the fluorophlogopite mica flakes are rich in Mg and are surrounded by the glass matrix; however, the mica free areas are found to have the same composition of the flakes, and for this reason, it is likely they are chunks of fluorophlogopite rather than mica free regions. Moreover, it was observed from Figure 3.8 that a spheroidal phase was present and the results of EDS showed that this phase was rich in Mg and F, suggesting that it was spheroidal magnesium fluoride (Figure 3.9).

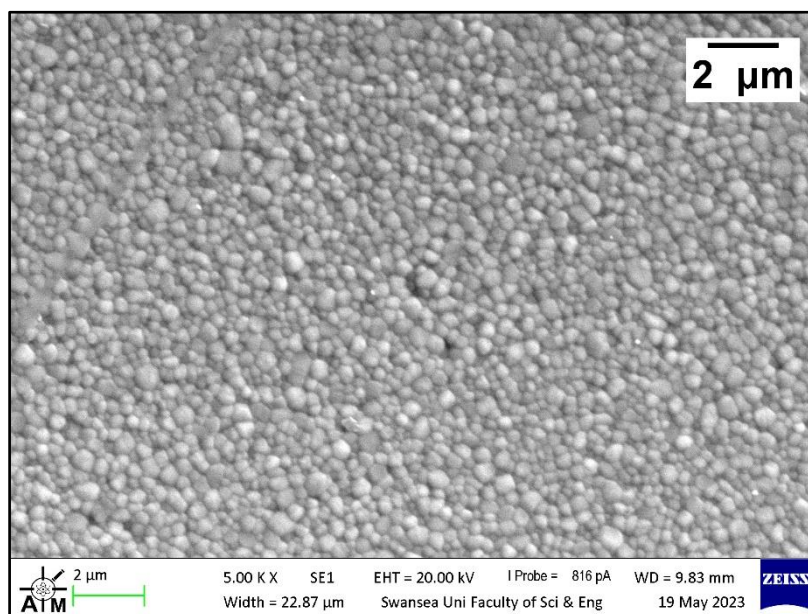
Figure 3.12 SEM image of the microstructure of as-received 3YSZ after thermal etching.

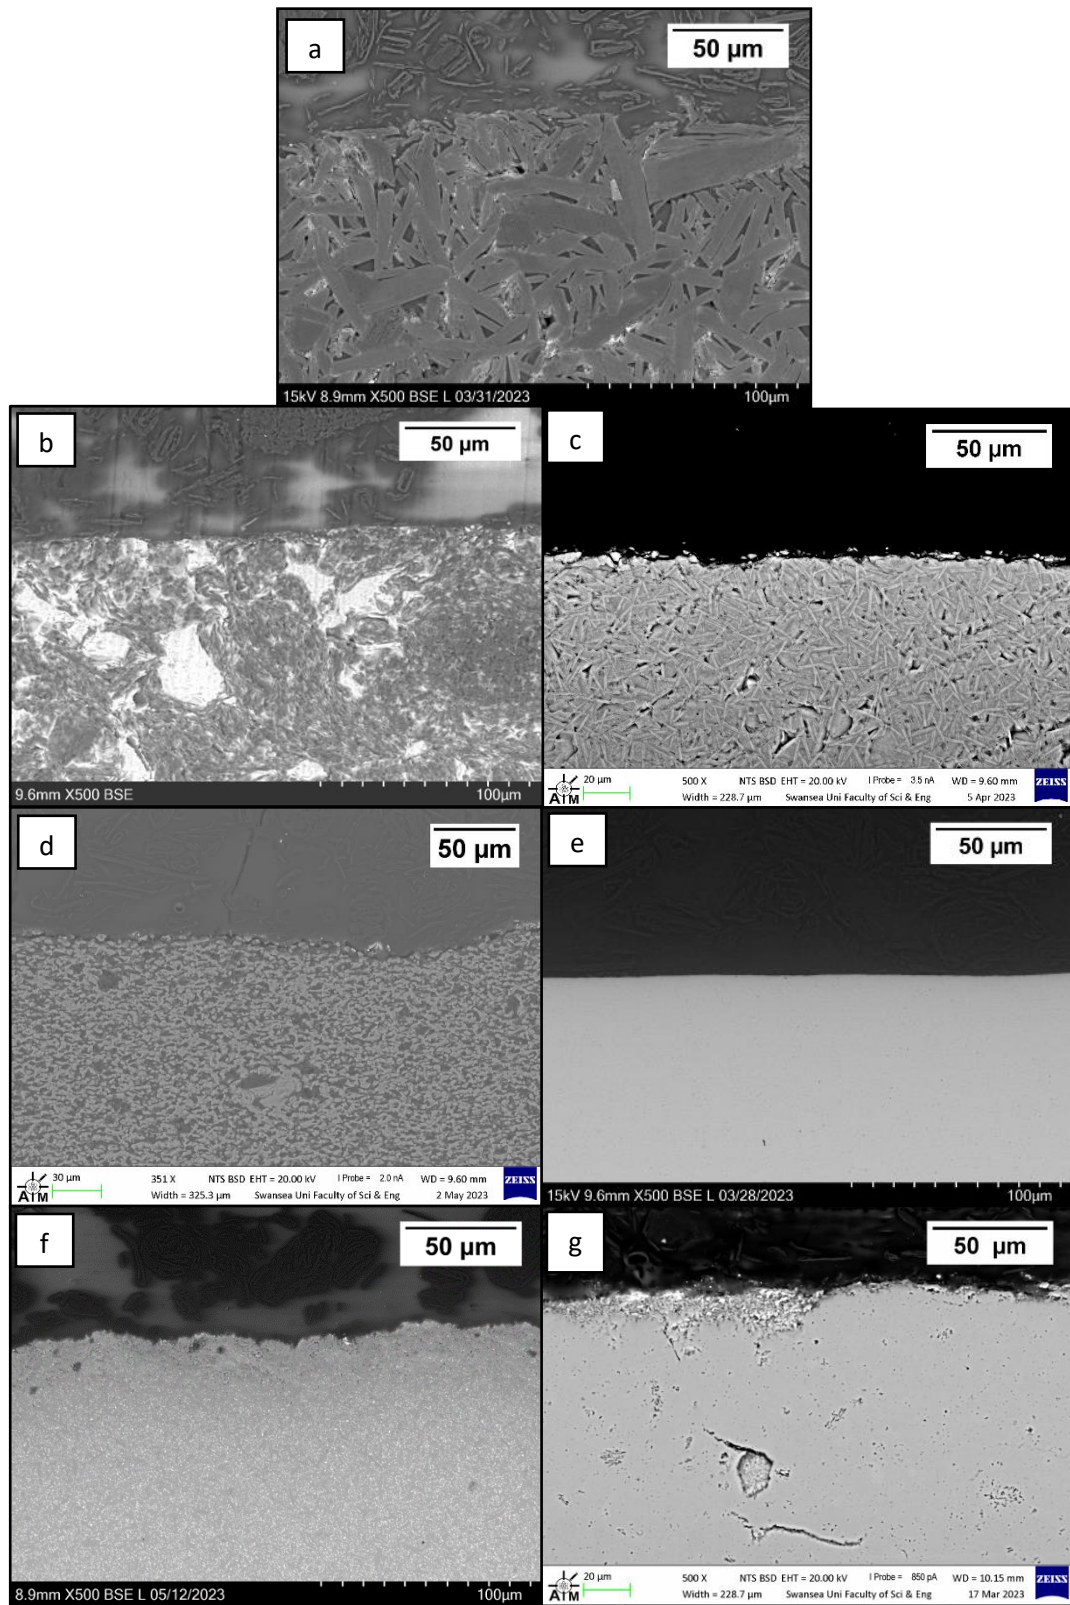
Figure 3.25 SEM cross-sections of the ceramic specimens hBN (a), BN Grade M26 (b), Macor® (c), AlN-BN (d), 3YSZ (e), Si₃N₄ (f) and Al₂O₃ (g) after immersion in Zn-Al.

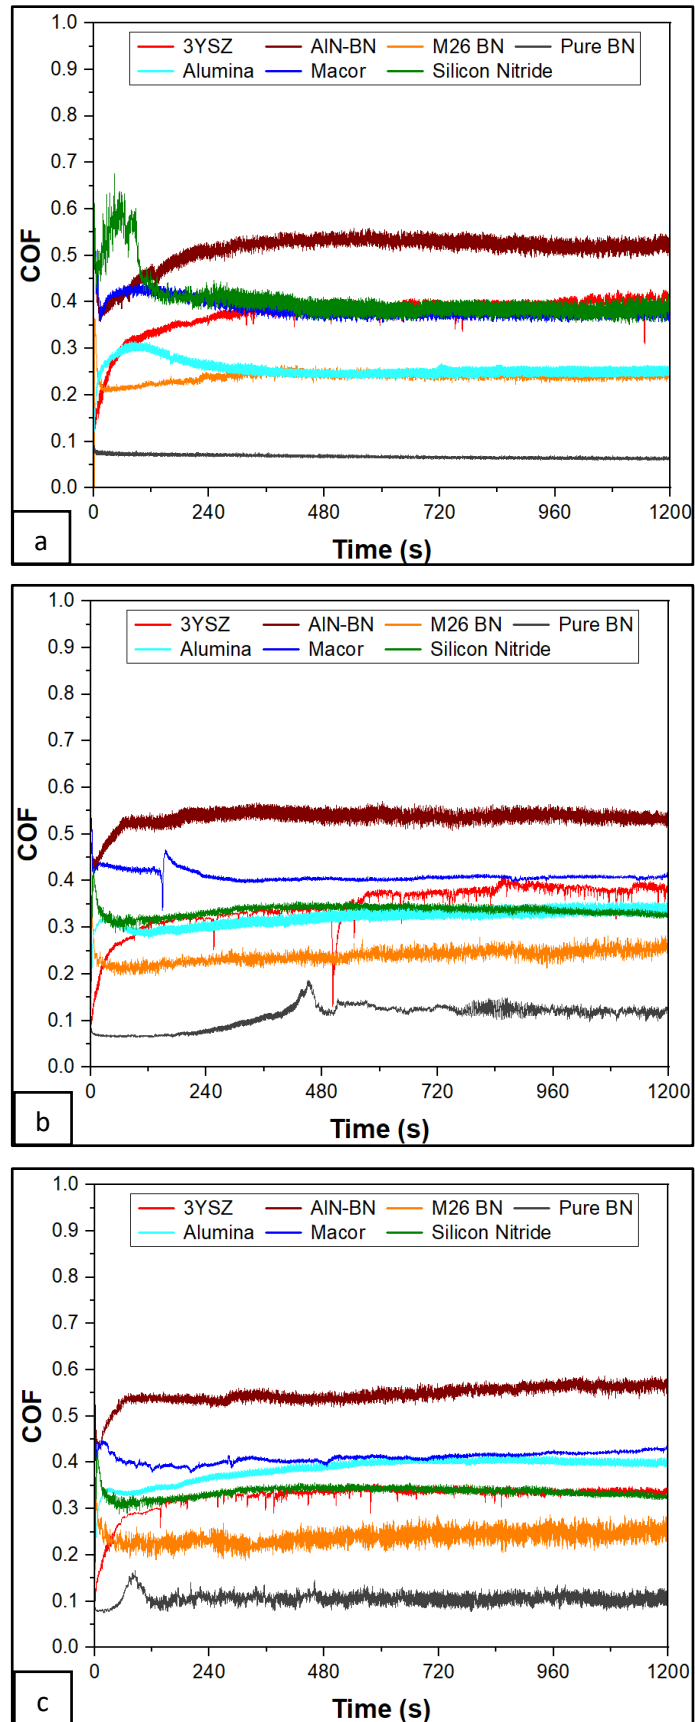
Figure 3.32 COF curves for the tests performed at 3.14 m/min (a), 6.28 m/min (b) and 9.42 m/min (c).

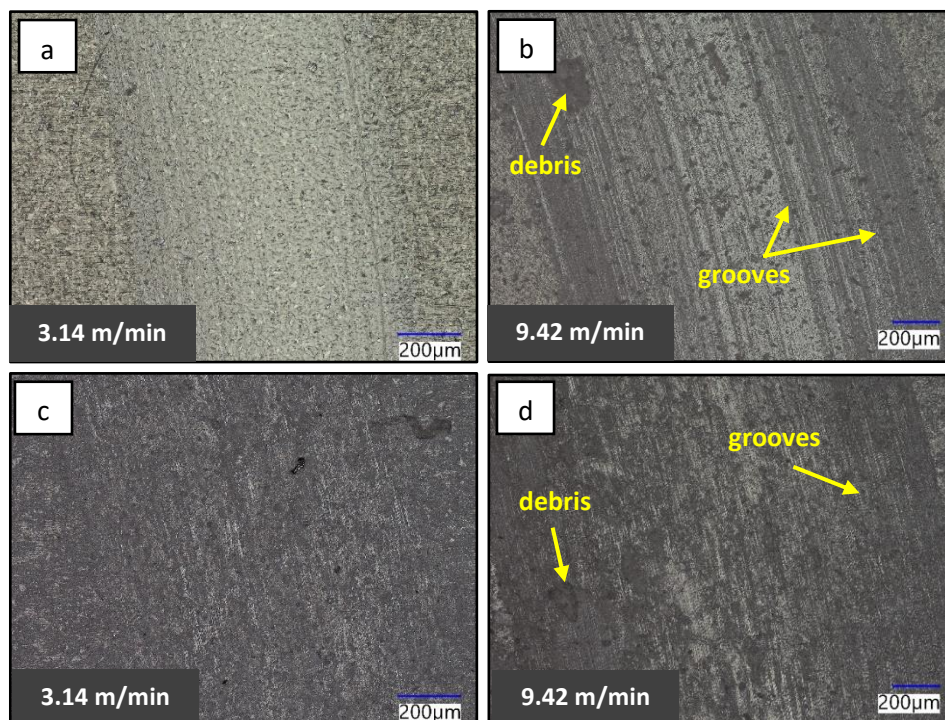
Figure 3.35 Optical images of the wear scars of pure hBN at 3.14 m/min (a), pure hBN at 9.42 m/min (b), BN M26 at 3.14 m/min (c) and BN M26 at 9.42 m/min (d).

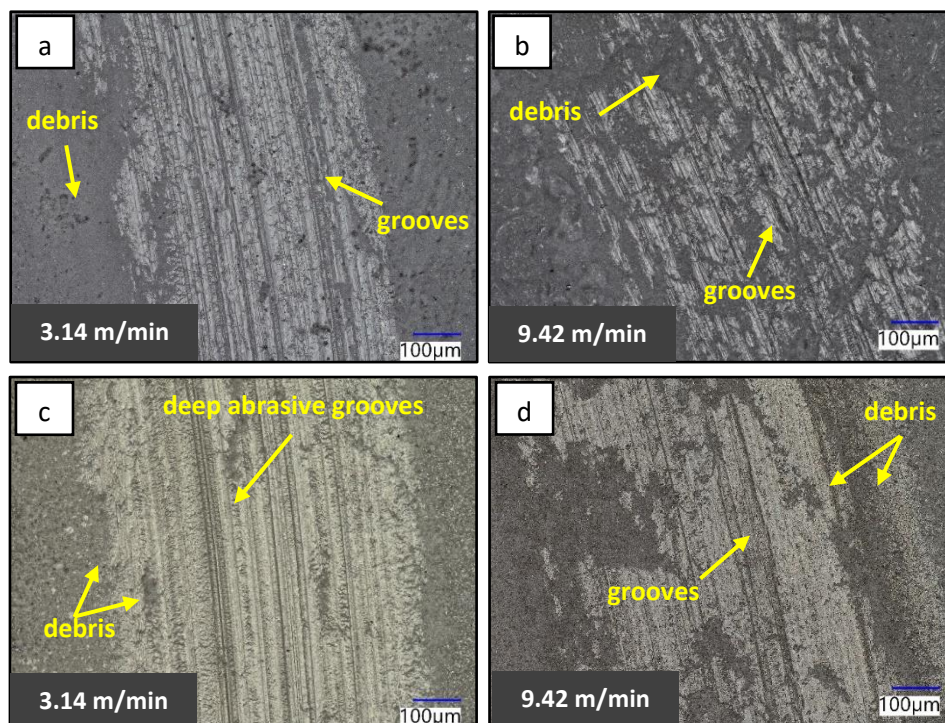
Figure 3.36 Optical images of the wear scars of Macor® at 3.14 m/min (a), Macor® at 9.42 m/min (b), AlN-BN at 3.14 m/min (c) and AlN-BN at 9.42 m/min (d).

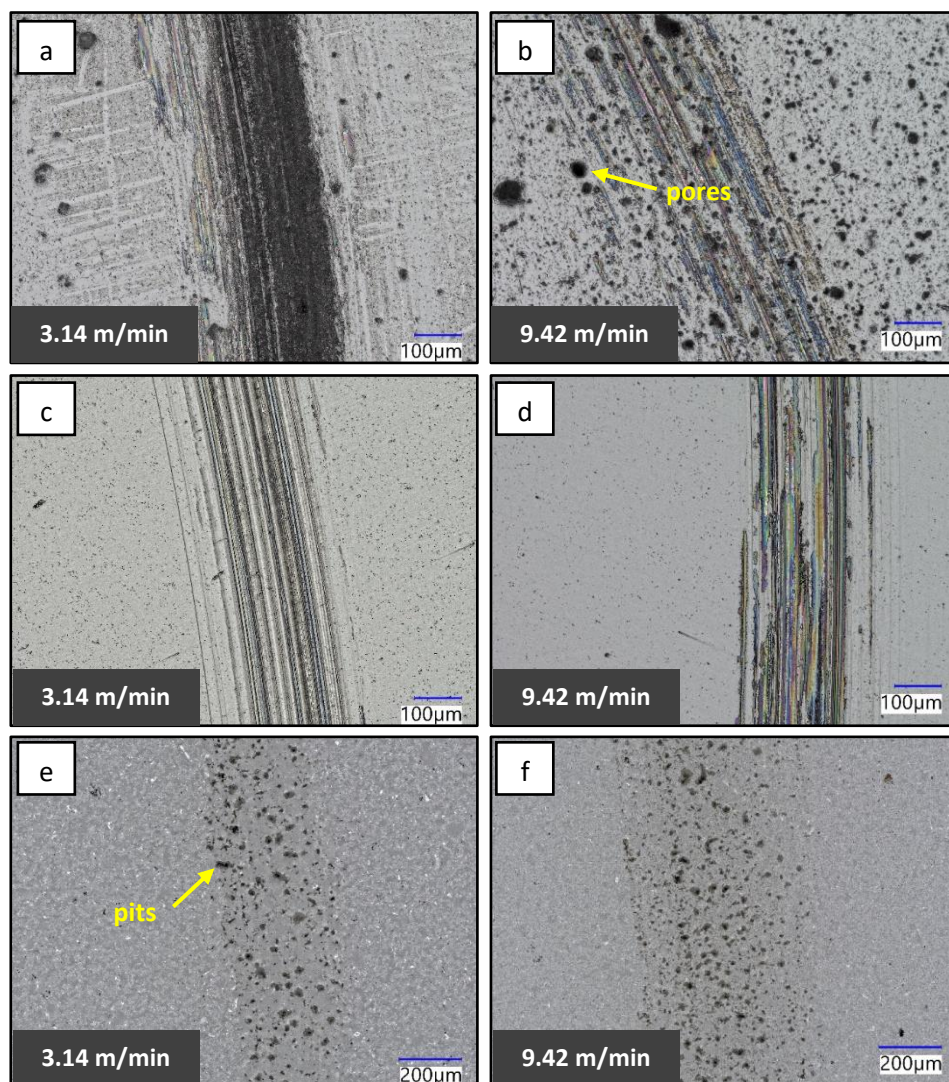
Figure 3.37 Images of the wear scars of 3YSZ at 3.14 m/min (a), 3YSZ at 9.42 m/min (b), Si_3N_4 at 3.14 m/min (c), Si_3N_4 at 9.42 m/min (d), Al_2O_3 at 3.14 m/min (e) and Al_2O_3 at 9.42 m/min (f).

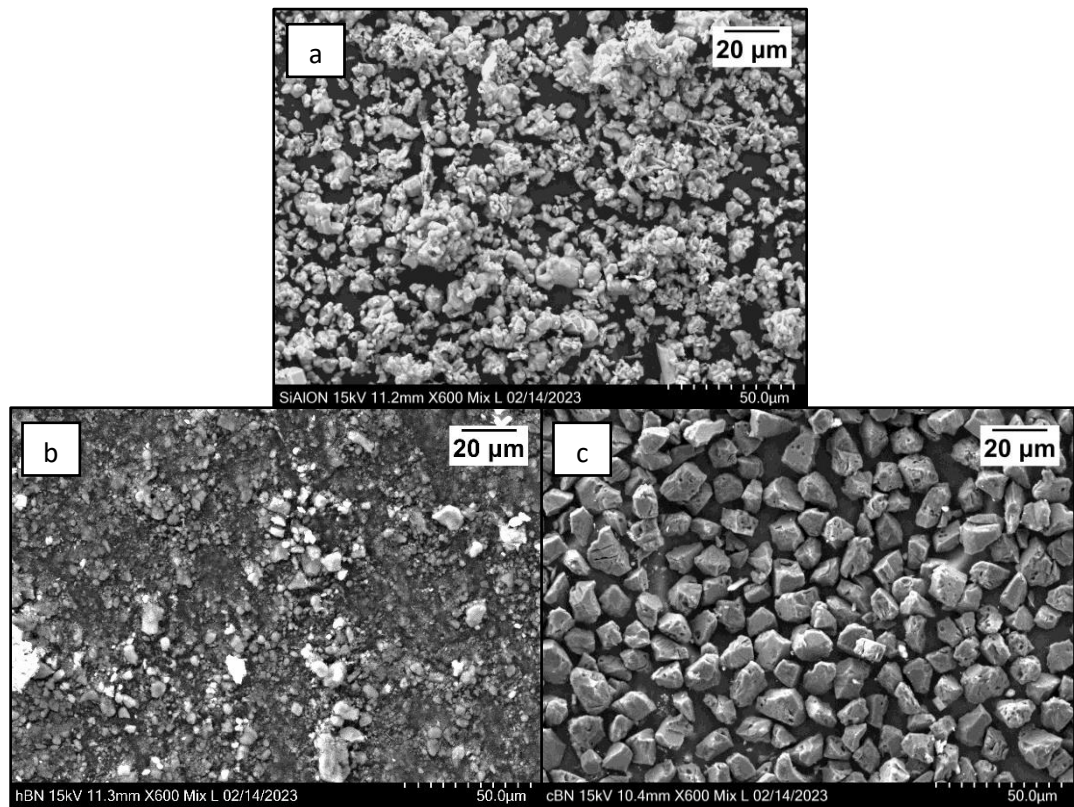
Figure 4.1 SEM images of SiAlON (a), hBN (b) and cBN powder (c).

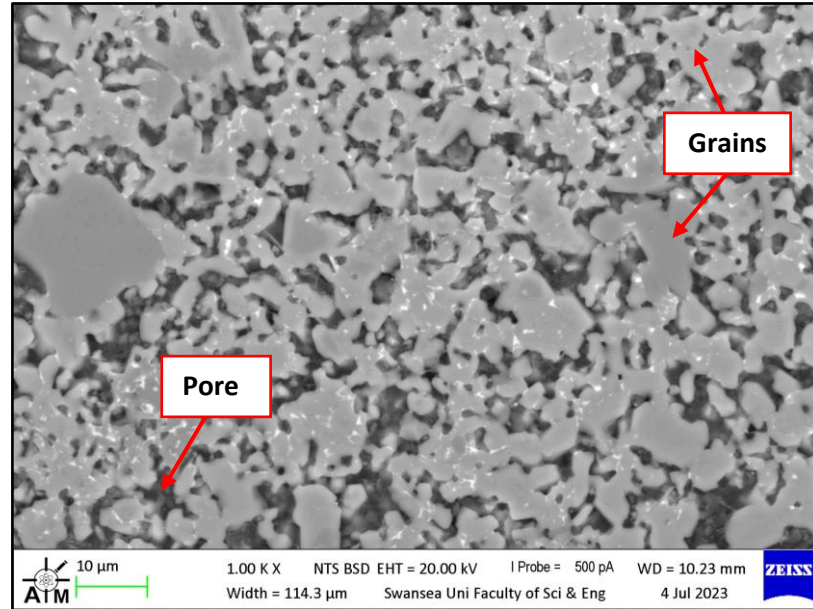
Figure 4.5 Microstructure of TRIAL1. The specimen was prepared using a dwell temperature of 1600 °C and a dwell time of 10 minutes.

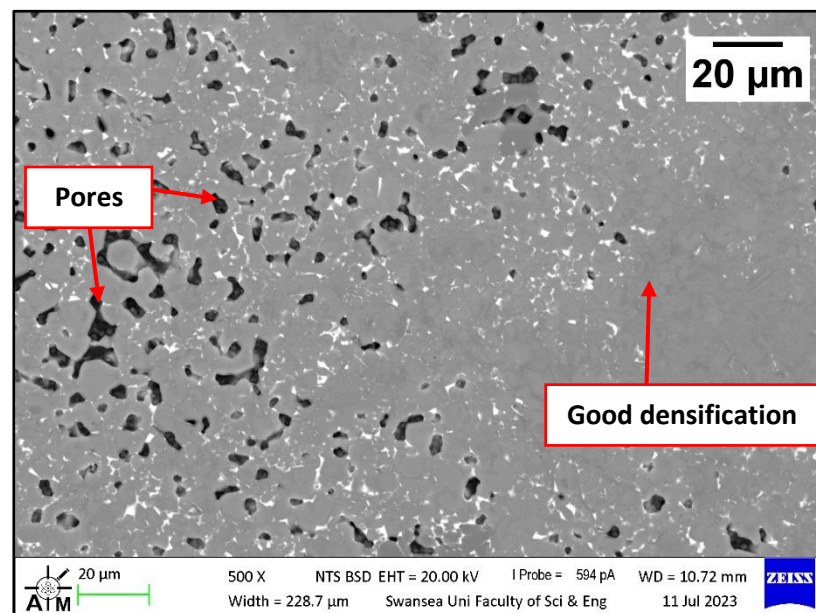
Figure 4.6 Microstructure of TRIAL2. The specimen was prepared using a dwell temperature of 1800 °C and a dwell time of 30 minutes.

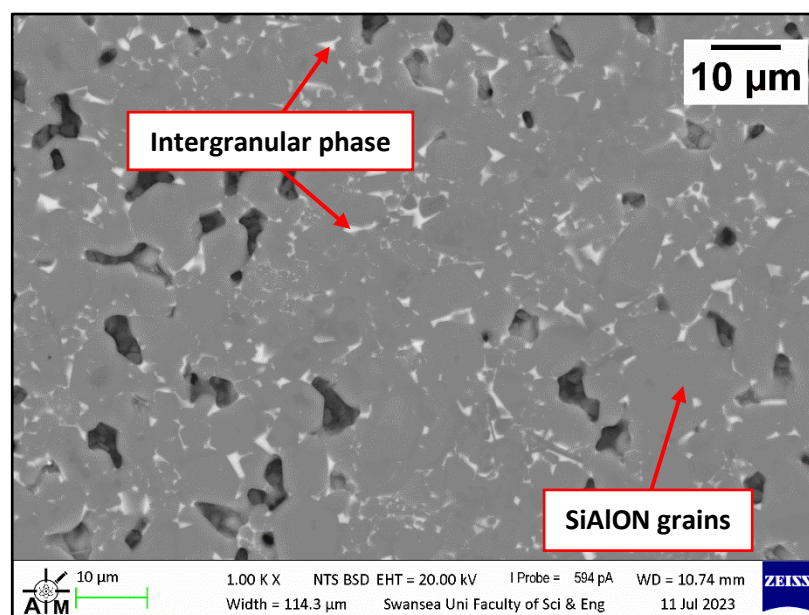
Figure 4.7 SEM image of TRIAL2, showing details of the SiAlON grains (darker contrast) separated by an intergranular phase (lighter contrast).

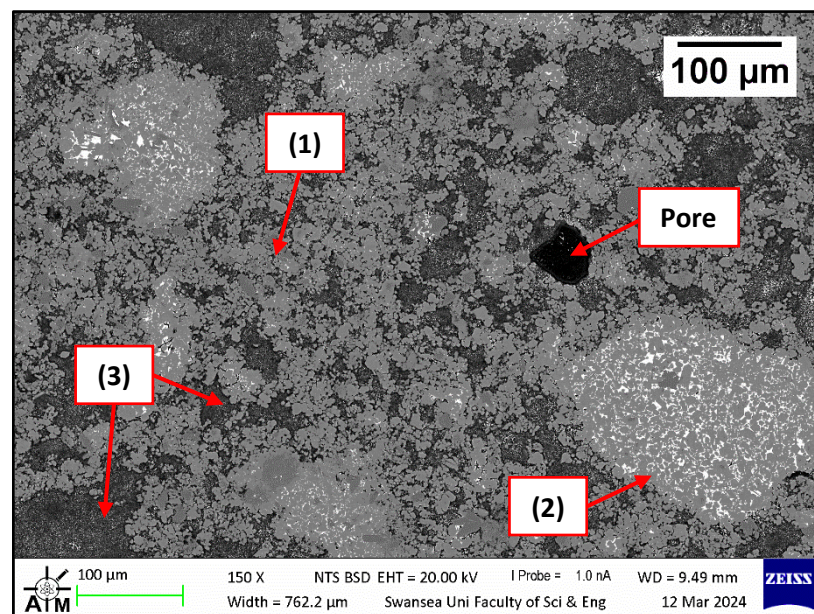
Figure 4.11 Microstructure of 30wt.%hBN-SiAlON after the addition of Y_2O_3 and Al_2O_3 sintering additives.

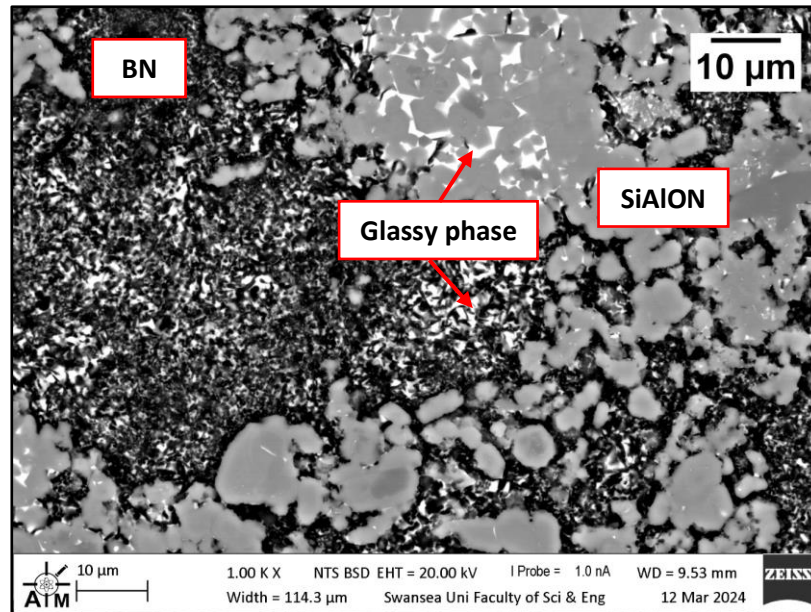
Figure 4.12 Image of the 30wt.%hBN-SiAlON microstructure.

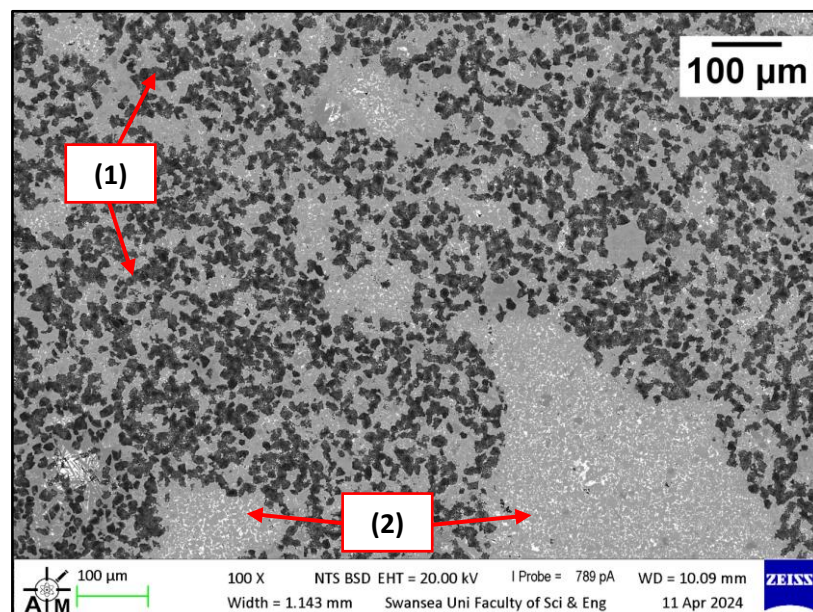
Figure 4.14 Microstructure of 30wt.%cBN-SiAlON after the addition of Y_2O_3 and Al_2O_3 sintering additives, showing BN rich (1) and SiAlON rich areas (2).

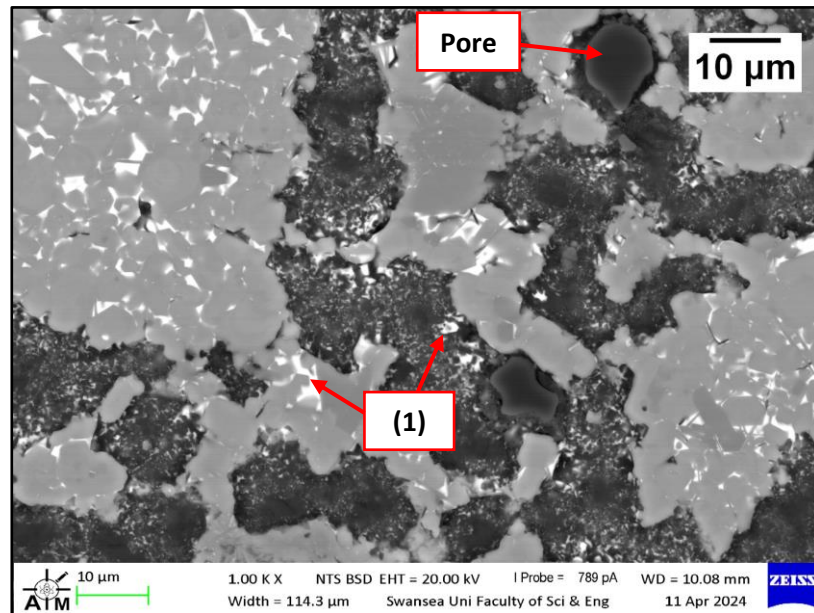
Figure 4.15 Magnified image of 30wt.%cBN-SiAlON showing details of the glassy phase (1).

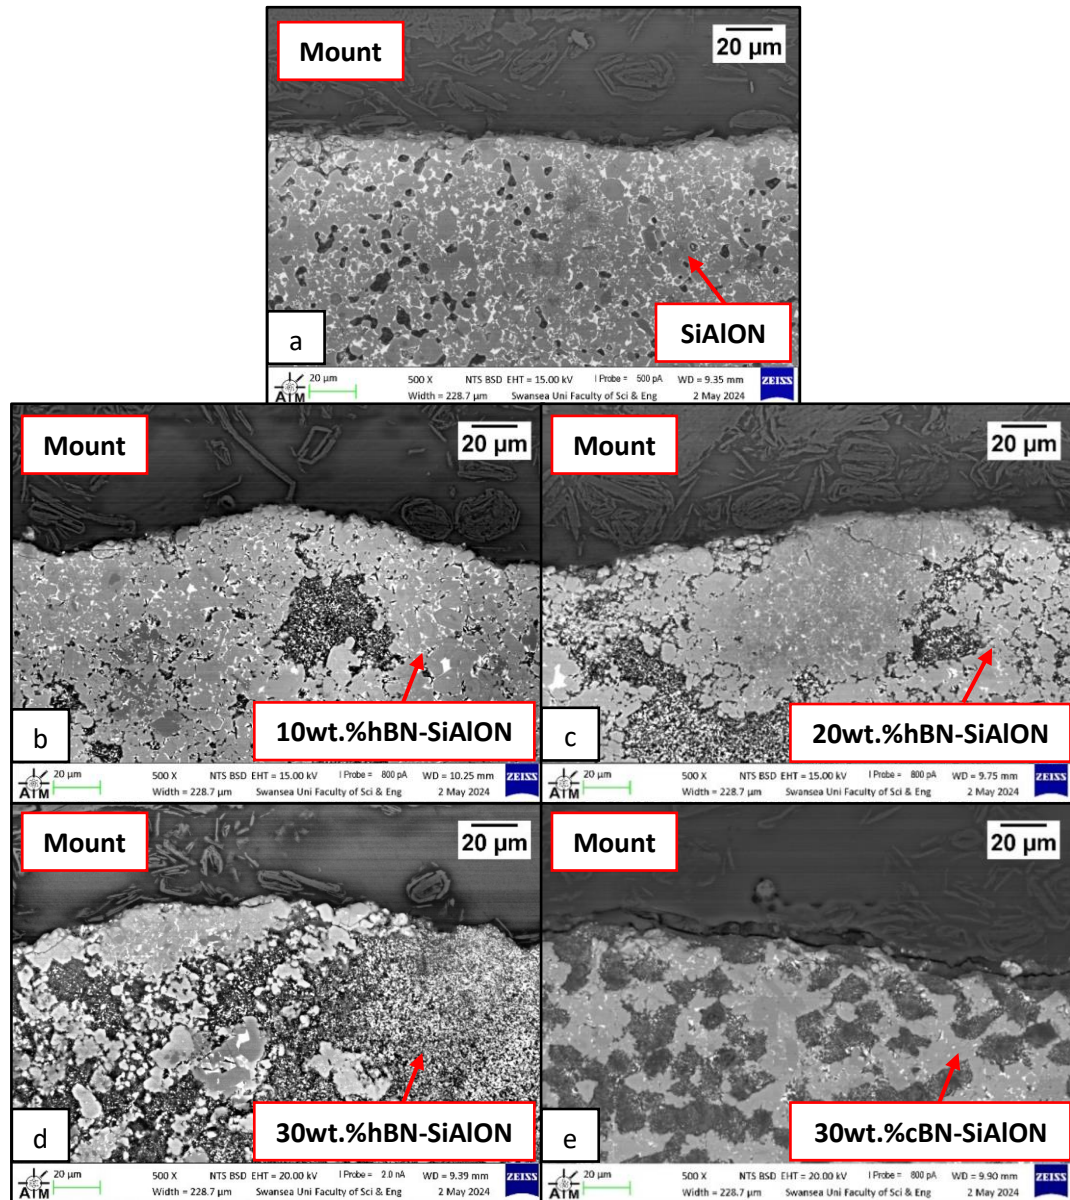
Figure 4.18 SEM cross-sections of the specimens prepared with FAST, namely SiAlON (a), 10wt.%hBN-SiAlON (b), 20wt.%hBN-SiAlON (c), 30wt.%hBN-SiAlON (d) and 30wt.%cBN-SiAlON (e), after immersion in Zn-Al.

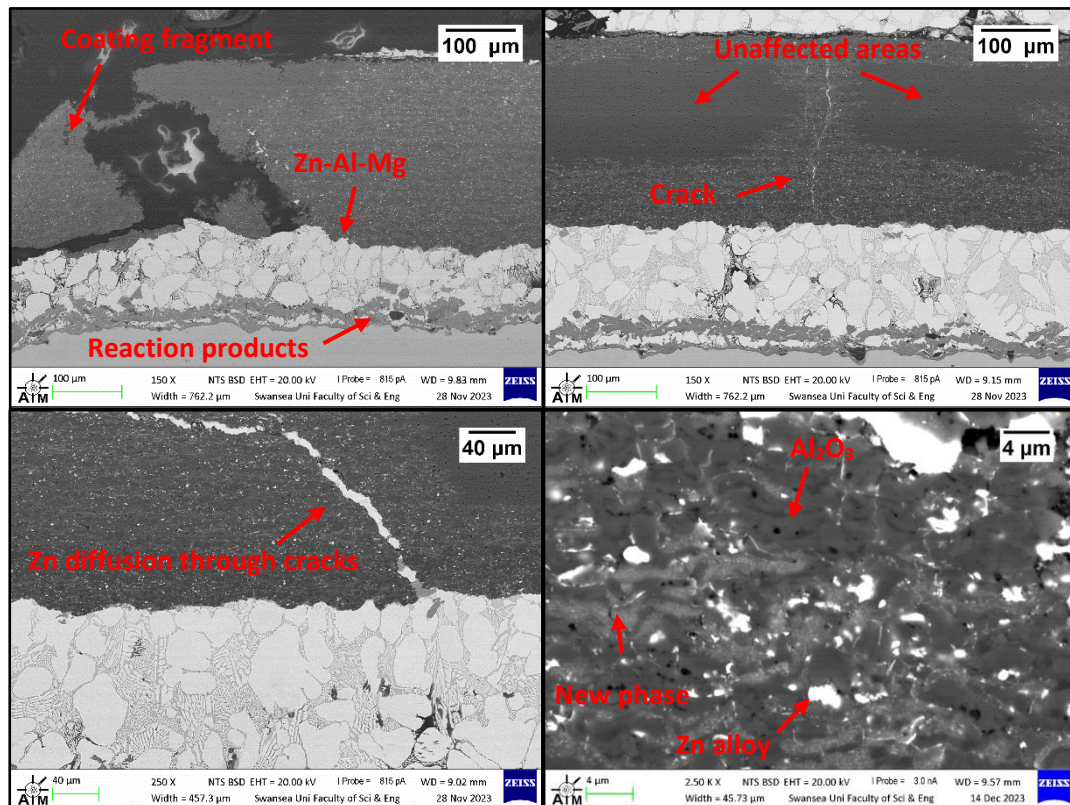
Figure 4.28 Cross-sections of the Al_2O_3 coatings after 4 weeks of immersion in Zn-Al-Mg: spallation of the coating (a); details of cracks and areas of the coating affected by degradation in molten metal (b); Zn diffusion through cracks (c); details of the three phases (d).

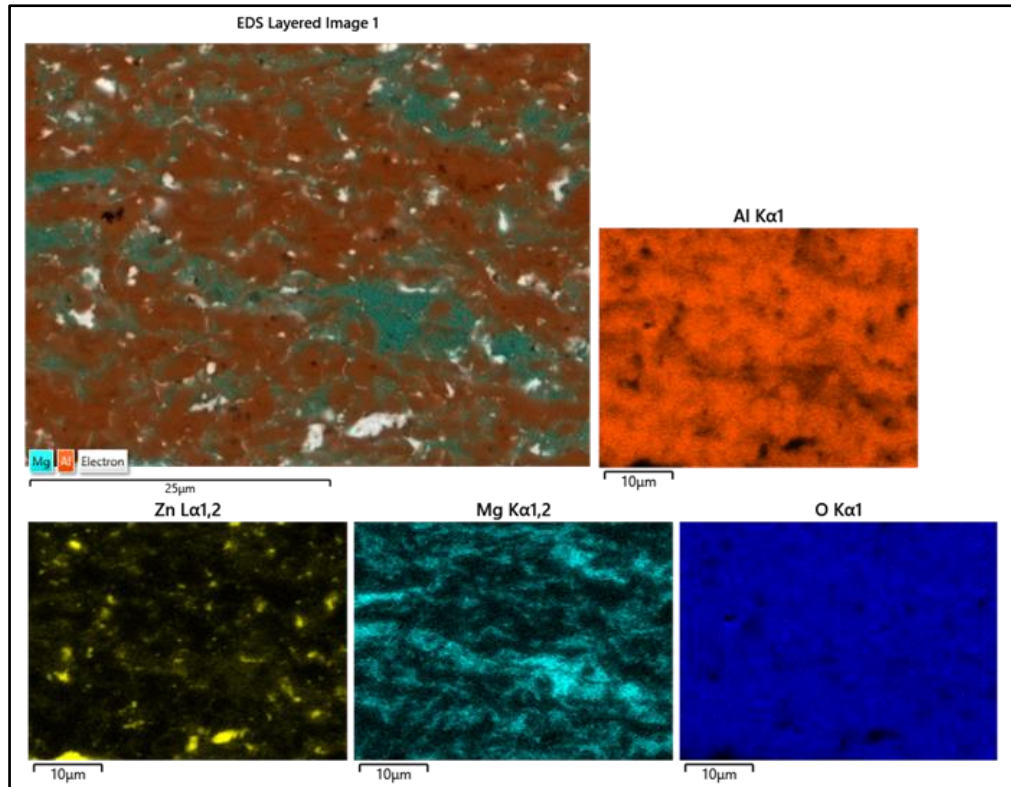
Figure 4.29 EDS maps of Al_2O_3 coating after immersion in Zn-Al-Mg.

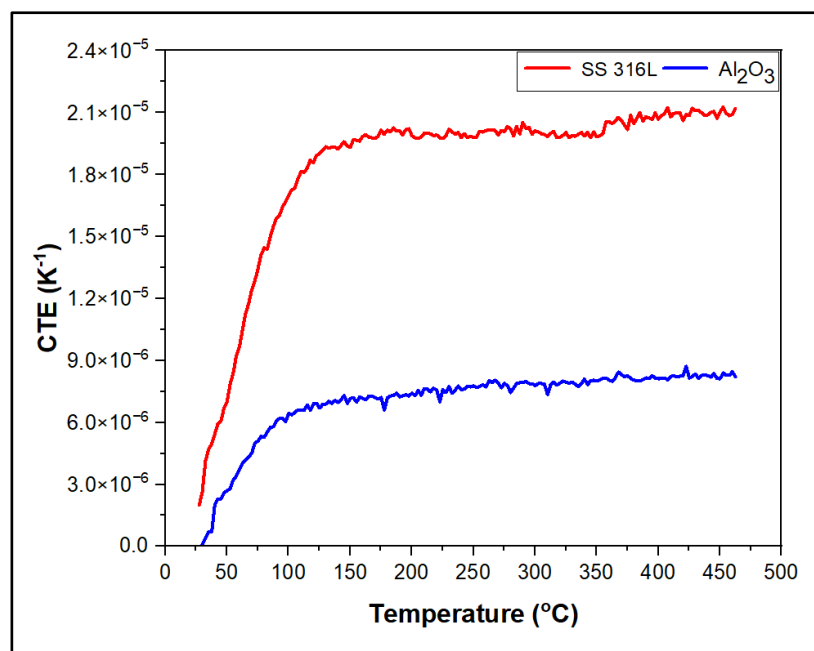
Figure 4.30 CTE of SS 316L and Al₂O₃ as a function of temperature in the range of 35–465 °C.

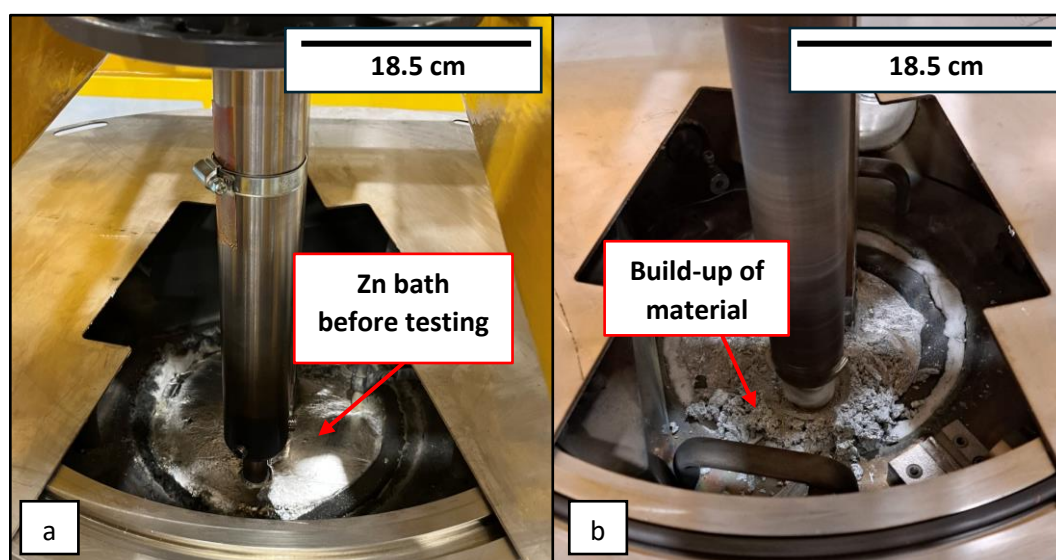
Figure 5.4 Photograph of the Zn bath before testing (a); Dross formation during testing (b).
