OPTIMISATION OF NEXT GENERATION GALVANISING POT HARDWARE

Thesis submitted to Swansea University in fulfilment of the
requirements for the Degree of Doctor of Philosophy

Swansea University, November 2024

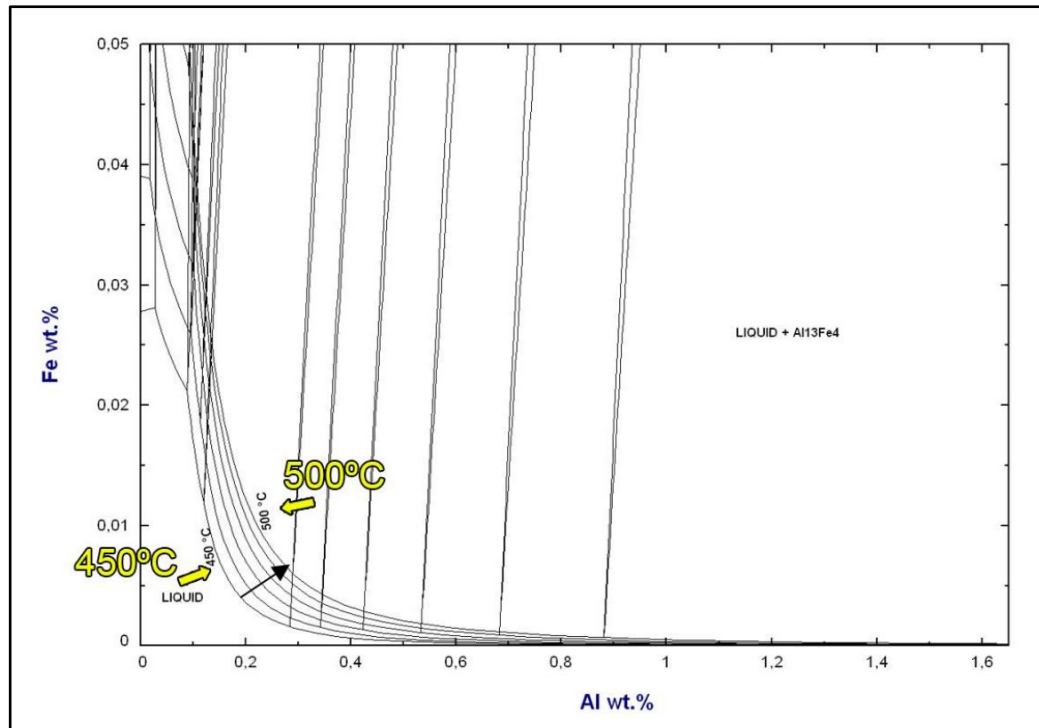
Figure 5.11 Phase diagram of the Zn-Al-Fe system at 460 °C for 1.5 wt.% Mg additions. Fe solubility lines are shown in the temperature range between 450 °C and 500 °C (Kuperus, 2018).

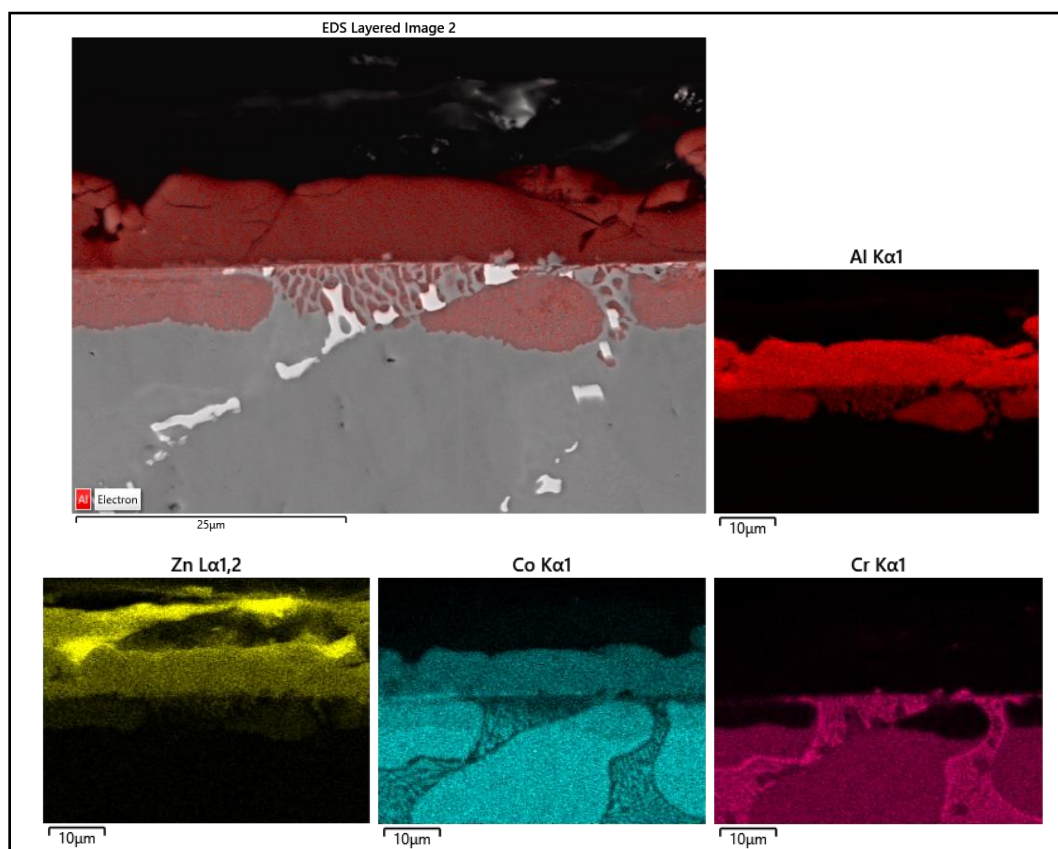
Figure 5.17 EDS mapping of the elements present in Wallex4™ after testing in Zn-Al.

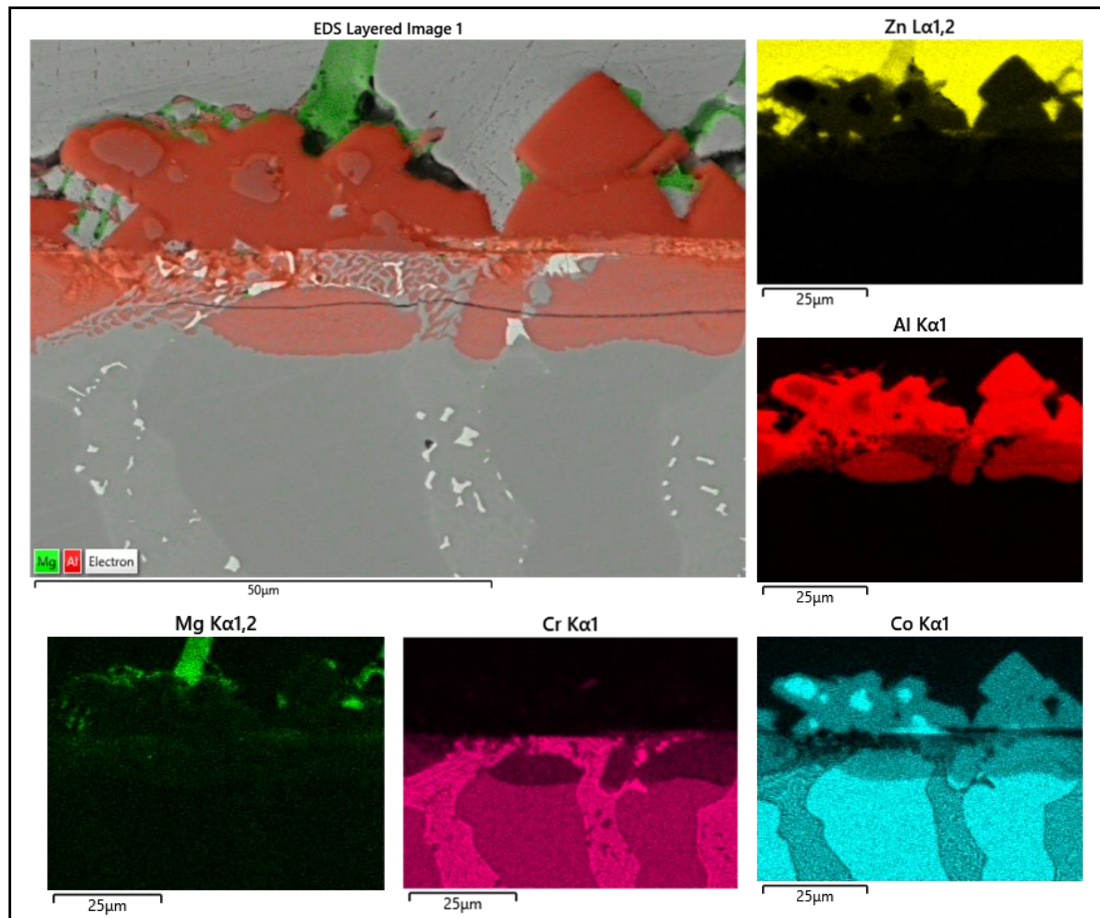
Figure 5.21 EDS mapping of the elements present in Wallex4™ after testing in Zn-Al-Mg.

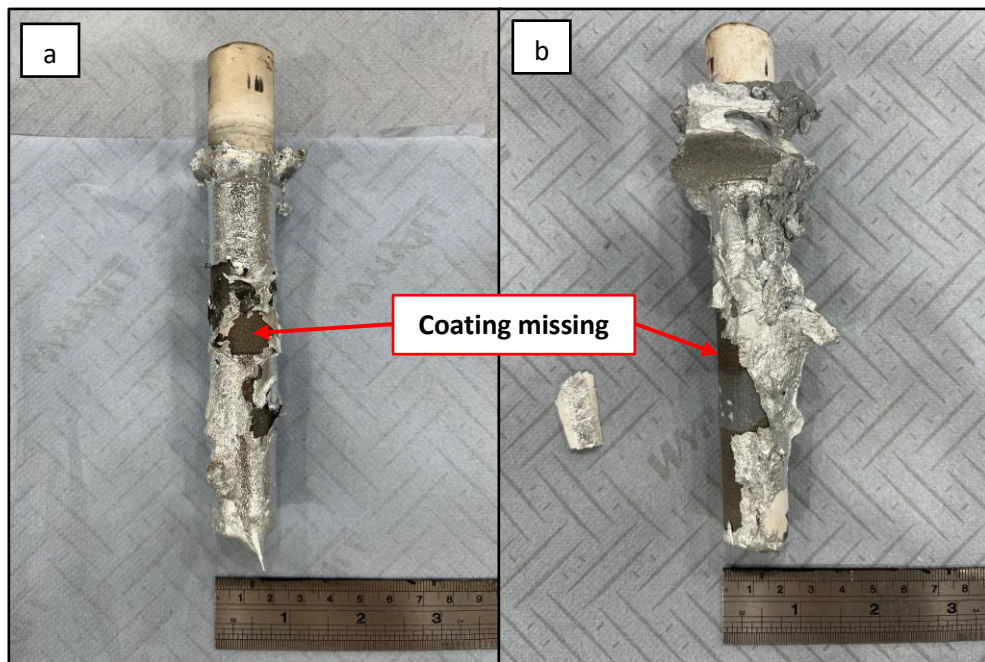
Figure 5.22 Visual inspection of the bar specimens tested in Zn-Al (a) and Zn-Al-Mg (b).

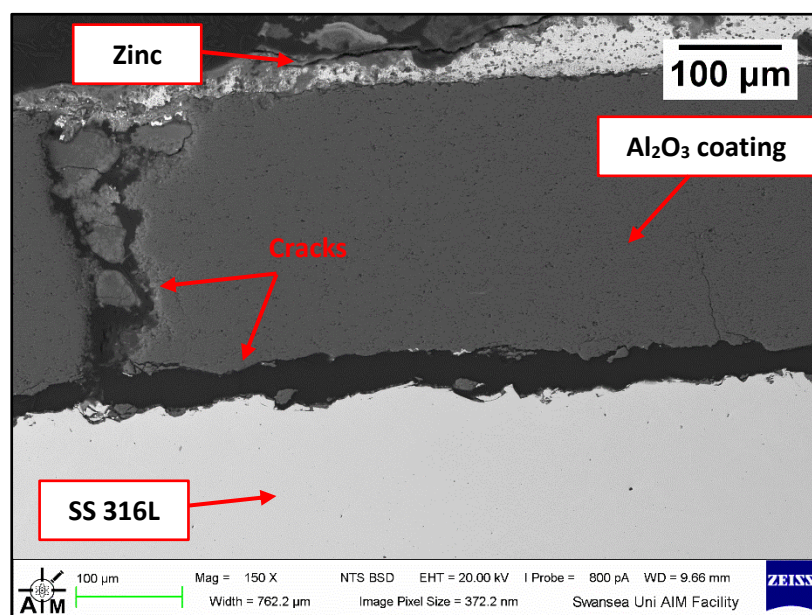
Figure 5.23 Cross-section of the Al₂O₃/SS 316L bar after dynamic testing in Zn-Al.

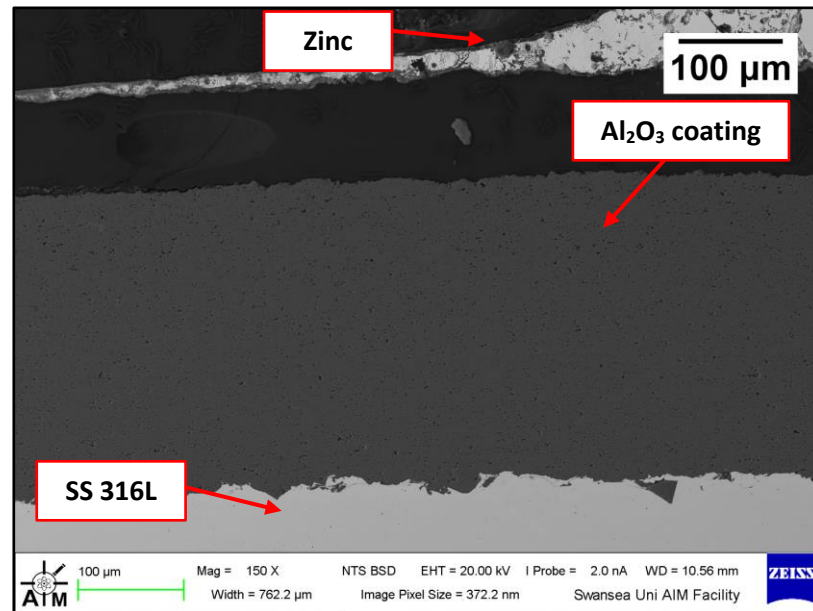
Figure 5.26 Cross-section of Al_2O_3 /SS 316L bar after dynamic testing in Zn-Al-Mg.

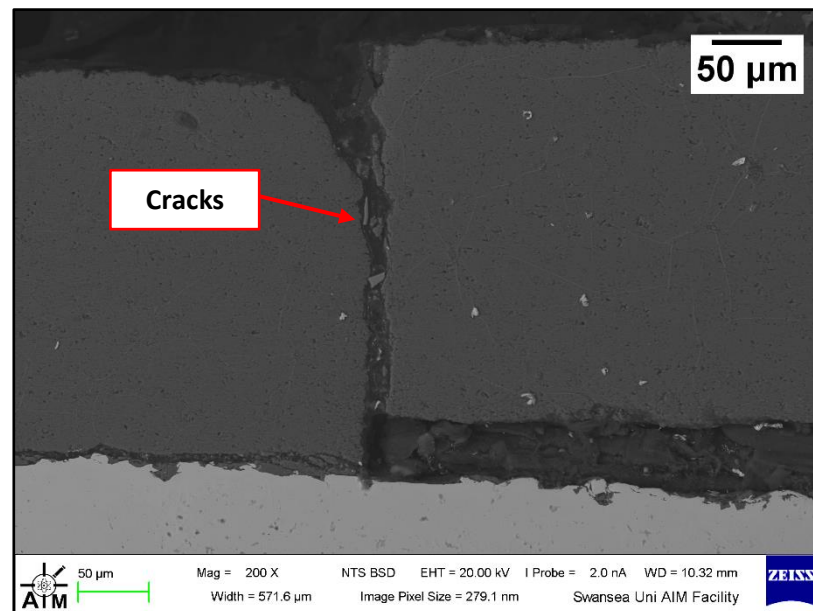
Figure 5.27 Cracks within the Al_2O_3 coating after dynamic testing in Zn-Al-Mg.
