Berry, L., Phillips, C. & Penney, D. (2016). Understanding the role of snout contamination in the formation of an oxide based defect in hot dip galvanised coating. *Surface and Coatings Technology*

Understanding the role of snout contamination in the formation of an oxide based defect in hot dip galvanised coating

Lewis J. Berry, Craig H. Phillips, David J. Penney

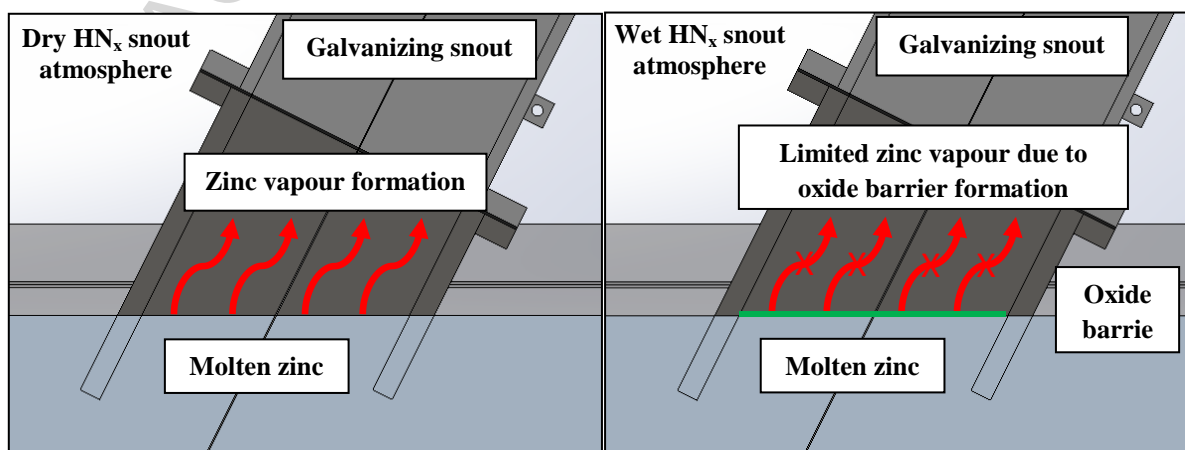
oxides can themselves induce coating quality issues. If the zinc oxide barrier layer within the snout becomes unstable, zinc oxide particles break away and become entrained within the coating through the action of the rapidly moving steel strip, as shown in Fig. 1b. It is therefore necessary to control the size and thickness of the zinc oxide layer through the use of extraction techniques that remove the zinc and a portion of the oxide barrier layer from within the snout. The use of pumps in the continuous removal of surface oxides formed produced through the introduction of wet HNx atmospheres was introduced by Becherer [11] and resulted in the elimination of zinc dust related defects. The Push/Pull surface cleanliness system was optimised by Phillips et al [12] utilizing water modelling to discern optimum settings for the removal of surface contamination. However, the use of a centrifugal snout pump Push/Pull type configuration can cause turbulence within the snout leading to interactions between the strip surface and the oxide layer, and as such new on line industrial techniques have been designed to continuously remove the surface dross layer [13].

Figure 1 – Schematic of the Continuous galvanizing line snout indicating the relationship between a dry & wet HNx atmosphere & the formation of Zn vapour

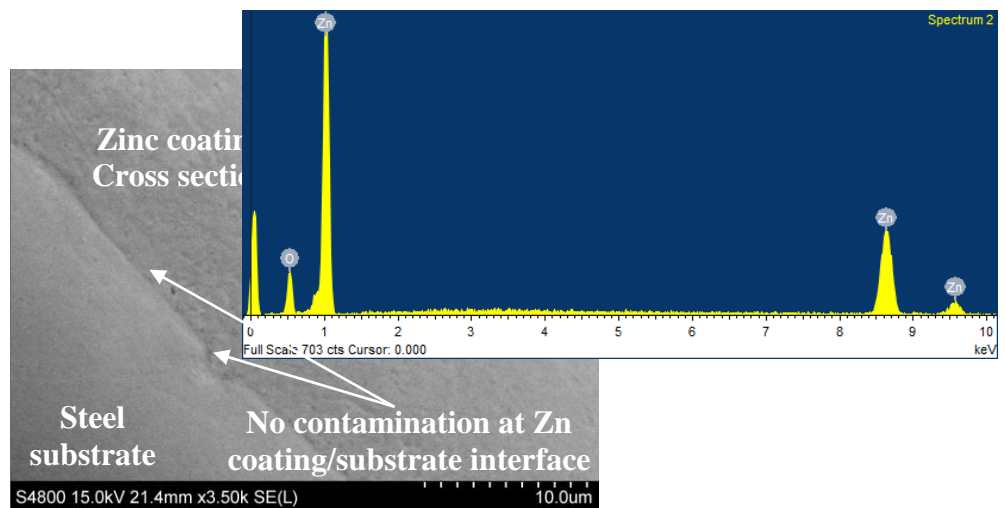
In order to discern root cause of the arrowhead, defective and non-defective material were cross sectioned and polished to a 0.3 $\mu\text{m}$  finish before being subjected to SEM/EDX analysis. The substrate / Zn coating interface regions of non-defective material, Fig. 7, and arrowhead defective material, Fig. 7, were compared. Contamination at the interface between the substrate and Zn coating was clearly observed within the defective samples but not within the non-defective samples. EDX analysis of the contamination indicated regions of high concentrations of zinc and oxygen. The presence of zinc and oxygen containing species adjacent to the expected position of the  $\text{Fe}_2\text{Al}_5$  interfacial layer suggests the entrainment of surface oxides from inside the snout. Previous instances of oxide containing defective coatings were investigated by Vlot [19] but associated with the entrainment of oxidized zinc vapour as opposed to the entrainment of zinc oxide material from the bath surface. No appreciable amount of aluminium was observed suggesting the formation of a ZnO barrier layer rather than  $\text{ZnAl}_2\text{O}_4$ , both of which would be possible given the typical dew point of injected wet  $\text{HNx}$  systems during galvanizing.

Figure 7 – SEM image of GI Full Finish steel cross section highlighting a contamination free  $\text{Fe}_2\text{Al}_5$  interfacial layer

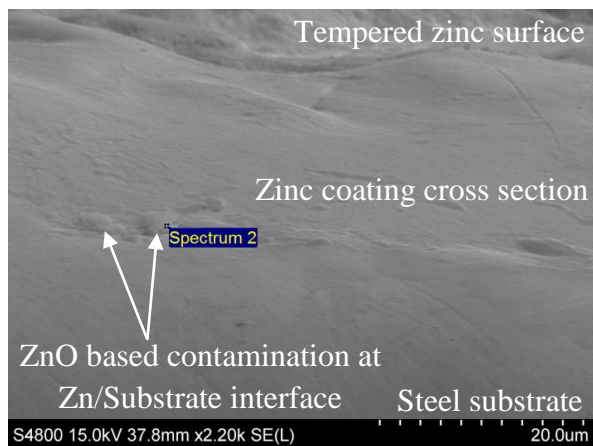
Figure 8 – SEM image of GI Full Finish steel cross section/EDX spectra highlighting the presence of oxide based contamination relative to Zn coating/substrate interface

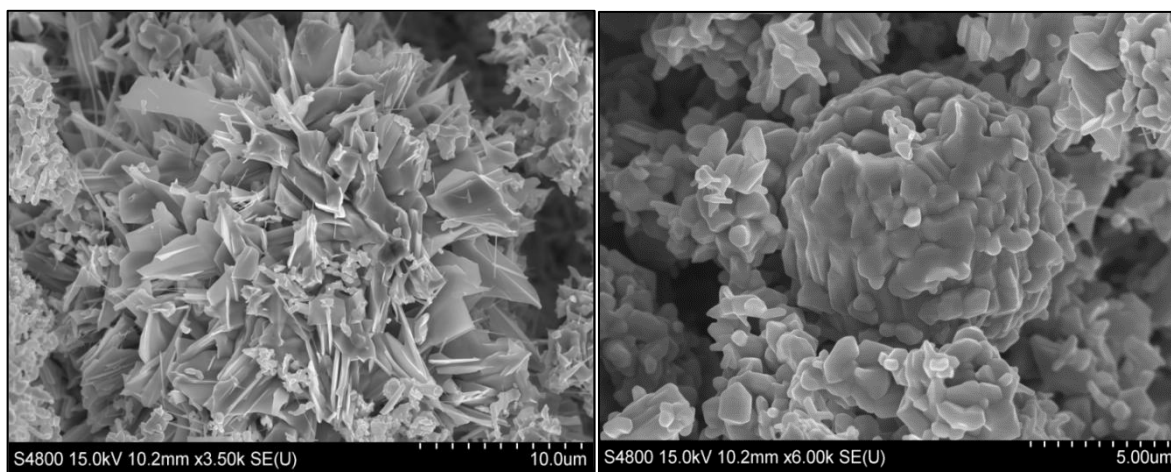
Figure 14 – SEM image of complex morphologies comprising white snout surface oxide produced on a molten zinc surface through the injection of wet  $\text{HN}_x$

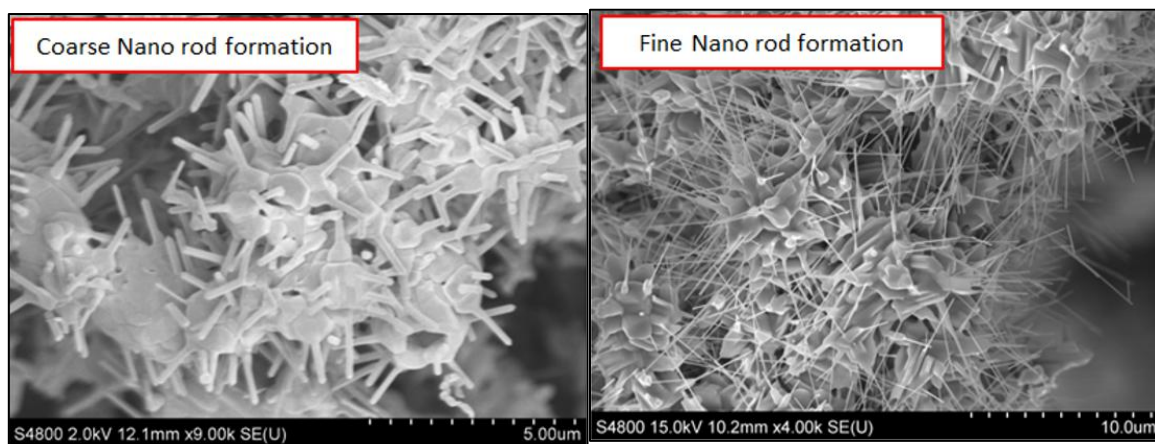
Figure 16 – SEM image of ZnO based coarse and fine nanorods formed through injection of wet  $\text{HN}_x$
