Neris, J., Santamarta, J., Doerr, S., Prieto, F., Agulló-Pérez, J. & García-Villegas, P. (2016). Post-fire soil hydrology, water erosion and restoration strategies in Andosols: a review of evidence from the Canary Islands (Spain). *iForest - Biogeosciences and Forestry*, 9(4), 583-592.
<http://dx.doi.org/10.3832/ifer1605-008>

Post-fire soil hydrology, water erosion and restoration strategies in Andosols: a review of evidence from the Canary Islands (Spain)

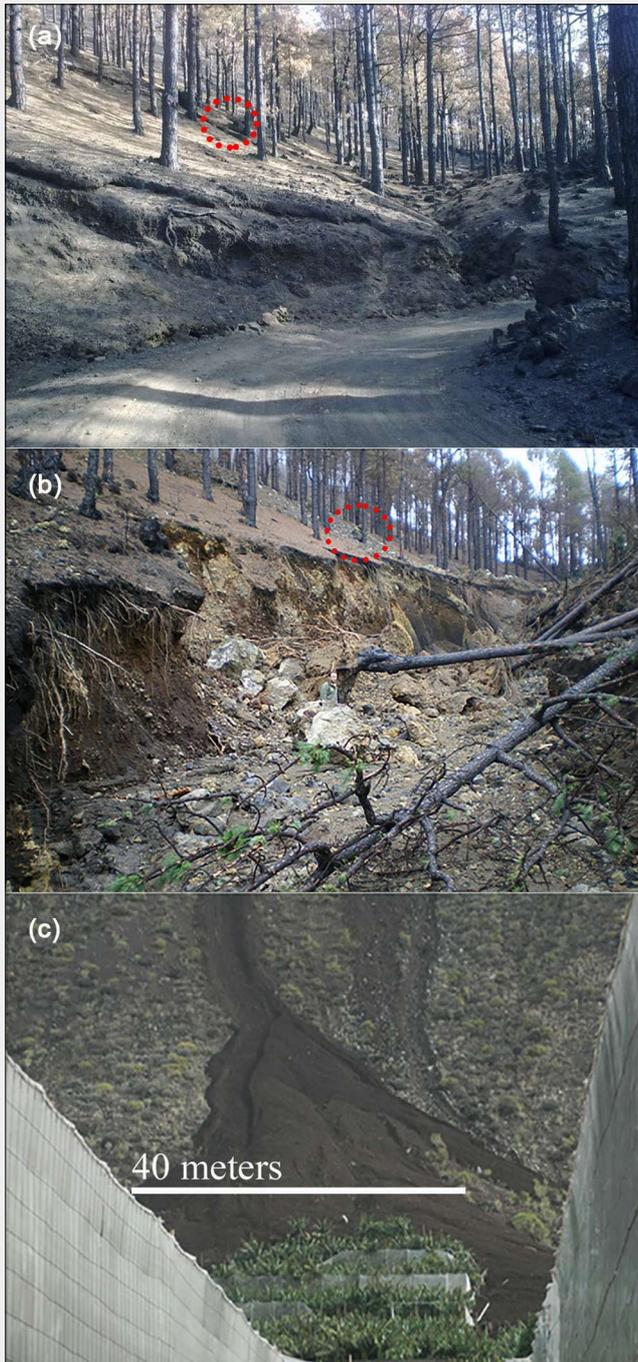
Fig. 2 - Landslides after the forest fire in La Palma (2009). Forest road before (a) and after (b) the torrential rains and subsequent landslides in 2009. Sediment deposition after the landslide affecting banana crops near the southern coastline of La Palma (c).

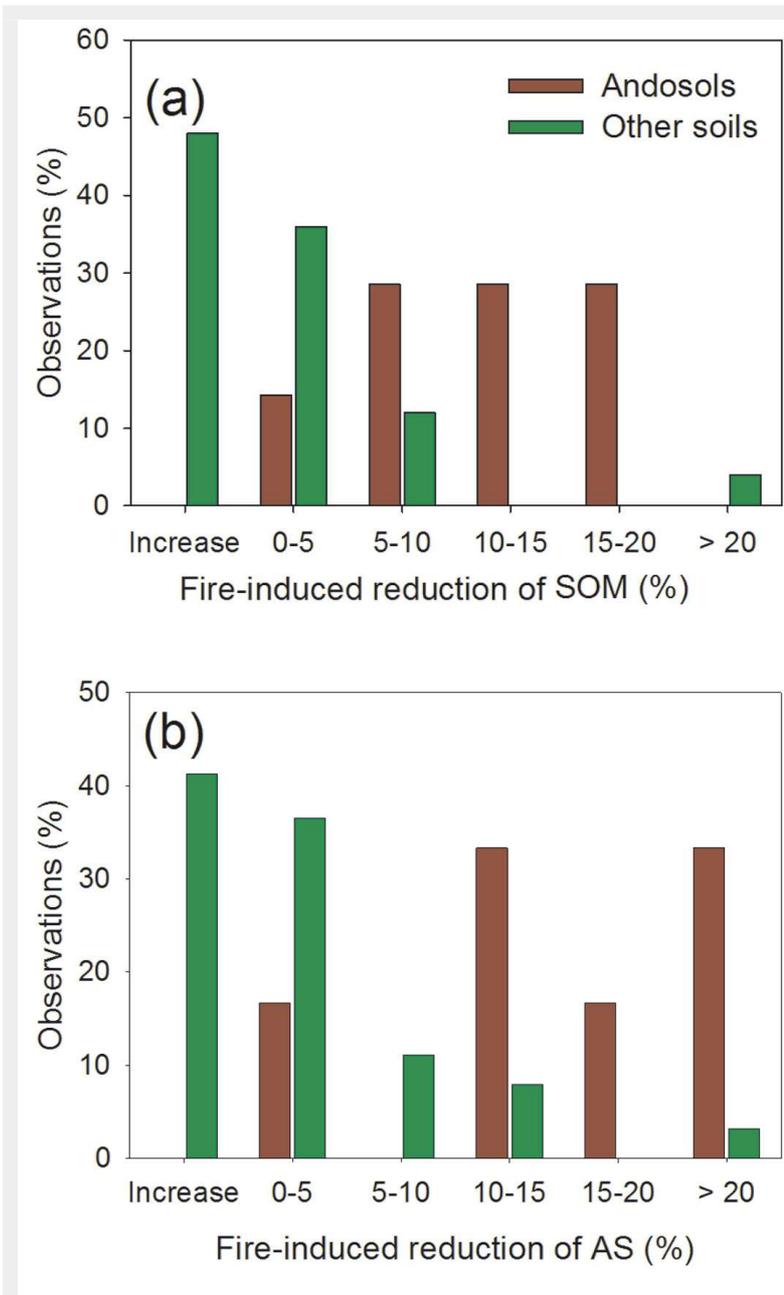
Fig. 4 - Comparison of the impact of fire on key soil properties in Andosols (red) and other soil types (green). Distribution of results reporting fire-induced reduction/increase in (a) soil organic matter (SOM: %) and (b) aggregate stability (AS: %) for Andosols (N = 7 for SOM and N = 6 for AS) and other soil types (N = 25 for SOM and N = 63 for AS) from published data. Values calculated as Unburned value minus Burned value. Data source: Andosols (De La Rosa et al. 2013, Morales et al. 2013, Neris et al. 2013b); other soil types (González-Pérez et al. 2004, Marcos et al. 2007, O’Dea 2007, Campo et al. 2008, Terefe et al. 2008, Are et al. 2009, Varela et al. 2010, Certini et al. 2011, Mataix-Solera et al. 2011, Badia-Villas et al. 2014).

al. 2007, O'Dea 2007, Campo et al. 2008, Terefe et al. 2008, Are et al. 2009, Varela et al. 2010, Mataix-Solera et al. 2011, Badia-Villas et al. 2014 – Fig. 4b). According to Mataix-Solera et al. (2011) this is the typical response of soils such as Andosols, whose main binding agent is SOM (Candan & Broquen 2009). As reported by several authors (De La Rosa et al. 2013, Morales et al. 2013, Neris et al. 2013a, 2014), Andosols' SOM can be severely reduced and its chemical composition altered by fire. According to the aforementioned authors, fire-induced SOM reduction ranges from 20 to 4 g 100 g⁻¹ and > 50% of the fire-affected soils evaluated showed a decrease in excess of 10 g 100 g⁻¹ (Fig. 4a). Contrastingly, the reduction of SOM in non-volcanic soils rarely exceeds 5 g 100 g⁻¹ (González-Pérez et al. 2004, Varela et al. 2010, Certini et al. 2011 – Fig. 4a). Additionally, several authors have reported a significant decrease in AS and the alteration of soil porosity of volcanic soils under severe drying processes (Buytaert et al. 2002, Woignier et al. 2008, Dorner et al. 2010). The combined impact of fire on both SOM and soil mineralogy could explain the considerably high reduction of AS exhibited by Andosols.

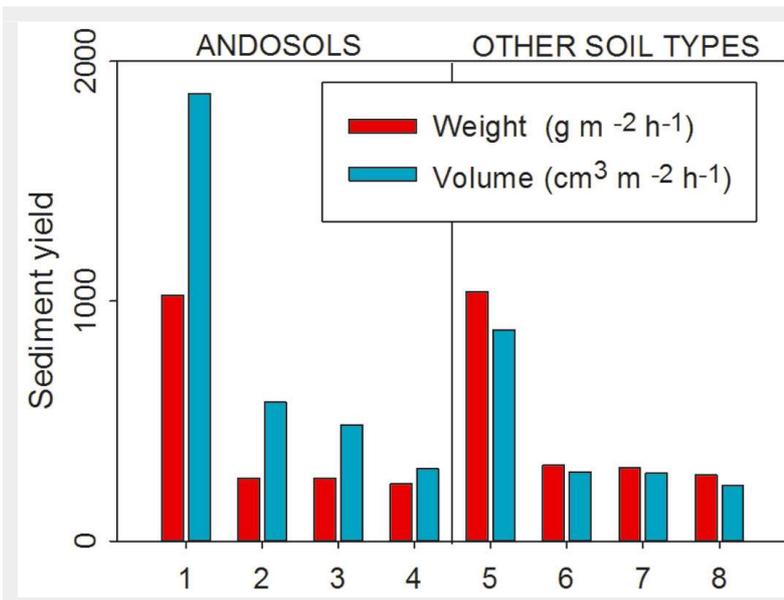
Fig. 5 - Comparison of post-fire sediment yields in Andosols and other soil types reported using rainfall simulations. Yield measured in weight (red) and volume (blue) for Andosols (left) and other soil types (right). Data source: (1): Morales et al. 2013; (2): Neris et al. 2013a; (3): Neris et al. 2013b; (4): Poulenard et al. 2001; (5): Woods & Balfour 2008; (6): Pierson et al. 2009; (7) Cerdà & Doerr 2008; (8): Woods & Balfour 2008.

dosols follow the generally reported trend of fire-induced enhancement of soil loss, with figures from rainfall simulation experiments ranging from 30 to 2000 g m⁻² h⁻¹ depending on fire severity and rainfall intensity (Poulénard et al. 2001, Morales et al. 2013, Neris et al. 2013a). Most authors hypothesize that this general response may be due to: (i) the increase in runoff; (ii) the decrease in soil cover and the protective effect of vegetation and organic layers (forest floor); and (iii) the reduction in aggregate stability (Shakesby & Doerr 2006). For Andosols, Poulénard et al. (2001) attributed the increase in soil loss to the rise in runoff and decrease in aggregate stability causing surface sealing. Neris et al. (2013a) hypothesized that the reduction in structural stability and the loss of soil cover are the key factors in the erosional response, as no significant changes were found in infiltration after the fire. Morales et al. (2013) highlight three factors (runoff, soil cover and aggregate stability) as being responsible for soil loss increase. Additionally, both Morales et al. (2013) and Neris et al. (2013a) suggest that fire severity plays a key role in the erosion process as it greatly influences the soil cover and, thus, the protection against raindrop impact and detachment by runoff in the post-fire period. Soil erosion from rainfall simulation experiments by Neris et al. (2013a), Poulénard et al. (2001) and Morales et al. (2013) for fire-affected Andosols is comparable to that reported for other soil types and environments (Benavides-Solorio & MacDonald 2001, Cerdà & Doerr 2008, Woods & Balfour 2008, Pierson et al. 2009). However, it has been demonstrated that Andosols' low bulk density is half or even one third of that of other fire-affected soil types (Neris et al. 2013a). Therefore, the expected volumetric soil loss can be considerably higher and its impact downslope can be catastrophic (Fig. 5). Regarding the erosion mechanism, Andosols show a distinctive behavior. According to previous studies, the erosion of this soil type is not a consequence of the dispersion of clay and transport of primary particles, but occurs mainly by detachment of small, highly water repellent, low bulk density, stable aggregates and their transport by flotation on the runoff (Poulénard et al. 2001, Rodríguez Rodríguez et al. 2002, Morales et al. 2013, Neris et al. 2013a).

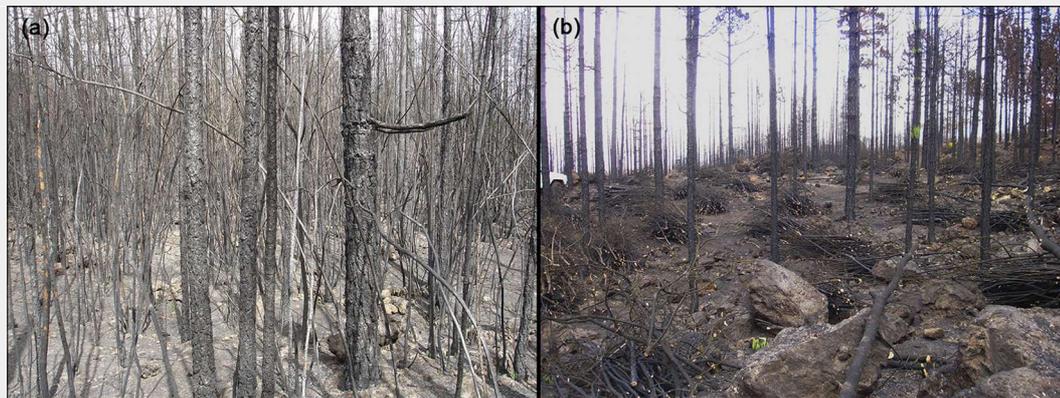
Fig. 7 - Example of restoration works after the large forest fire of 2007 in Tenerife. Fire-affected forest area before (a) and after (b) silvicultural practices.

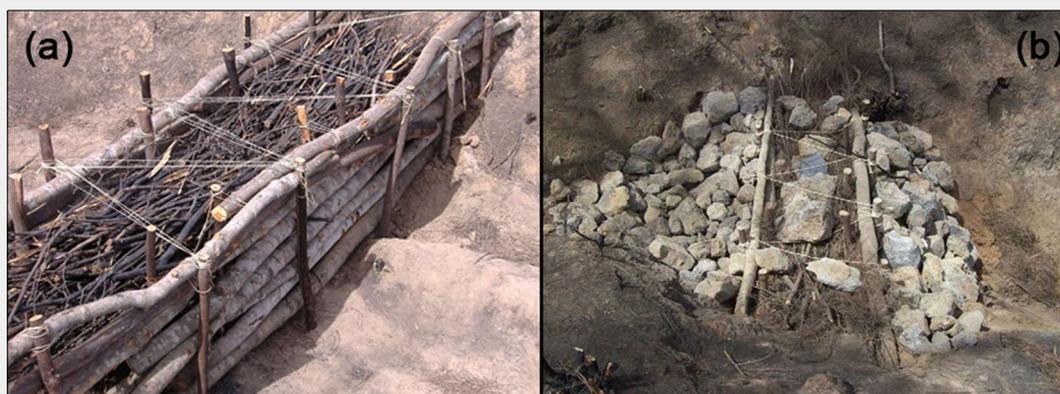
Fig. 8 - Construction process of the rock and biomass mixed dam. Trench constructed and filled with debris from the silvicultural works (a) and reinforced by rocks (b).

In addition to the traditional channel treatments, an innovative structure adapted to local conditions, called rock and biomass mixed dam, was developed after a forest fire in Tenerife that burned 17 000 ha in the summer of 2007 (Ministerio de Medio Ambiente y Medio Rural y Marino 2008). Due to the magnitude of the wildfire and the resulting risks, the structure was designed to be low-cost, easy and rapid to be implemented to reduce hydrological risks. The mixed dam is a temporary structure that combines different mitigation techniques such as contour logs, contour trenches and rock dams. Similarly to other channel treatments, its main objective is to reduce water velocity and enhance infiltration and sediment deposition. The mixed dam consists of vegetal debris used as vertical stakes (mainly burned logs

of *Erica* sp. and *Myrica faya*) and horizontal logs (mainly from burned *Pinus canariensis*) and biodegradable rope to tie the stakes and logs together as a trench and to anchor the whole structure to adjacent trees. The trench is reinforced on the outside by the rock slope to gain stability (less than 50% slope angle) and filled on the inside with vegetal debris obtained from silvicultural work and topped again with rocks (Fig. 8). Its dimensions vary depending on the channel width, although always ranging from 1 to 2 m in height and 8 to 10 m in width. A prediction of the maximum water flow and water level expected in the post-fire period are essential to design these structures. Additionally, the rock density, the resistance to flexion of the wood stakes and logs, the resistance reduction coefficients and the load increase coefficients for both permanent (structure weight) and temporary loads

(water flow) are taken into account in their design. The distance between these structures in a channel is determined according to the structures' height and the channel slope angle (Tardío Cerrillo & Caballero Serrano 2009).

This structure is usually used as a principal treatment in ephemeral or small-order channels and as a secondary treatment complementing rock dams and gabions in larger channels. Due to the biodegradable nature of most of their components, these structures can also facilitate colonization by plants (Tardío Cerrillo & Caballero Serrano 2009 - Fig. 9). This innovative structure has several useful features: (i) it reduces the channel slope and, thus, water speed and detachment capacity; (ii) promotes infiltration and sedimentation; (iii) economizes resources and time by using on-site material for its construction; (iv) enhances the colonization of vegetation due to the biodegradable nature of most of its components. The advantages attributable to this mixed dam are: (i) notable sediment storage capacity, mainly large material as vegetal debris or rocks; (ii) high adaptability of the design and the components used to the environment conditions; (iii) notable vegetation recovery and colonization of the channels due to the nature of its components.

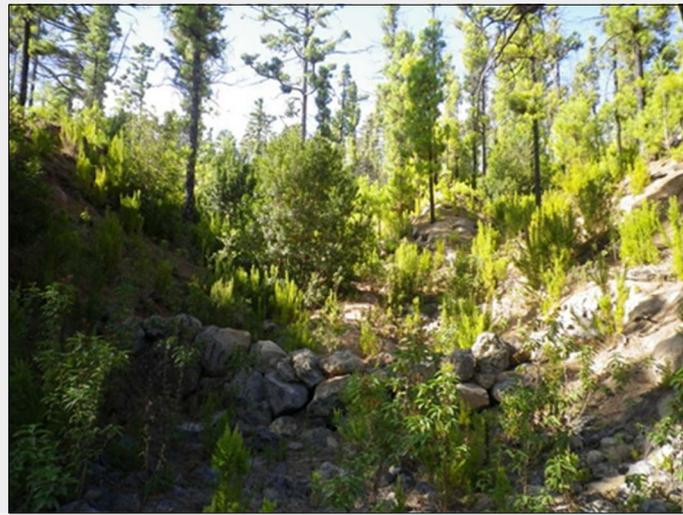
Fig. 9 - A mixed dam structure built in Tenerife after the large wildfire of 2007, colonized by forest species one year after its construction.

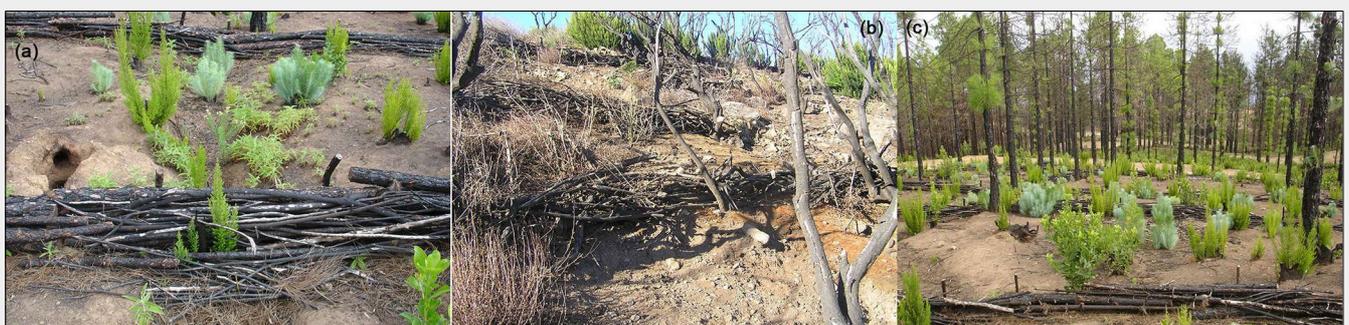
Fig. 10 - Example of surface treatments after the large wildfire of 2007 in Tenerife. Small dams built using on-hand logs and branches.

Regarding hillslope treatments, the construction of erosion barriers to reduce runoff and sediment transport is the most used mitigation action in the Canary Islands. It includes contour-felled logs and small dams constructed using vegetal material, mainly small burned logs and branches obtained from the silvicultural work (Fig. 10). Due to budget constraints, no monitoring programmes have been put in place to evaluate the effectiveness of these treatments for Andosols. However, erosion barriers, widely used at the beginning of the century as an effective on-site control of runoff and erosion in Spain (Fernández et al. 2011, Badia et al. 2015, Ferreira et al. 2015) and elsewhere (Raftoyannis & Spanos 2005, Robichaud et al. 2008, Myronidis et al. 2010, Ahn et al. 2013, Aristeidis & Vasiliiki 2015), have been replaced lately by dry mulch treatments by land managers. This treatment aims to provide cover to the mi-
